WATERLOO BUS TRIPPINGS BETWEEN 6 DECEMBER 2010 AND 3 FEBRUARY 2011

PREPARED BY: Electricity System Operations Planning and Performance

DATE: 25 March 2011

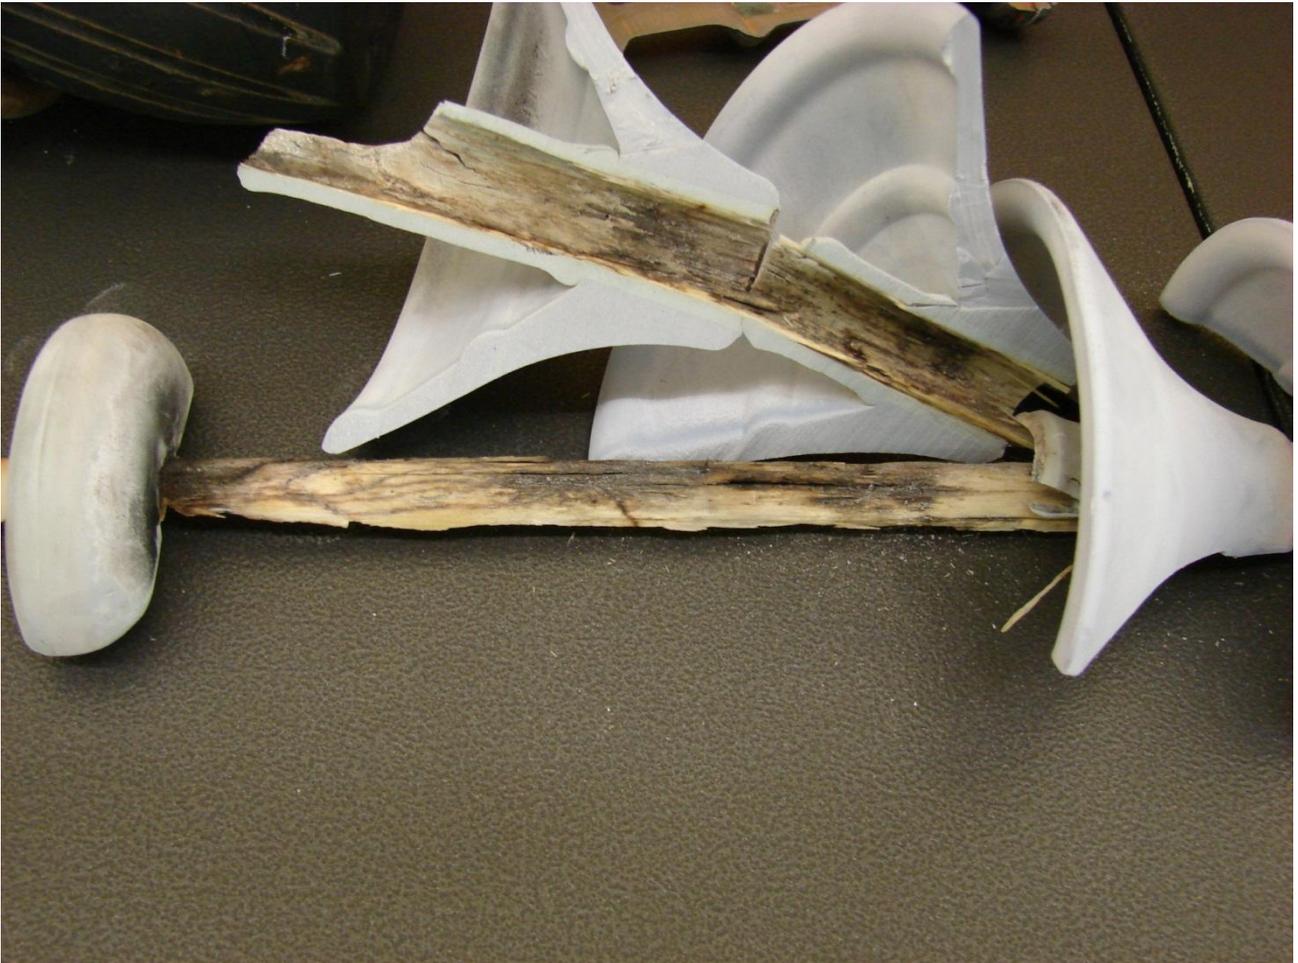
This time the search for the cause of the bus zone tripping included the use of specialized binoculars. The binoculars were able identify that the T phase on the Western side of the busbar had flashed over. The flash over was not previously identified because the failed insulators were at a considerable height above ground. The polymeric insulators (LAPP type) on the Western side had tracked but the tracking marks were not facing the ground. Flashovers were occurring underneath rubber sheaths that had tracked along the fiberglass core.

The Waterloo 132 kV bus zone B tripped on the operation of bus zone protection on four separate occasions - on 6 and 7 December 2010, 14 January 2011 and 3 February 2011. The bus zone protection system operated as designed. Damaged LAPP type polymeric insulators on the Western side of the bus were the root cause of the four incidents. See photographs of the damage caused by the flash over under LAPP insulator in Appendix 1. All the LAPP type polymeric insulators at Waterloo have since been replaced.

Figure 3 Damage caused by flashover occurring underneath the rubber sheaths

All LAPP type polymeric insulators at Waterloo substation were replaced on 04 February 2011. The removed LAPP insulators were HV tested to assess their condition. Although the insulators passed the tests for wet and dry conditions, their deterioration and susceptibility to high voltages was noted. The flashed LAPP insulators were dissected to confirm the level of damage. See photographs in Appendix 1.

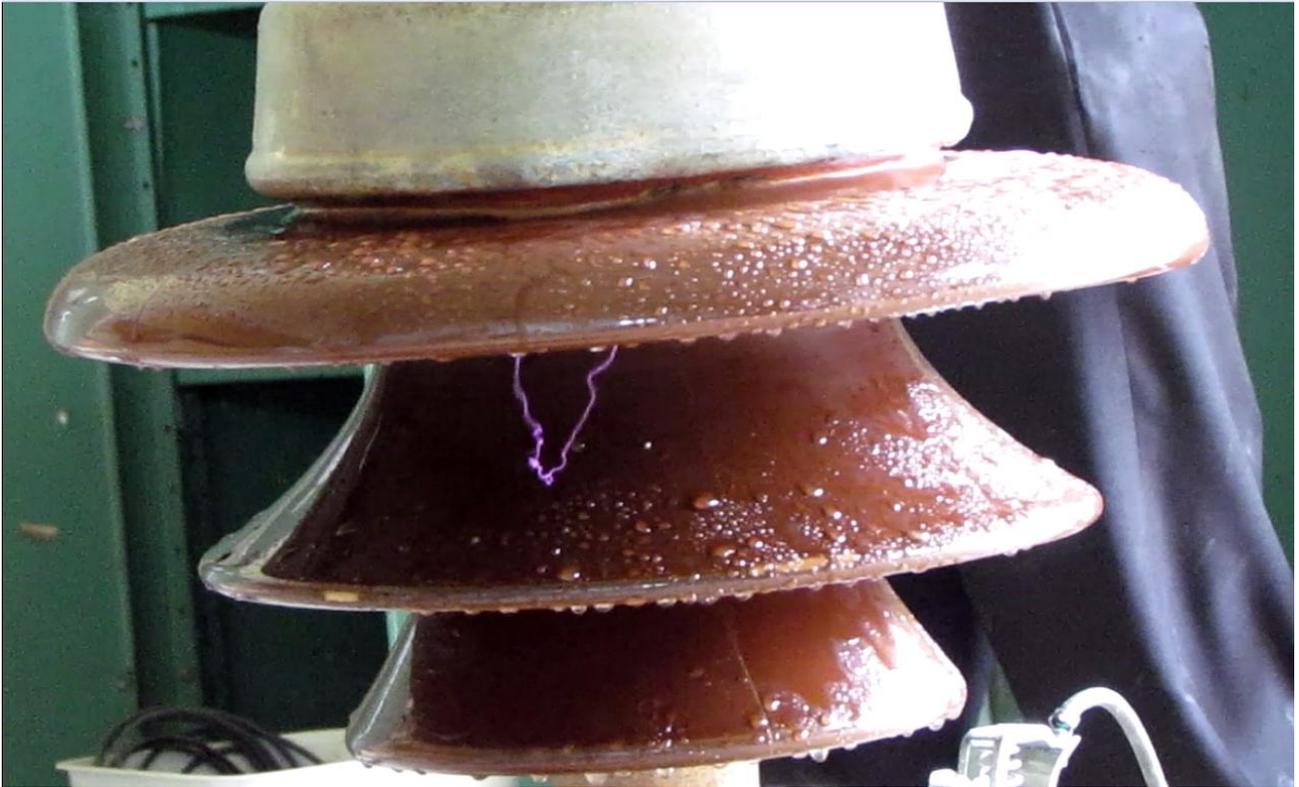
Electranet also carried out HV tests on the cracked porcelain insulators that had been removed. These tests showed that the cracked porcelain insulators could flash over when excessive moisture was applied. See photograph in Appendix 2. Heavy rainfall was experienced during all of the tripping occurrences mentioned in this report.

Figure 4 Flashover occurring during moisture tests

Several cracked insulator discs that were found on the Mintaro - Waterloo 132kV transmission line isolator 6165 were replaced before the busbar was reenergised. Some insulators that showed signs of pollution were also cleaned on the day.
