POWER SYSTEM NOT IN A SECURE OPERATING STATE IN VICTORIA ON 15 JUNE 2016

REVIEWABLE OPERATING INCIDENT REPORT UNDER THE
NATIONAL ELECTRICITY RULES

Published: **November 2016**

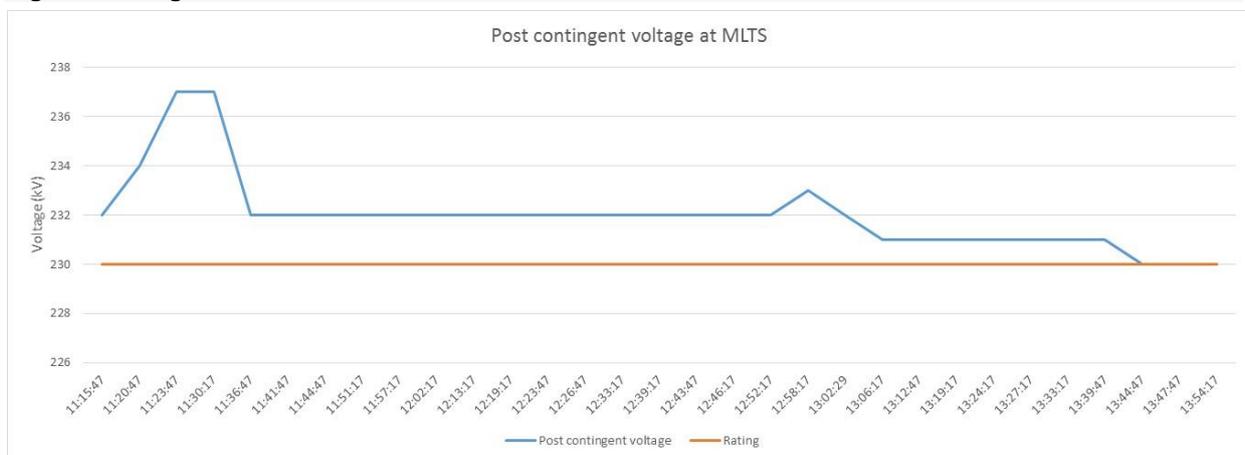
Figure1: Voltage violations at MLTS

When the MLTS-ELTS-BATS line was energised from BATS, AEMOs Contingency Analysis (CA) tools immediately showed post contingent voltage violations at the MLTS end of the line⁷. This was then exacerbated when the Mt Mercer wind farm reconnected to the power system. Although CA showed violations for a number of potential contingencies⁸, the most severe violations would occur with the loss of the BATS-MLTS line. Figure 1 shows the voltage levels that would have occurred at MLTS if the BATS-MLTS line had tripped. The maximum allowable voltage at MLTS is 230kV.

The table below shows the list of contingencies that would have resulted in voltage violations at MLTS. That is if the contingency in column 1 had occurred then the voltage at MLTS would reach the values shown in column 4. The maximum allowable voltage at MLTS is 230kV.

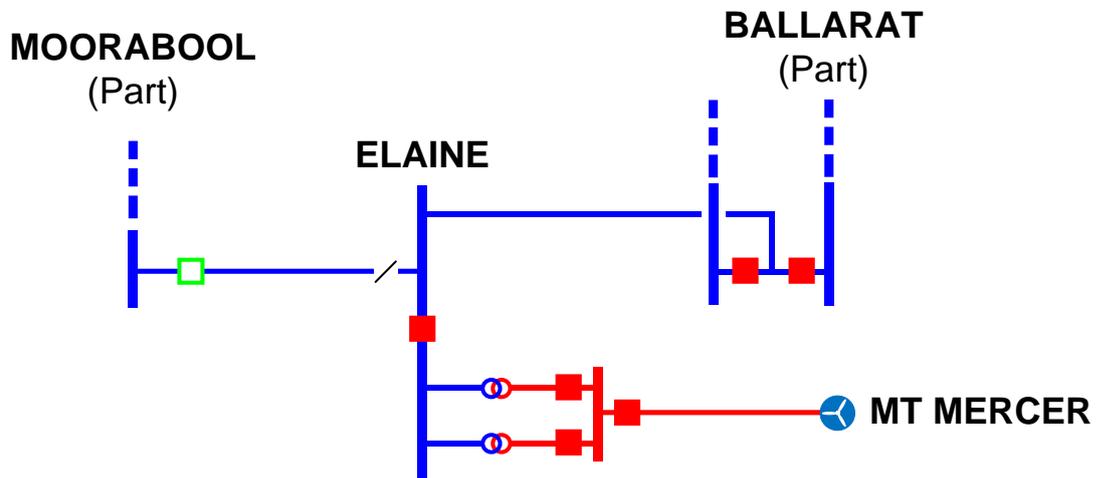
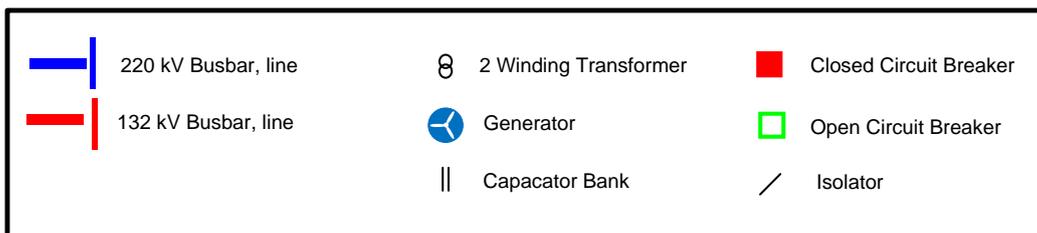
APPENDIX A. – POWER SYSTEM DIAGRAM

¹² Due to the switchgear arrangements at ELTS this required the outage of the BATS-ELTS line as part of the switching sequence. Refer to appendix A.

The diagram below provides an overview of the relevant part of the transmission network in Victoria during the incident.
