POWER SYSTEM OPERATING INCIDENT REPORT – TRIP OF WALLERAWANG UNIT 7 AND WALLERAWANG – ORANGE NORTH 132 KV LINE ON 2 JULY 2012

PREPARED BY: Systems Capability

DATE: 16 October 2012

FINAL

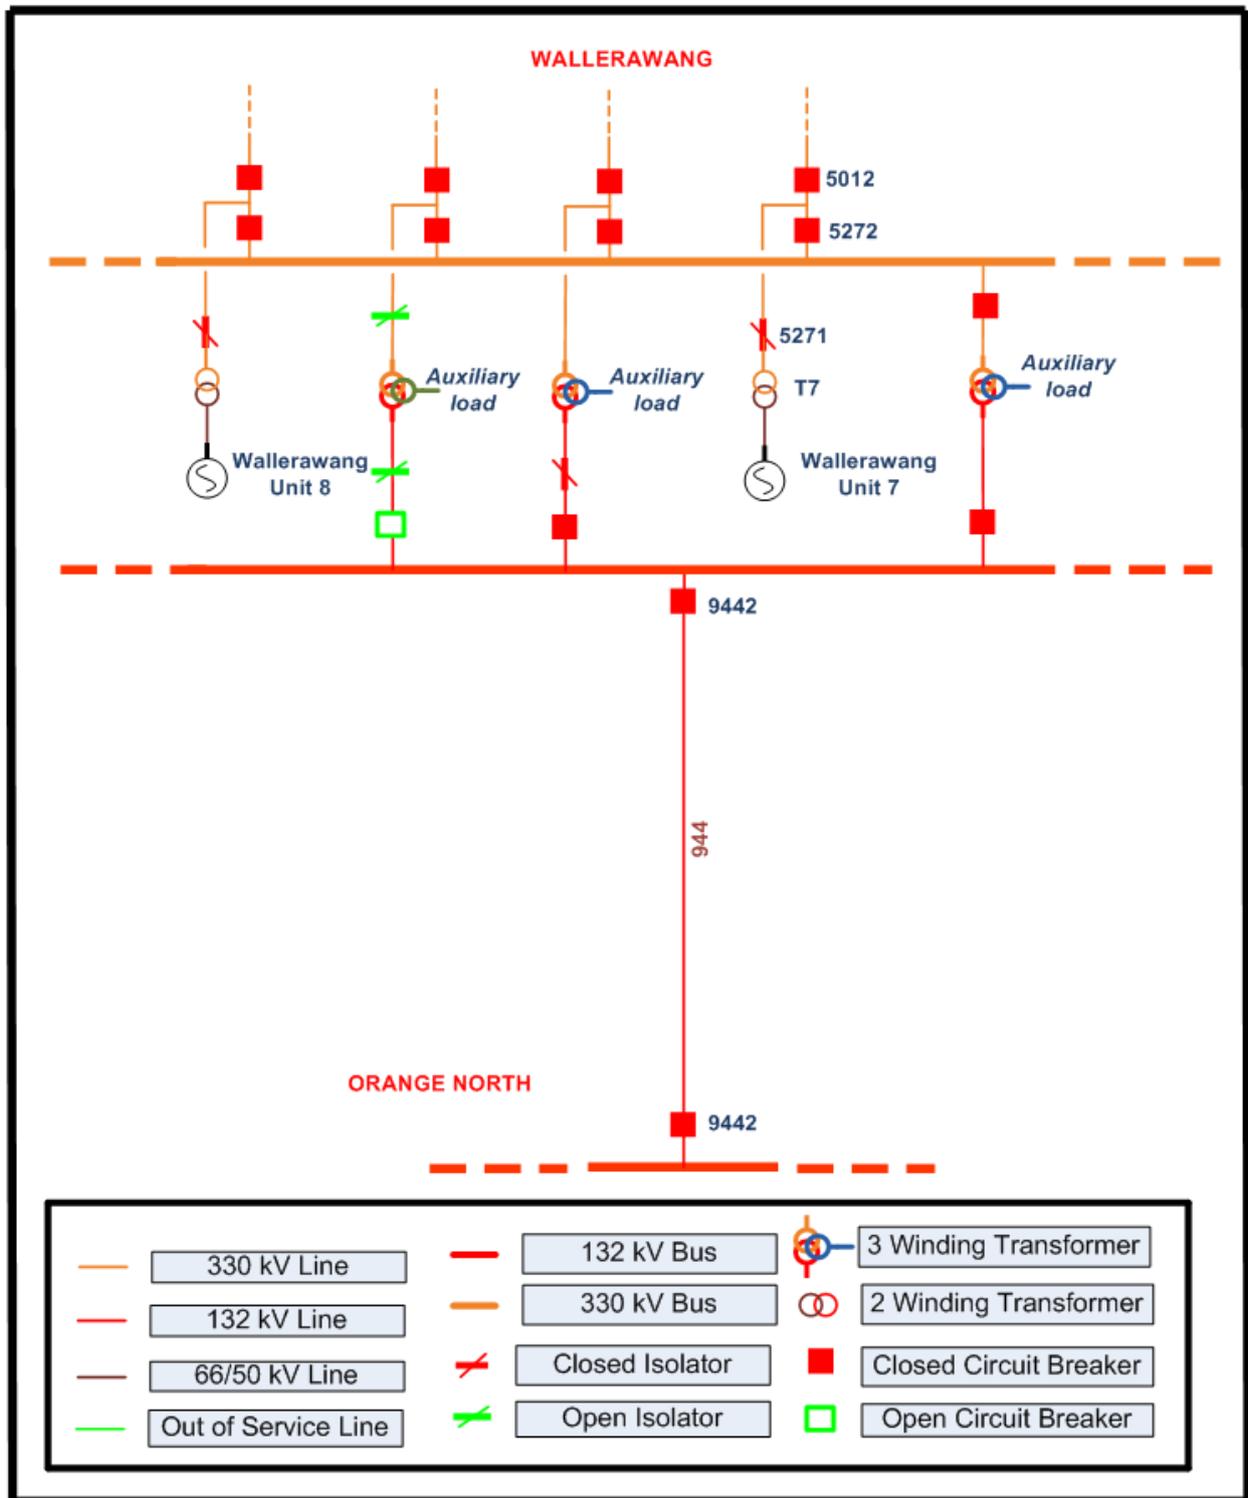
Figure 1 - Status of the power system prior to the incident

The status of the power system prior to the incident is shown in Figure 1. For clarity only equipment relevant to this incident has been included in the diagram. Wallerawang Unit 7 was generating approximately 472 MW at the time of the incident.

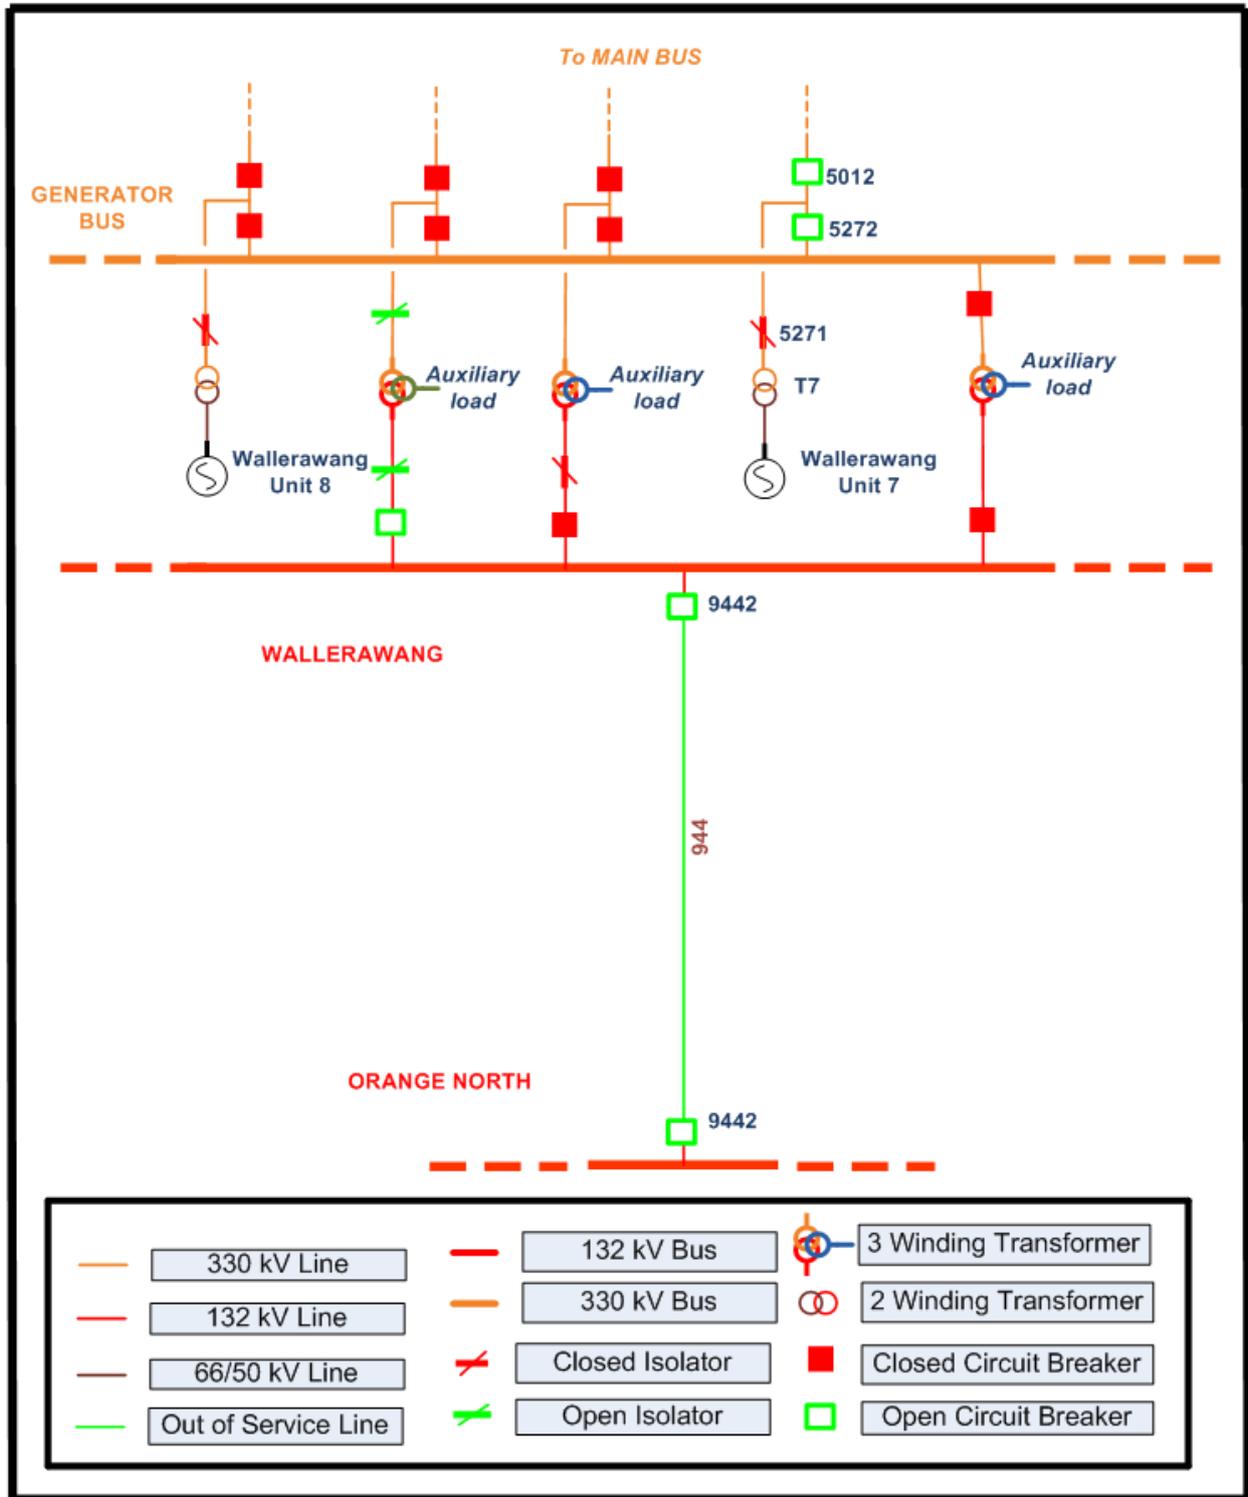
Figure 2 - Status of the power system immediately after the incident

At 1606 hrs Monday 2 July 2012 a fault occurred on the 944 Wallerawang – Orange North 132kV line. The fault was cleared by circuit breakers (CB's) 9442 at Orange North and Wallerawang. From the Orange North protection system data, the fault location is estimated to have been approximately 78 km from Orange North. An auto-reclose attempt was unsuccessful and the Wallerawang – Orange North line remained de-energised.

Coincident with the fault on the Wallerawang – Orange North line the Wallerawang Unit 7 generator transformer restricted earth fault protection operated to trip Wallerawang Unit 7 from approximately 472 MW (CB's 5272 and 5012 opened). Refer to Figure 2 for the status of the power system immediately after the incident. No load was interrupted as a result of this incident.

A fault on the Wallerawang – Orange North line resulted in the inadvertent trip of Wallerawang Unit 7. The cause of the Wallerawang – Orange North line fault could not be determined. The cause of the trip of Wallerawang Unit 7 has been identified as incorrect wiring of the restricted earth fault protection. The incorrect wiring was corrected on the 27 July 2012.

On the 27 July 2012 the cause of the mal-operation of the Wallerawang Unit 7 generator transformer restricted earth fault protection was identified as incorrect wiring of the restricted earth fault protection system. The wiring was corrected on 27 July 2012.
