New South Wales bushfires on 15 April 2018

February 2019

Reviewable Operating Incident Report under the
National Electricity Rules

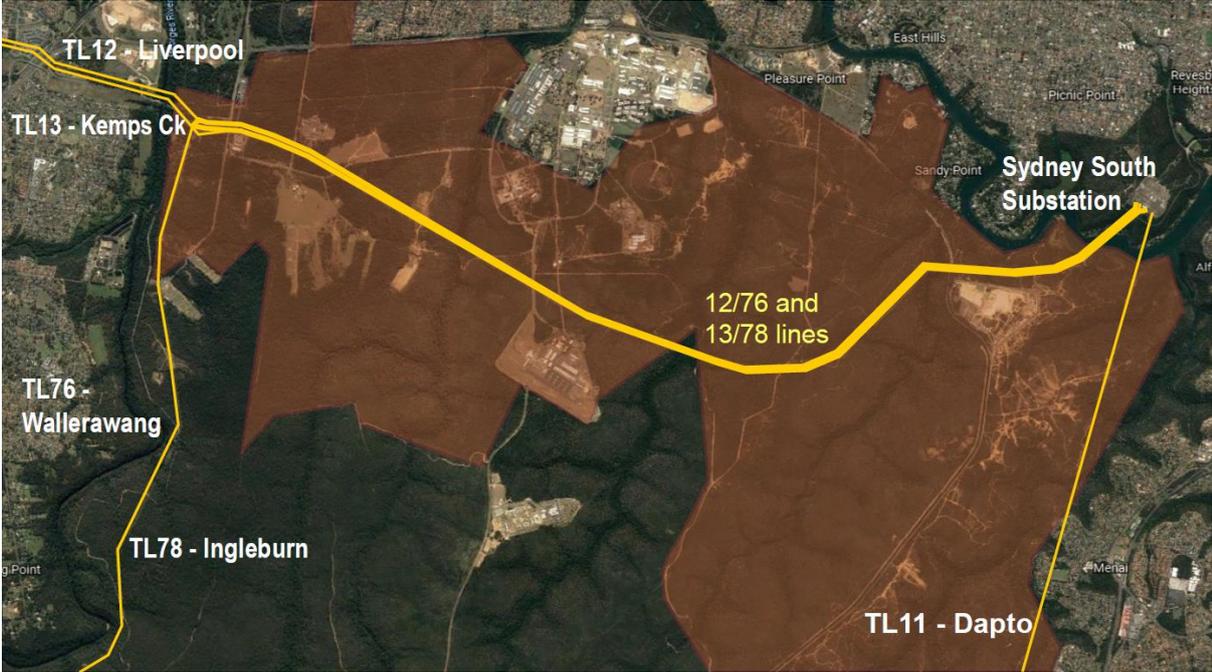
A1. Fire area

The diagram below, provided by TransGrid, shows the transmission corridors for the 11, 12, 13, 76, and 78 lines in relation to the fire area (shaded in red).
