# Trip of Multiple Transmission Elements at Ross Substation on 22 May 2018

Reviewable operating incident report under the  
National Electricity Rules

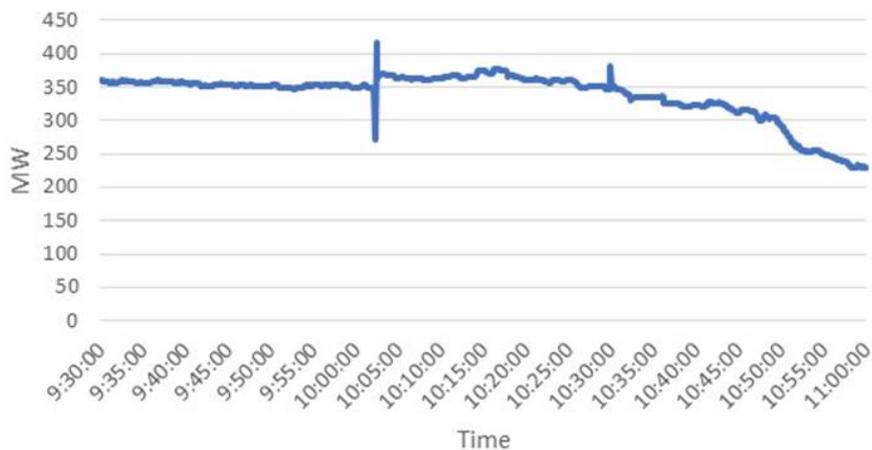
**Figure 1 Ross cut-set flow**

At 1029 hrs, Powerlink restored the No. 3 and No. 4 Transformers to service. This action returned the power system to a secure operating state before the flow across the Ross cut-set was substantially reduced. Figure 1 shows the Ross cut-set flow.

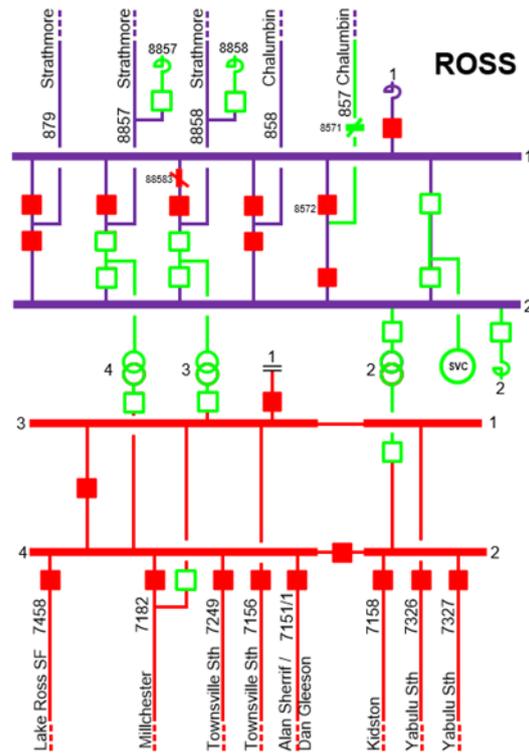
**After**

The link between the AC and DC systems caused a voltage transient on the 125 V 'X' battery system. This voltage transient impacted the inputs to some of the protection relays supplied by this battery system resulting in the simultaneous trip of Nos. 2, 3, and 4 Transformers, and the No. 2 and 8858 line reactors.

The diagrams below show the status of switchgear at Ross substation before and immediately after this incident.
