# POWER SYSTEM INCIDENT REPORT: TRIP OF 7139 AND 7284 132KV FEEDERS IN QUEENSLAND - 25 JANUARY 2010

PREPARED BY: Electricity System Operations Planning and Performance

FINAL

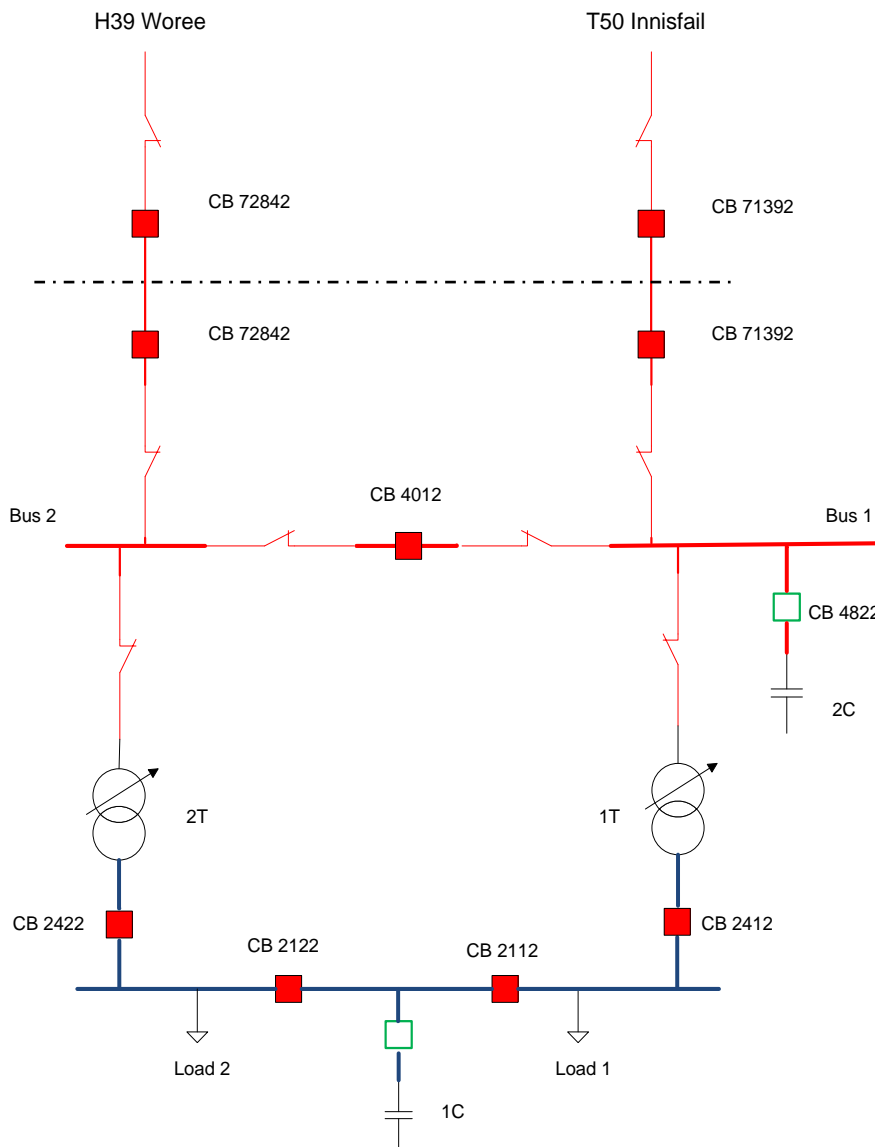
**Figure 1 Edmonton substation system configuration prior to tripping**

At 03:45:12 hours on 25 January 2010, protection systems detected a high voltage fault on the 7284 Woree – Edmonton 132kV line. The fault was believed to have been caused by thunder

storm and lightning activity present close to the Edmonton substation at the time. To clear the high voltage fault, protection systems operated to trip the circuit breakers (CB 72842) at Woree and Edmonton.

Coincident to the tripping of the Woree – Edmonton line, the Innisfail – Edmonton 132kV line also tripped at both Edmonton and Innisfail, interrupting approximately 14 MW of Edmonton load. The Woree – Edmonton line auto-reclosed at 03:45:17 restoring the Edmonton load.

Subsequent analysis and testing by Powerlink identified that a faulty protection relay was responsible for the tripping of the Innisfail – Edmonton line.

Investigations into the tripping of the Innisfail – Edmonton line identified a faulty protection relay. This protection relay was then replaced.

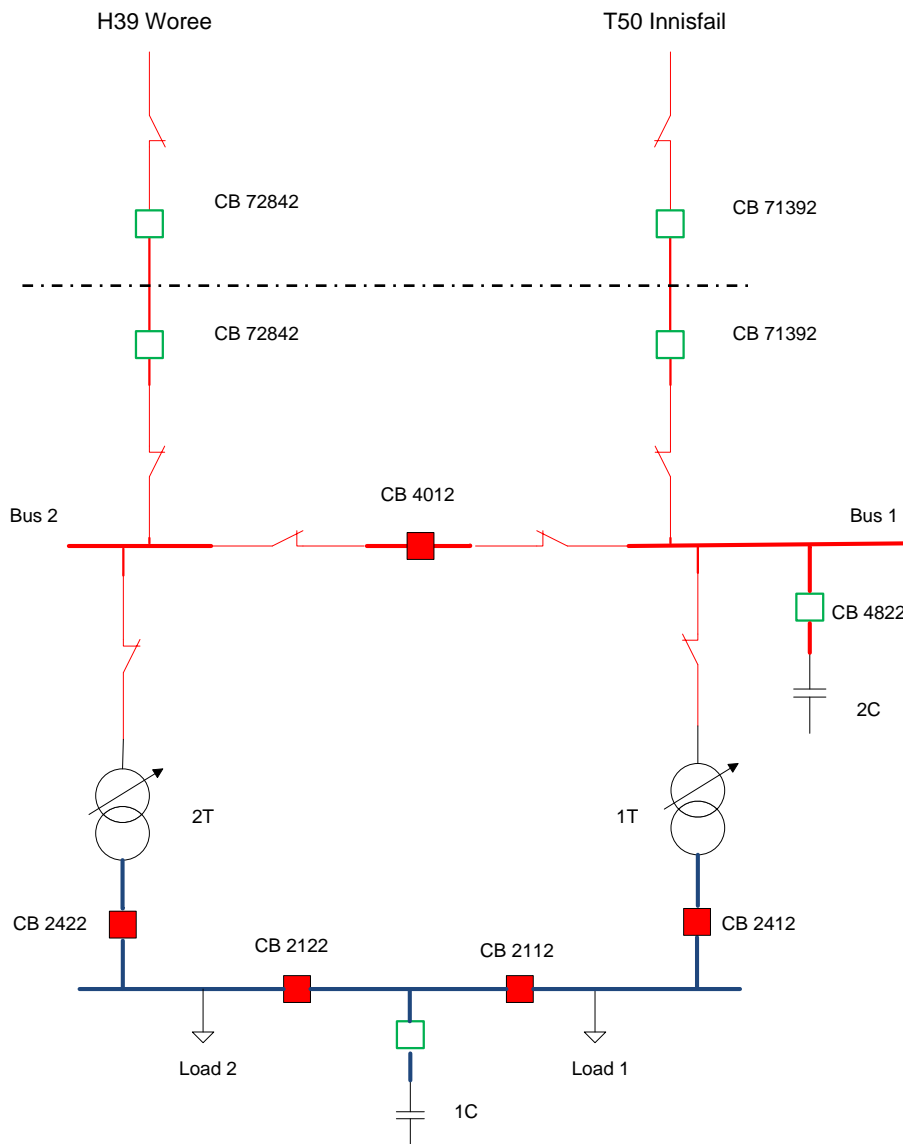
**Figure 2 Edmonton substation following the clearance of the high voltage fault**

Following the auto-reclosure of the Woree – Edmonton line approximately 5 seconds after the initial fault and the consequent energization of the Edmonton substation, the protection system of the 132/22 kV No. 1 transformer operated and initiated signals to trip the following circuit breakers:

- Bus section CB 4012
- CB 71392 of the Edmonton – Innisfail feeder (open following the trip of 7284)
- No. 2 Capacitor CB 4822 (previously open pre-fault)
- No. 1 Transformer 22kV CB2412

There was no interruption to Edmonton load this time since the supply was maintained via the No. 2 132/22kV transformer.

Plant restoration commenced at 06:55 hours once the cause of the No. 1 transformer trip was identified. Powerlink established that there was an issue with the manufacturer’s firmware installed on the No. 1 transformer protections.

The tripping of the No. 1 transformer at Edmonton was due to an issue with the manufacturer's firmware used on the No. 1 132/22kV transformer protections. The firmware has been upgraded to a version that addresses the protection issues as recommended by the manufacturer.

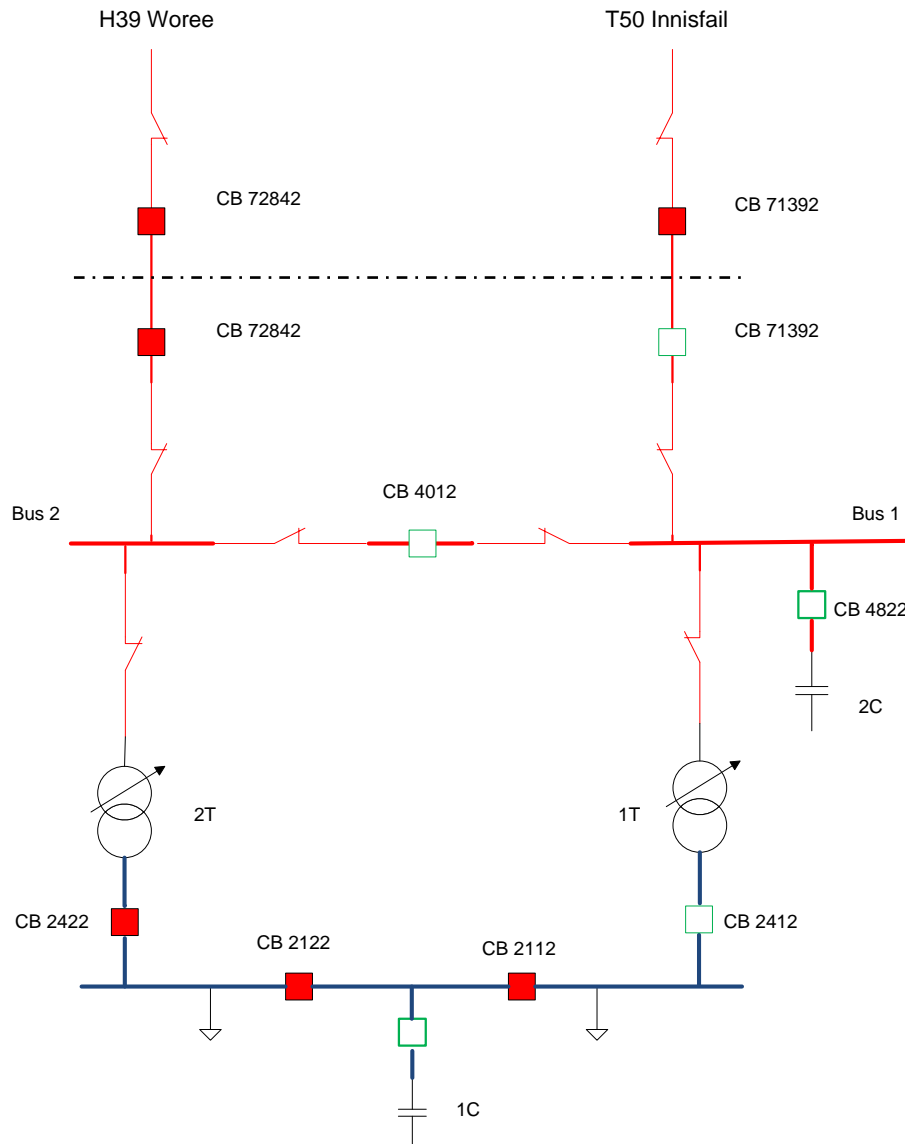
**Figure 3 Edmonton substation following the auto reclose operations**

At 03:45:22 hours, 10 seconds after the initial fault, auto reclose of the Innisfail – Edmonton line was initiated. The line successfully reclosed only at the Innisfail end, while the Edmonton end failed to reclose. This was as expected due to a latched trip signal that was still present following the tripping of the No.1 transformer.
