TANGKAM 110 KV NO.1 BUSBAR TRIP ON THE 27 JANUARY 2010

PREPARED BY: Electricity System Operations Planning and Performance

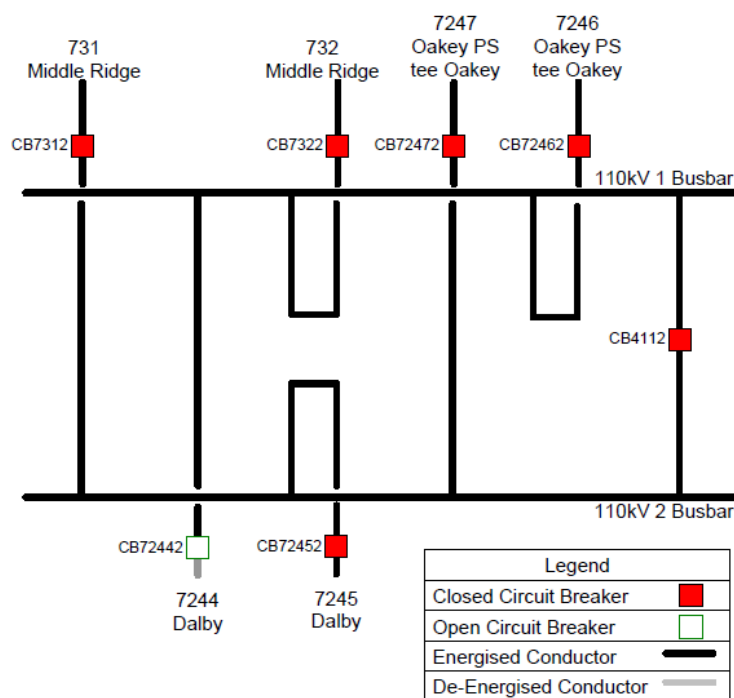
Figure 1: T147 Tangkam 110 kV Substation Circuit Breaker Status Prior to Busbar Trip

Figure 1 shows the status of relevant circuit breakers at Tangkam 110 kV substation prior to the incident.

The No.2 generating unit at Oakey Power Station connects to the transmission network via the feeder 7246. The No.2 generating unit at Oakey Power Station was generating at 144 MW prior to the busbar trip.

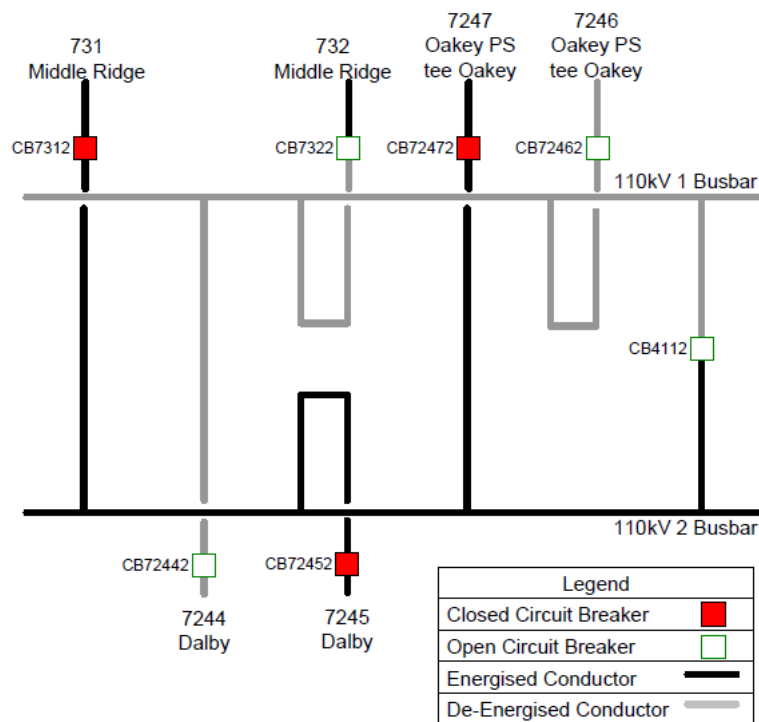
Figure 2: T147 Tangkam 110 kV Substation Circuit Breaker Status after the Busbar Trip

At 12:59:42 hrs on the 27th January 2010, the Tangkam substation 110 kV No.1 busbar tripped. The trip occurred due to the operation of the circuit breaker protection system during planned secondary system work within the substation. The following circuit breakers tripped at Tangkam substation:

- CB 4112 (No.1 – No.2 bus section circuit breaker).
- CB 7322 (Tangkam – Middle Ridge (732) 110kV feeder circuit breaker. This resulted in de-energising the feeder).
- CB 72462 (Tangkam – Oakey Power Station tee Oakey (7246) feeder circuit breaker. This resulted in tripping the No.2 generating unit at Oakey power station and de-energisation of the Tangkam – Oakey Power Station tee Oakey (7246) feeder).

Figure 2 shows the statuses of the circuit breakers after the Tangkam substation 110 kV No.1 busbar tripped.

Powerlink established that the main cause of this power system incident was the incorrect description of a terminal connection in the Tangkam secondary system diagrams.

This issue has been addressed to avoid any future reoccurrence. A high voltage fault was not present on the transmission network at the time of this event.
