POWER SYSTEM INCIDENT REPORT

TRIP OF PLAYFORD POWER STATION EAST 132KV BUS ON 27 JANUARY 2010

PREPARED BY: ESOPP

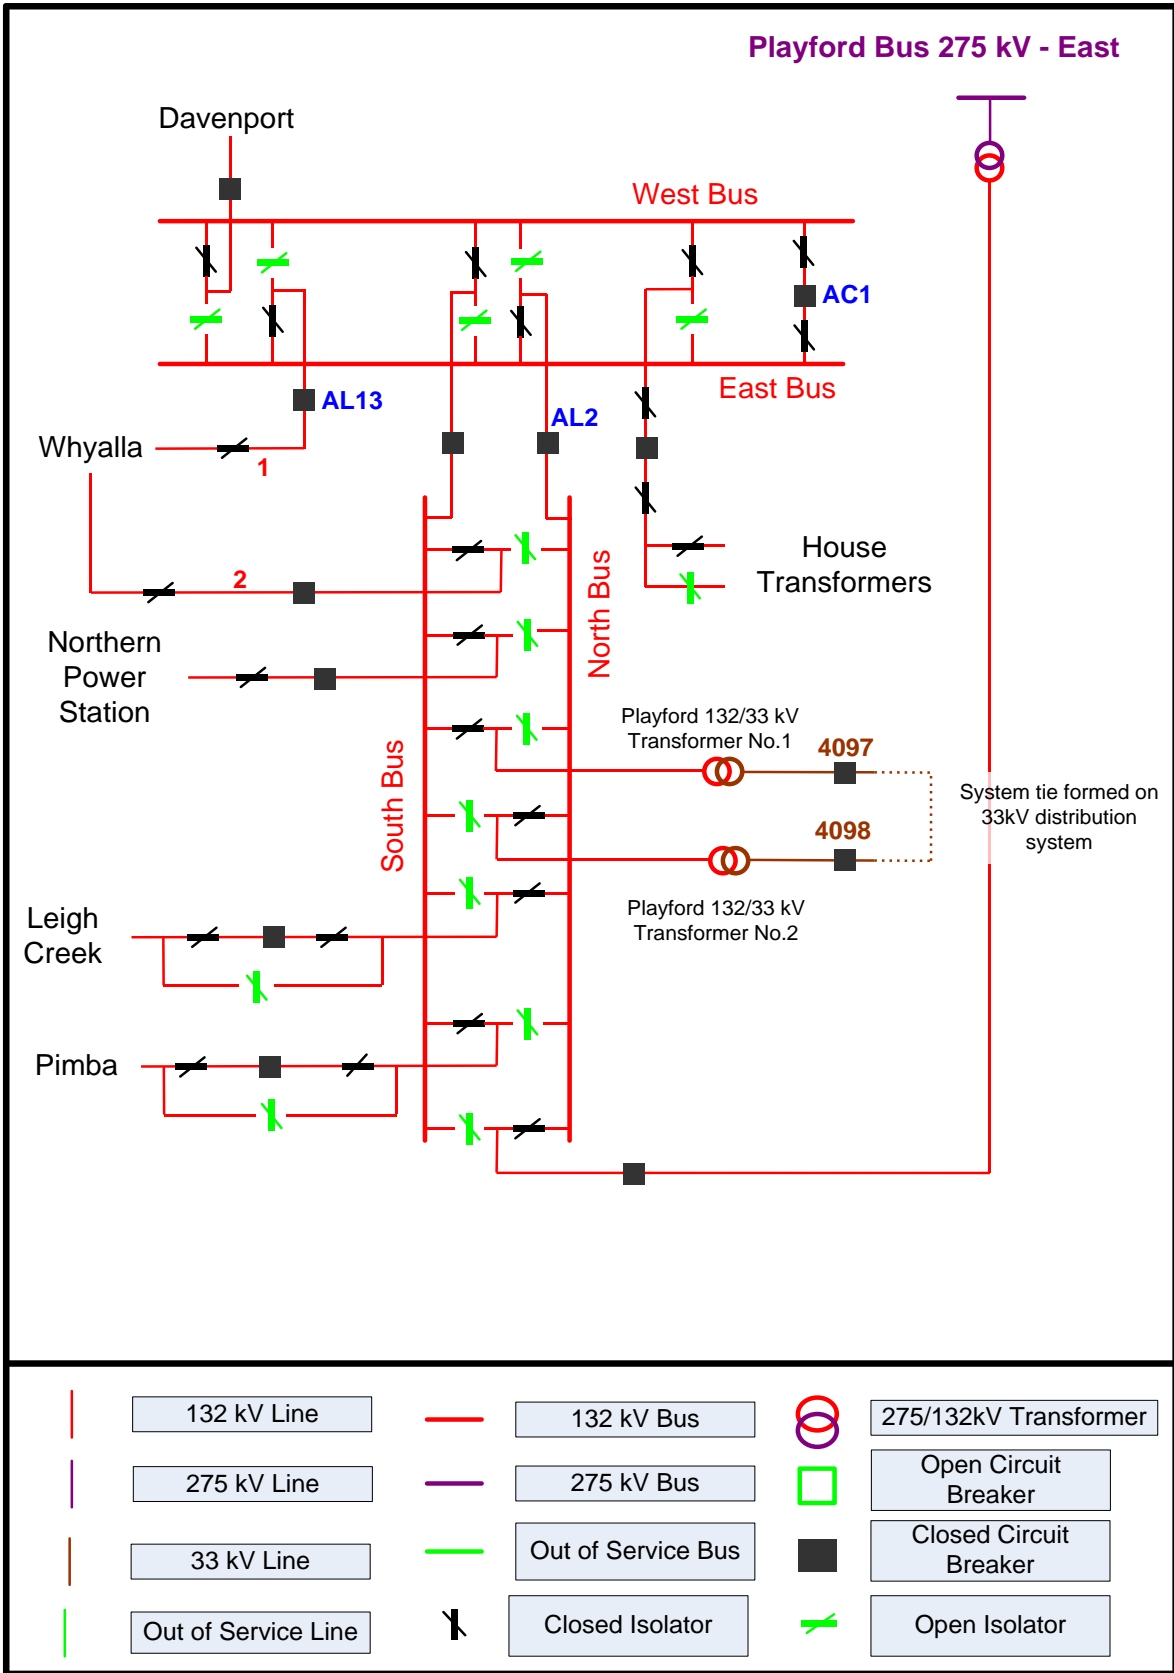
Figure 1 below illustrates the status of circuit breakers and isolators on all 132kV busbars at Playford A Power Station before tripping. The trip also offloaded the lightly loaded No.1 132kV Playford to Whyalla line, which did not result in any load interruptions. The trip of the 132kV East bus also resulted in the formation of a weak system tie via the 33kV distribution system between the Playford A Power Station 132kV North and South buses. The system tie was subsequently split to avoid any potential issues that could arise following loss of the Playford to Davenport 275kV line. Figure 2 outlines the status of Playford A Power Station after the bus trip.

FIGURE 1: STATUS OF 132KV BUSSES OF PLAYFORD A POWER STATION SWITCHYARD BEFORE THE BUS TRIP AT 21:47 HRS

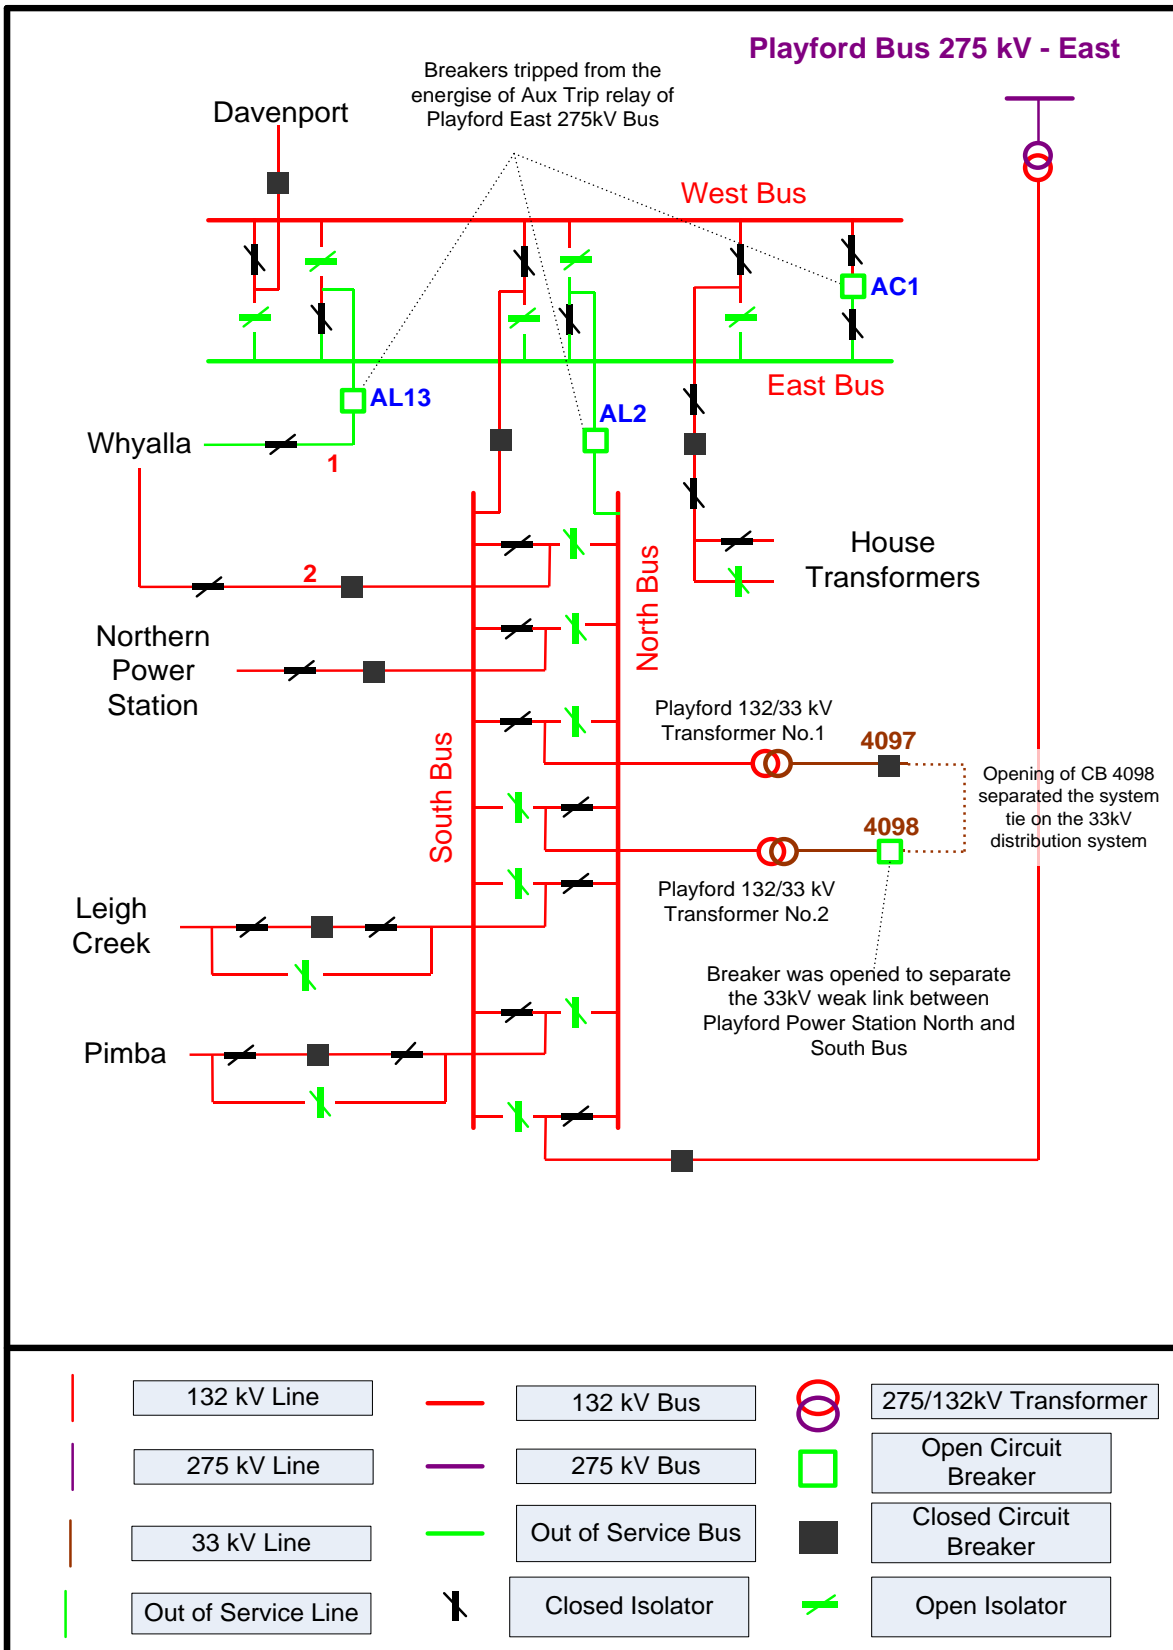
FIGURE 2: STATUS OF 132KV BUSSES ON PLAYFORD A POWER STATION SWITCHYARD AFTER THE BUS TRIP
