POWER SYSTEM INCIDENT REPORT: TRIP OF TORRENS ISLAND B1 AND B2 GENERATING UNITS – 21/01/2010

PREPARED BY: Electricity System Operations Planning and Performance

FINAL

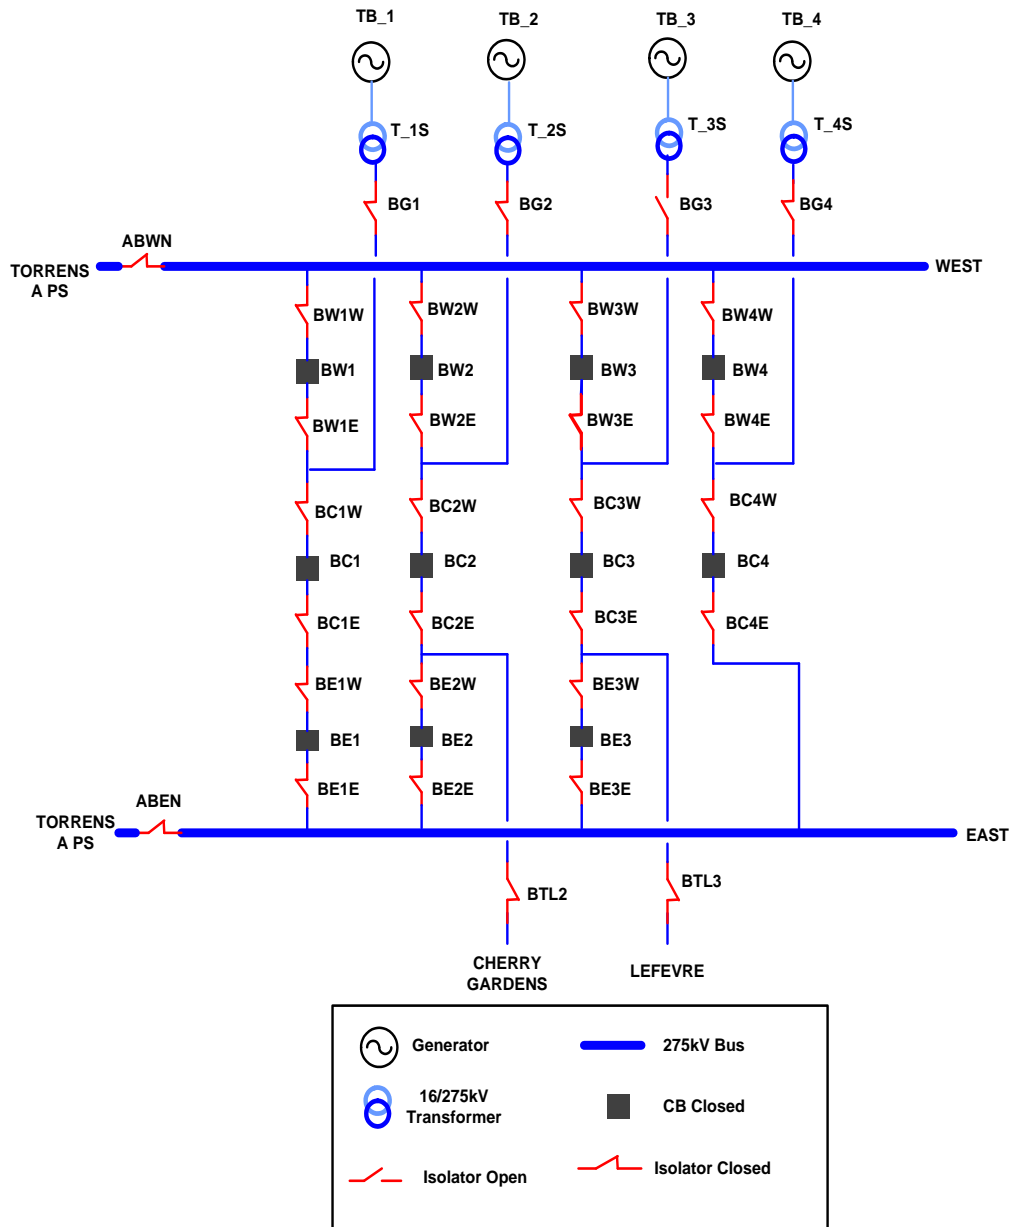
Figure 1: Network Topology at Torrens B Power Station before trip

On 21st January, 2010 while cooling water screen washing operations were being carried out, a flexible rubber bellows unit on the screen washing pump outlet failed flooding the cooling water valve pit with sea water. This resulted in loss of cooling water for generating units B1 and B2. As a result the generating unit B2 (TORRB2) tripped at 18:10 hrs. This was followed by generating unit B1 (TORRB1) tripping at 18:11 hrs.

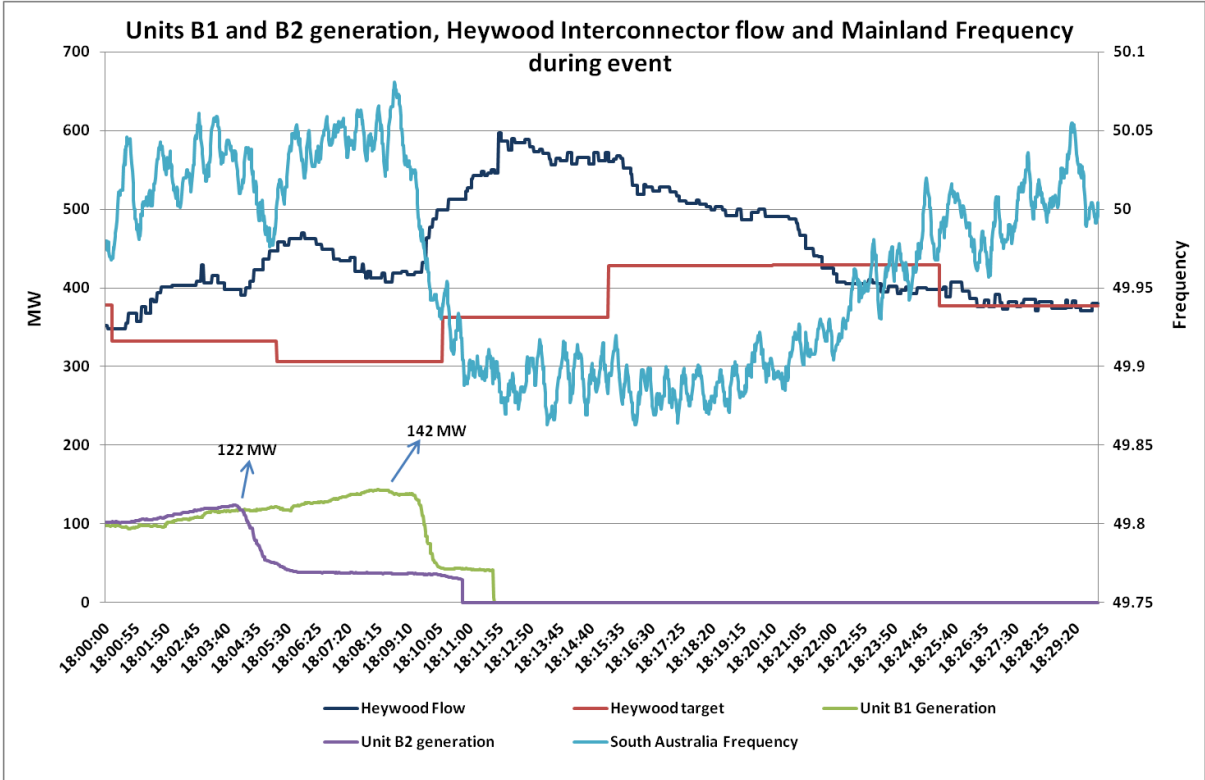
Figure 3: Generation pattern of B1 and B2 units, Heywood interconnector flow and its market Target, South Australian Frequency

at 18:04 hrs to 597 MW at 18:11 hrs immediately after the two generating units tripped. The Heywood Interconnector power transfer target was 362 MW in the dispatch interval (18:10-18:15) during which the two generating units tripped and 428 MW in the immediately following dispatch interval.

Real Time Contingency Analysis (RTCA) flagged post-contingent thermal rating violations of Heywood-South East lines at 18:14 hrs but the violations cleared in the next RTCA run at 18:19 hrs. The power system was returned to a secure operating state at 18:21 hrs when the Heywood Interconnector flow was reduced below its power transfer limit. Response of generation in Queensland, New South Wales and Victoria to the frequency decline combined with the cumulative non-conformance of South Australian generation led to Heywood interconnector power transfer above its targets. The individual non-conformances of generation were small; hence the declaration of individual unit non-conformances wasn't necessary.

The power system frequency reduced to 49.87 Hz during the event, but was well within the frequency operating standard requirement of 49.5Hz - 50.5Hz for a generation event.

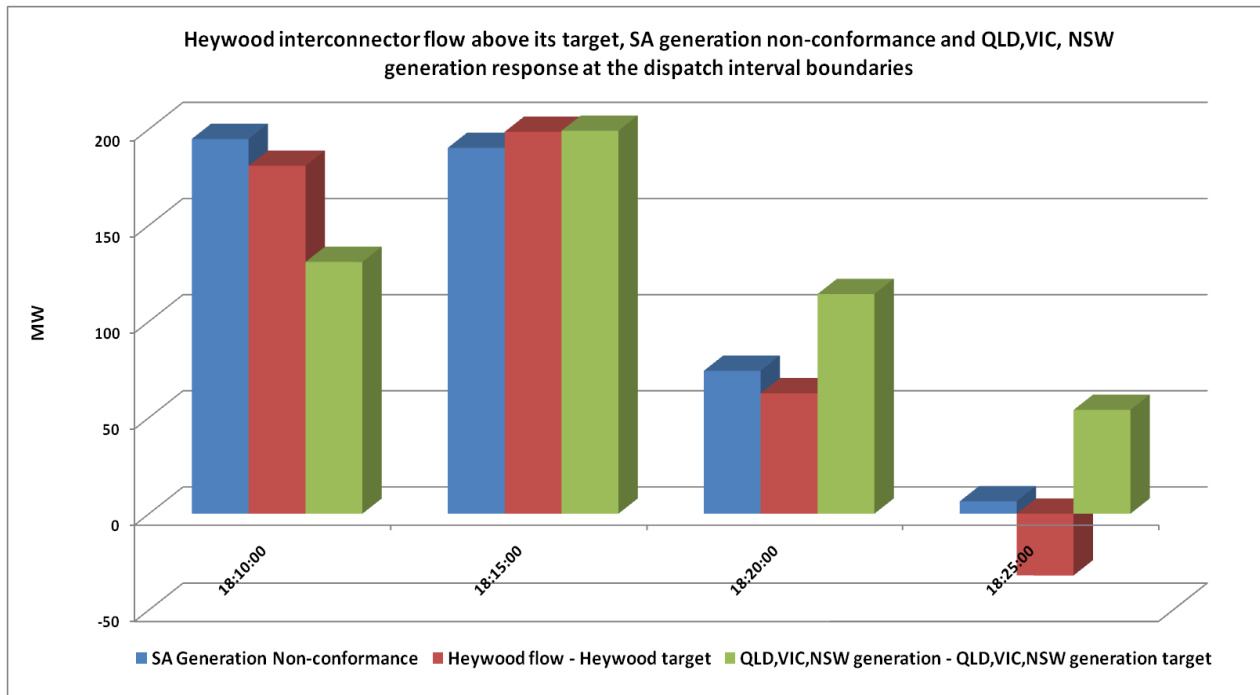
Figure 4: Increased Heywood Interconnector flow, generation response of Qld, NSW and VIC and generator non-conformance at the end of the dispatch intervals

Figure 4 below gives an indication of the cumulative non-conformance of South Australian generation, the power transfer on Heywood Interconnector and generation response from Queensland, Victoria and New South Wales during the course of the event.
