PLAYFORD 275KV EAST BUS TRIP ON 27 JULY 2010

PREPARED BY: Electricity System Operations Planning and Performance

DATE: 26 October 2010

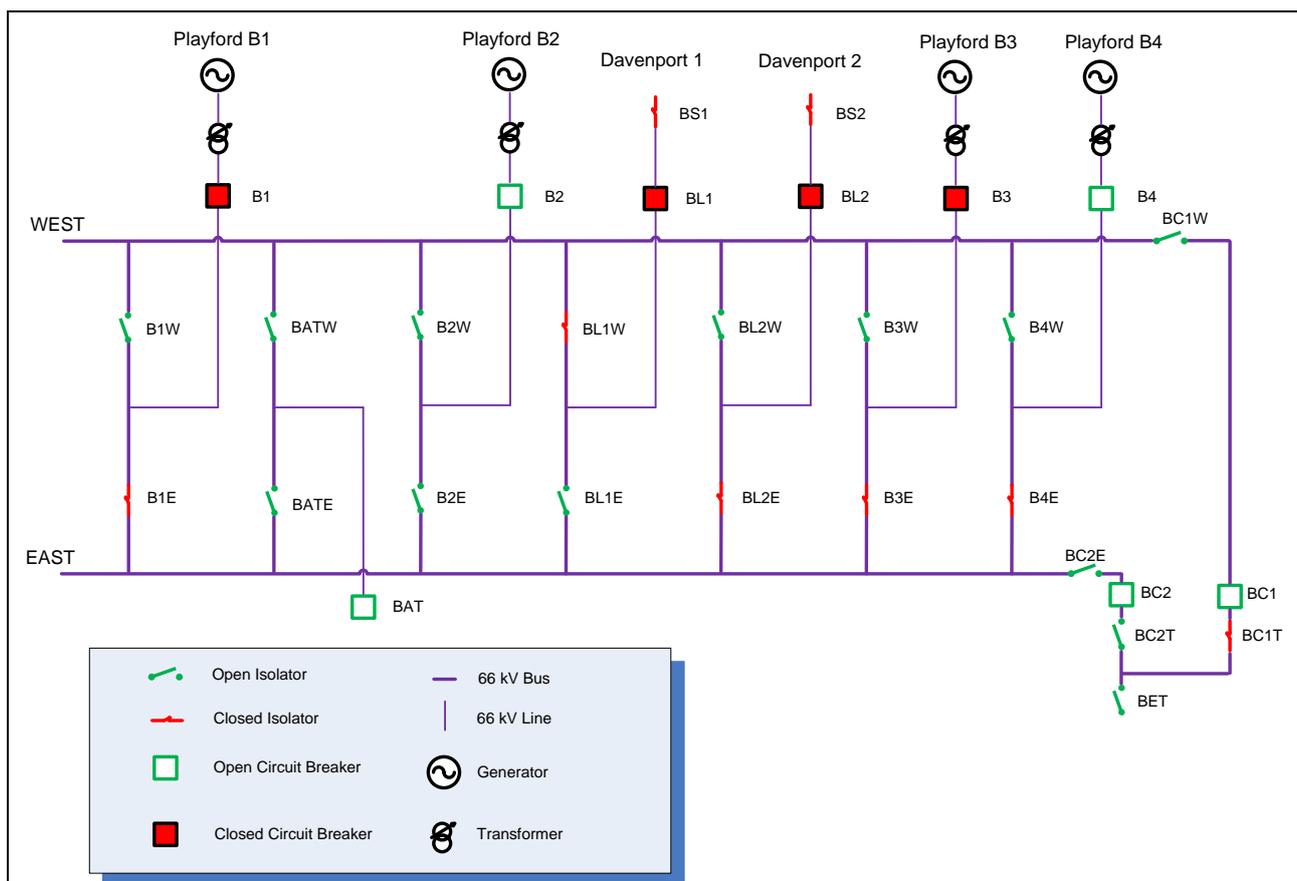
On 27th July 2010, in preparation for the replacement of circuit breaker BC2, part of the 275kV busbar surrounding BC2 was isolated as shown in Figure 1 below.

Figure 1 Playford 275kV system configuration during BC2 replacement

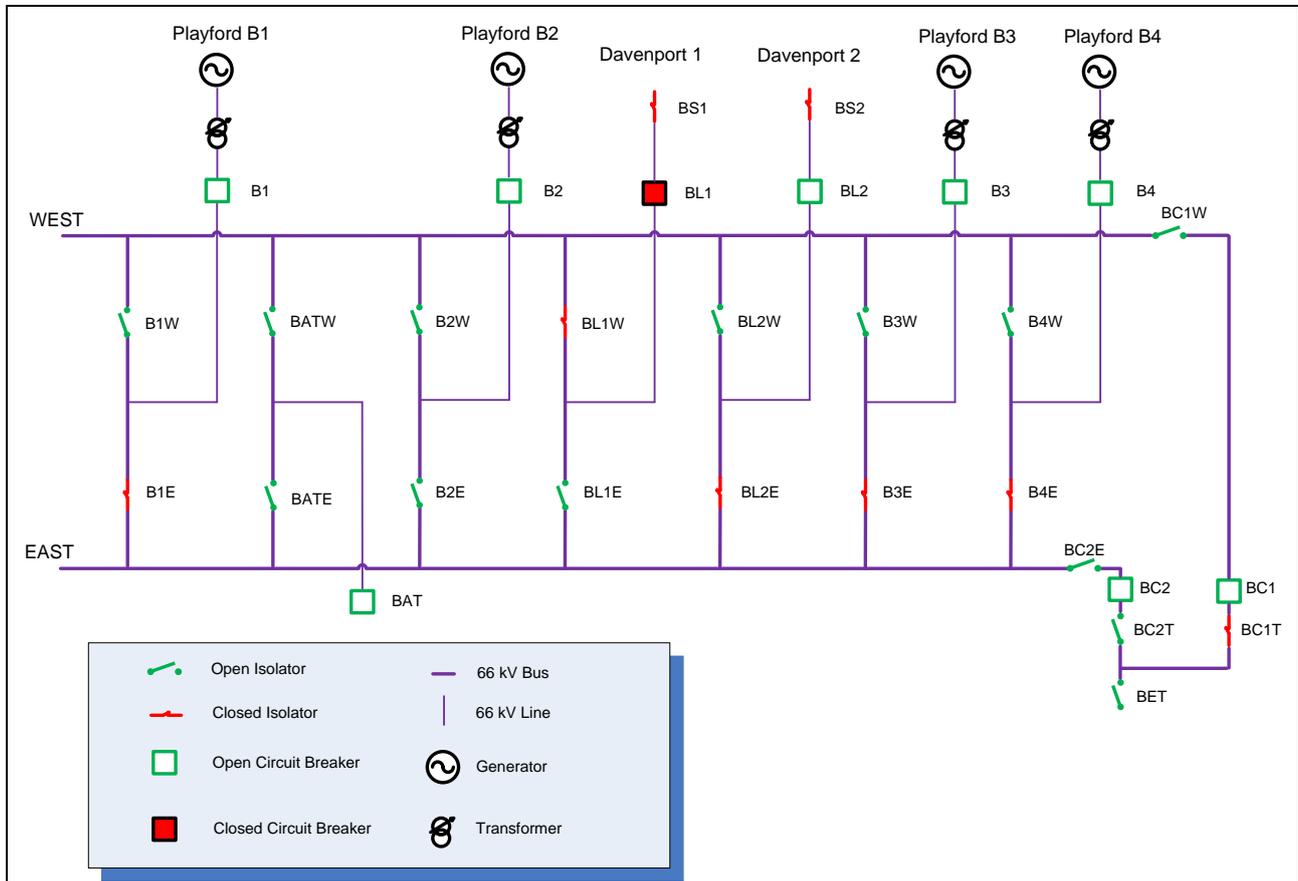
As part of the planned work, some of the secondary wiring associated with circuit breaker BC2 was being removed when one of the wires associated with the East bus zone protection inadvertently came into contact with an earth wire. The earth in this case was above the zero potential due to a non-related pre-existing earth fault.

This triggered trip signals to be sent to circuit breakers B1, B3, BL2 and BC2 (already open for CB replacement) due to the operation of the East bus zone protection and bus zone back-up protection simultaneously. The bus zone protection systems operated as designed to trip the circuit breakers.

Figure 2 below shows the state of the Playford bus following the operation of the bus zone protection.

Figure 2 System configuration after East bus zone protection was activated

Subsequent investigations by ElectraNet revealed that the inadequate secondary system isolation led to this incident. The earth wire was above the zero potential because of a pre-existing fault that provided a positive DC path to the bus zone protection systems. The faulty wiring connecting the DC positive to earth wire was repaired on 28 July 2010.

ElectraNet has issued instructions to relevant staff reinforcing the importance of properly isolating the relevant equipment when undertaking similar work in the future.
