POWER SYSTEM INCIDENT REPORT TRIP OF POINT HENRY NO.1 220 KV BUSBAR ON 29 JULY 2010

PREPARED BY: Electricity System Operations Planning and Performance

FINAL

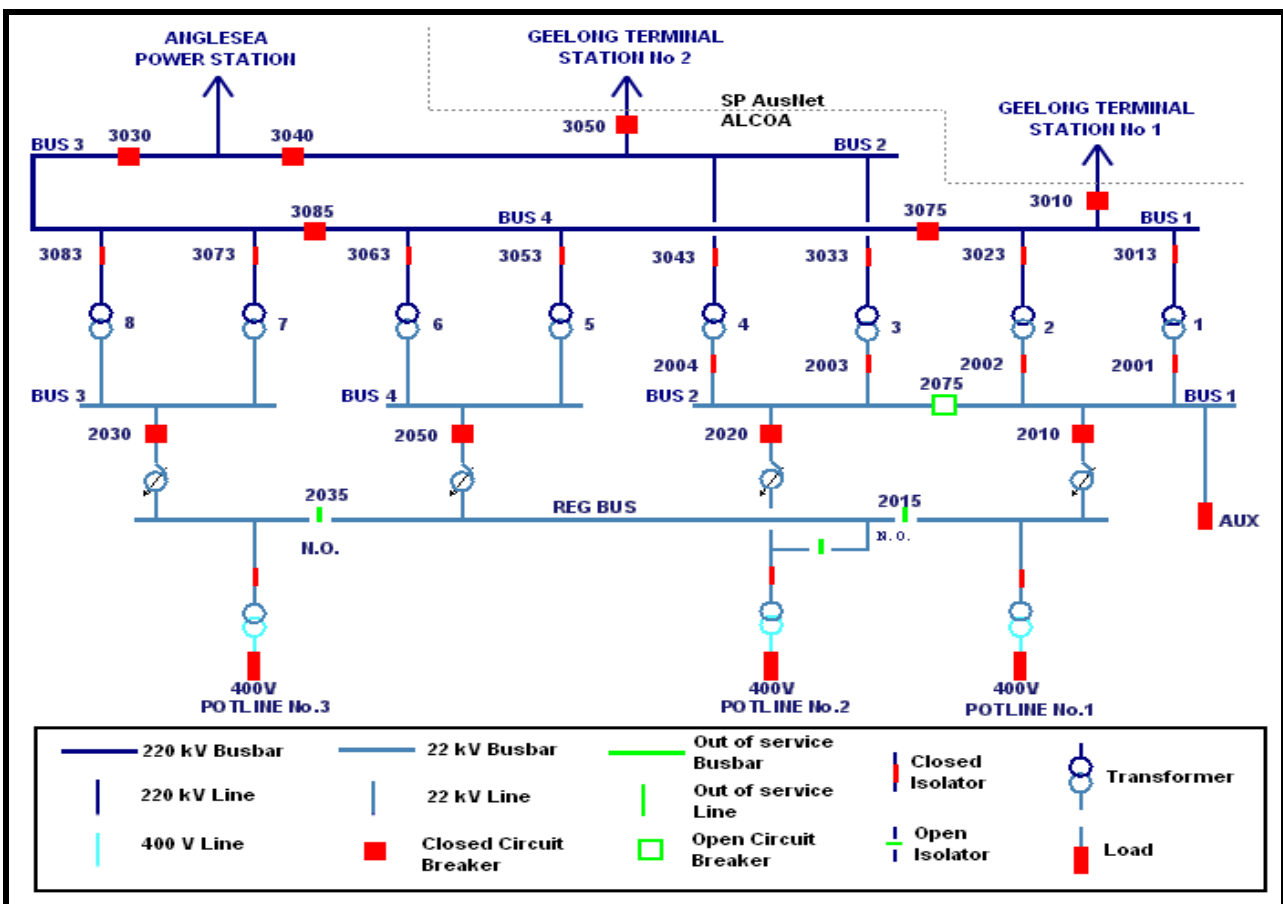
Figure 1 shows statuses of relevant circuit breakers at Point Henry 220kV switchyard prior to the event.

Figure 1 - Statuses of relevant circuit breakers at Point Henry 220kV switchyard prior to the event

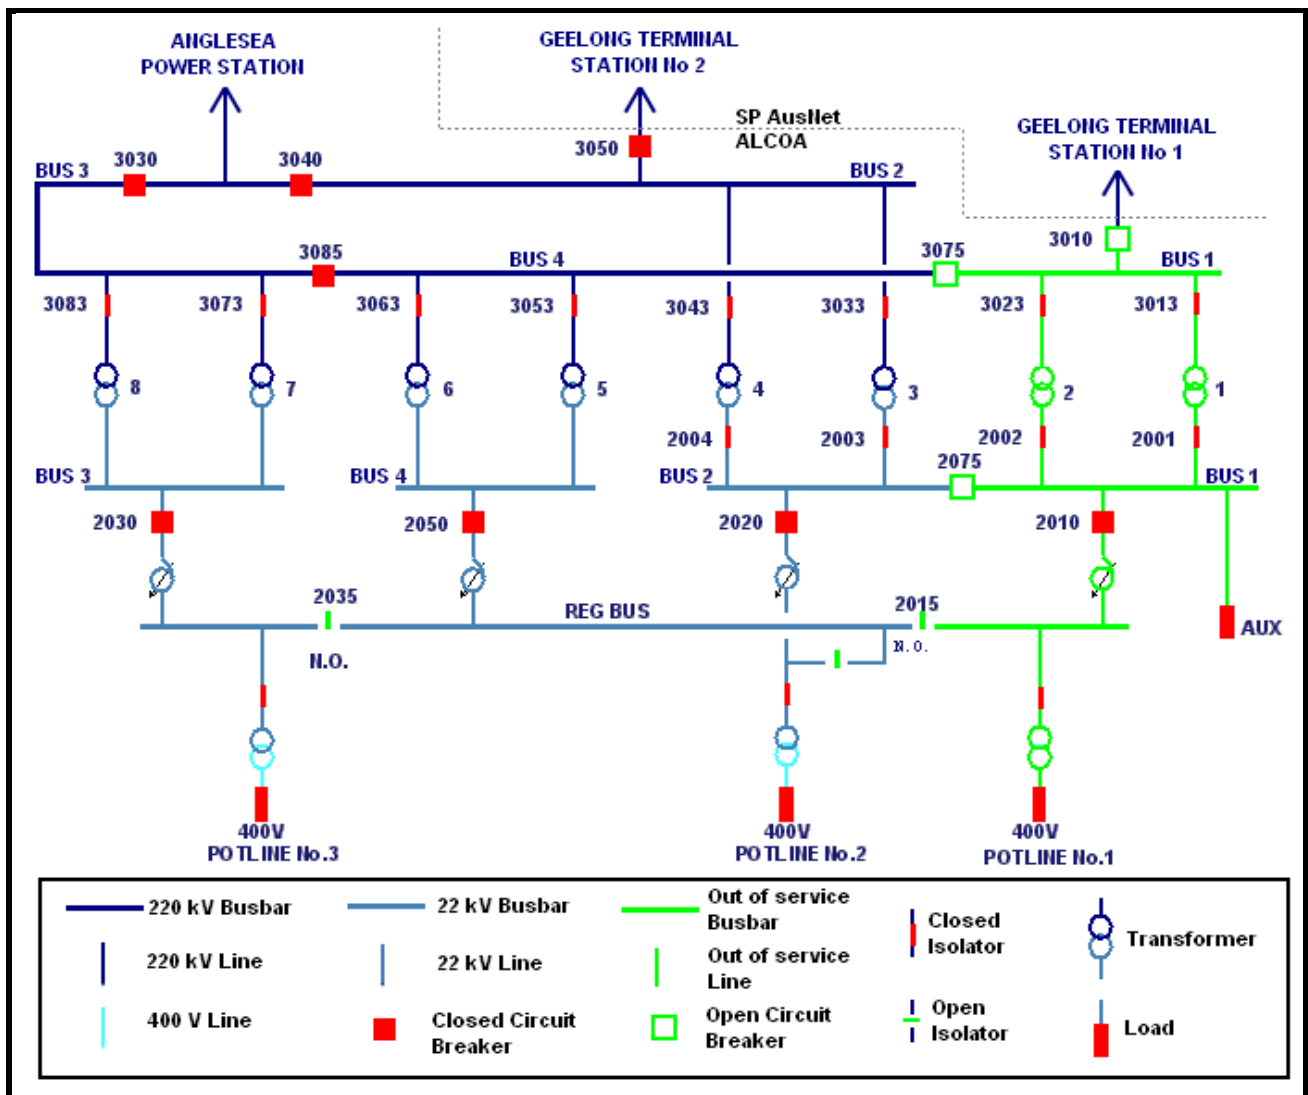
The operation of these circuit breakers de-energised both the No.1 220 kV busbar and the No.1 22 kV busbar at Point Henry and off-loaded the Geelong to Point Henry No. 1 220 kV transmission line. Potline No. 1 and plant auxiliary load totalling approximately 105 MW was also off-loaded. Figure 2 shows the status of the relevant circuit breakers after the operation of the protections.

The operation of the protection that caused the trip was attributed to a handheld meter being inadvertently dropped on a protection relay associated with the No.1 22kV busbar protection.

Figure 2 - Statuses of relevant circuit breakers at Point Henry 220kV switchyard after the event

ALCOA has advised AEMO that work practices have since been modified to avoid the reoccurrence of such incidents in future. AEMO was satisfied that the event did not require reclassification of the loss of Point Henry No. 1 220 kV busbar as a credible contingency event.
