POWER SYSTEM INCIDENT REPORT: TRIP OF NO 1 AND 2 NEW OSBORNE 66 KV BUSBARS ON 26 SEPTEMBER 2010

PREPARED BY: Electricity System Operations Planning and Performance

FINAL

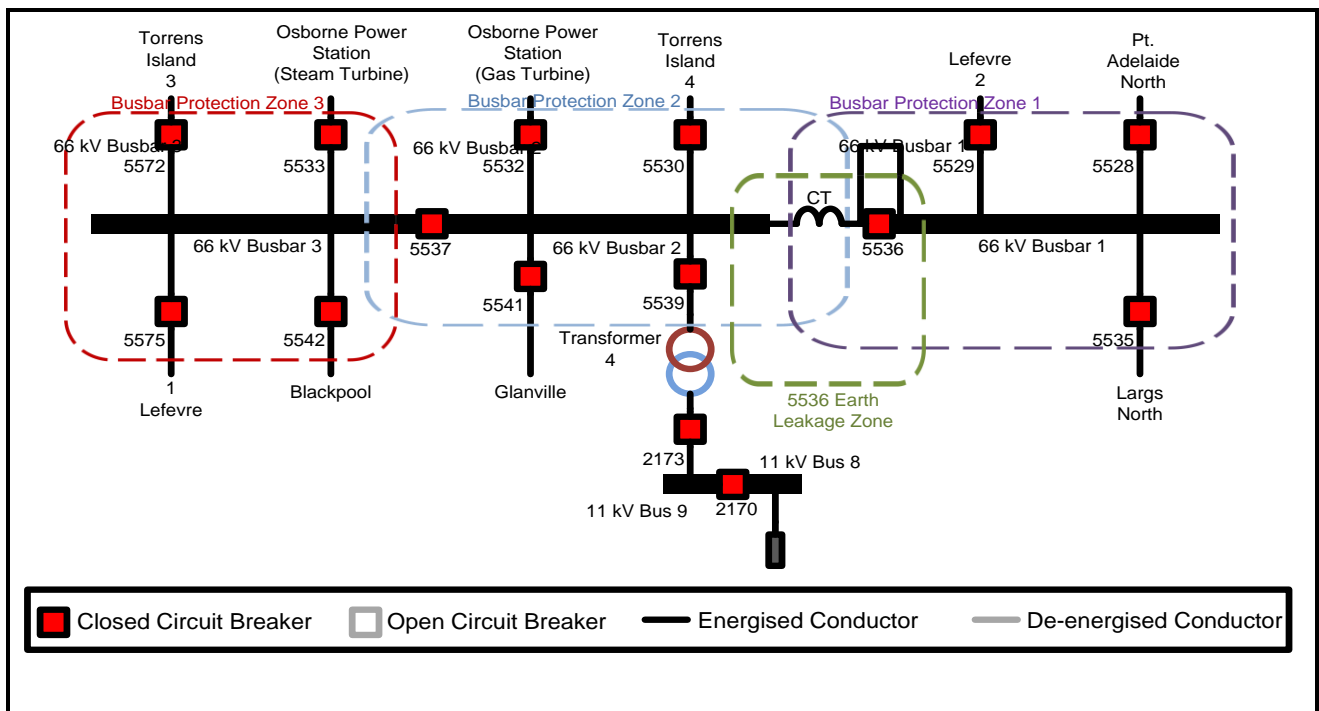
Prior to the incident at 1119 hrs on 26 September 2010 all network elements connected to the New Osborne 66 kV busbar at the New Osborne substation were in service. The pre-incident state of the busbar can be seen in figure 1.

Figure 1 - New Osborne 66 kV substation at 1119 hrs on 26 September 2010 prior to the incident

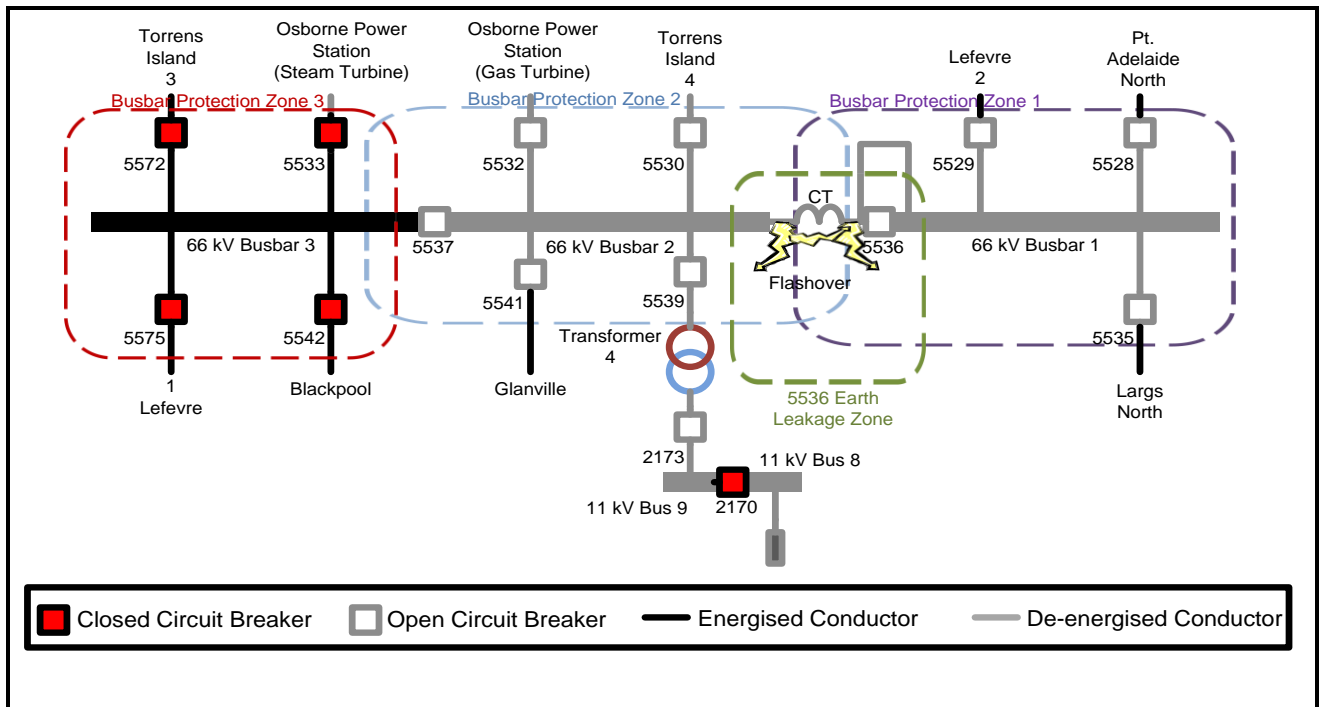
The state of the 66 kV busbar at the New Osborne substation after tripping of No.1 and 2 busbar sections is shown in figure 2.

Figure 2 - New Osborne 66 kV Substation at 1119 hrs on 26 September 2010 after the operation of busbar 1 and 2 protection systems
