POWER SYSTEM OPERATING INCIDENT REPORT TRIP OF KAREEYA NO.2 132 KV BUSBAR ON 8 JUNE 2011

PREPARED BY: Electricity System Operations Planning and Performance

DATE: 16 September 2011

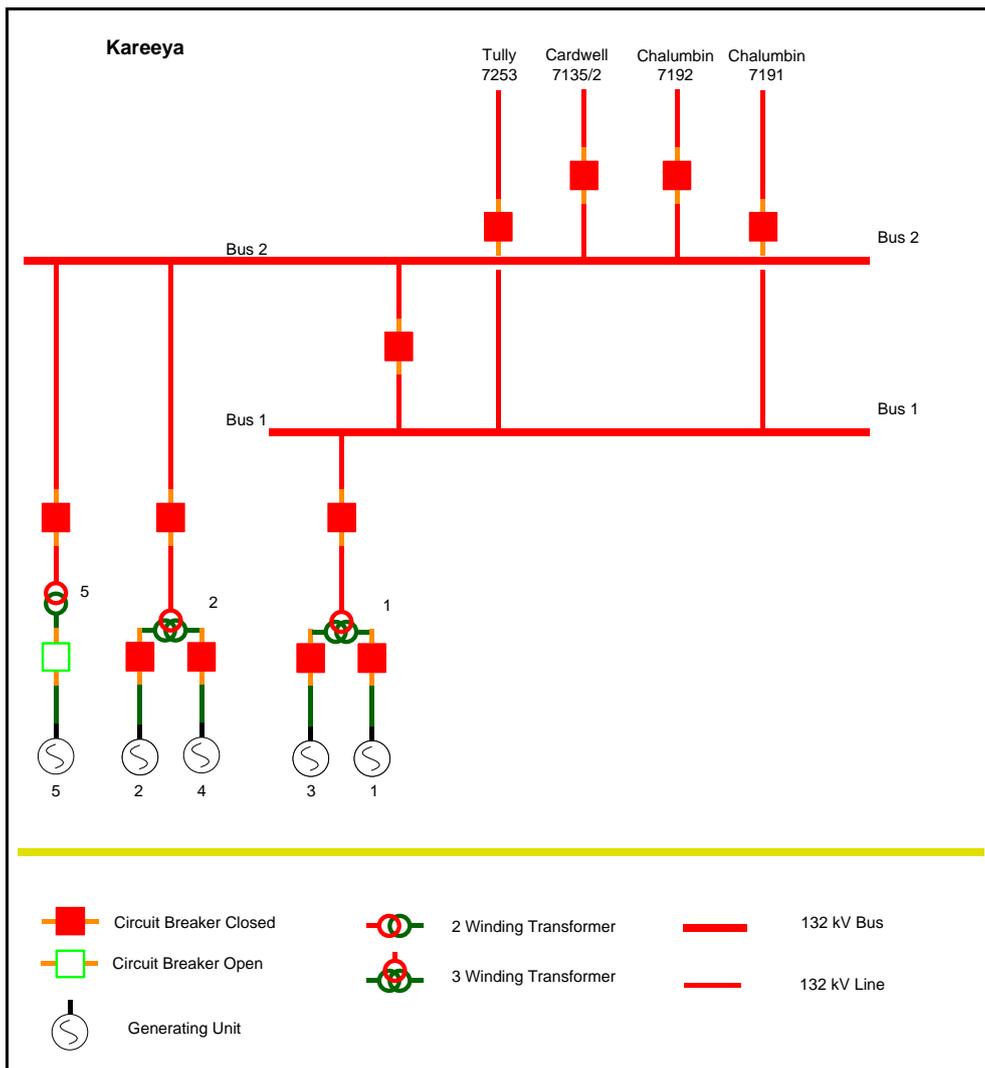
The status of the power system prior to the incident is shown in Figure 1. For clarity, only equipment relevant to this incident has been included in the diagram. Note that the No.5 generating unit at Kareeya power station was not in service at the time.

Figure 1 – Status of Kareeya power station prior to the incident

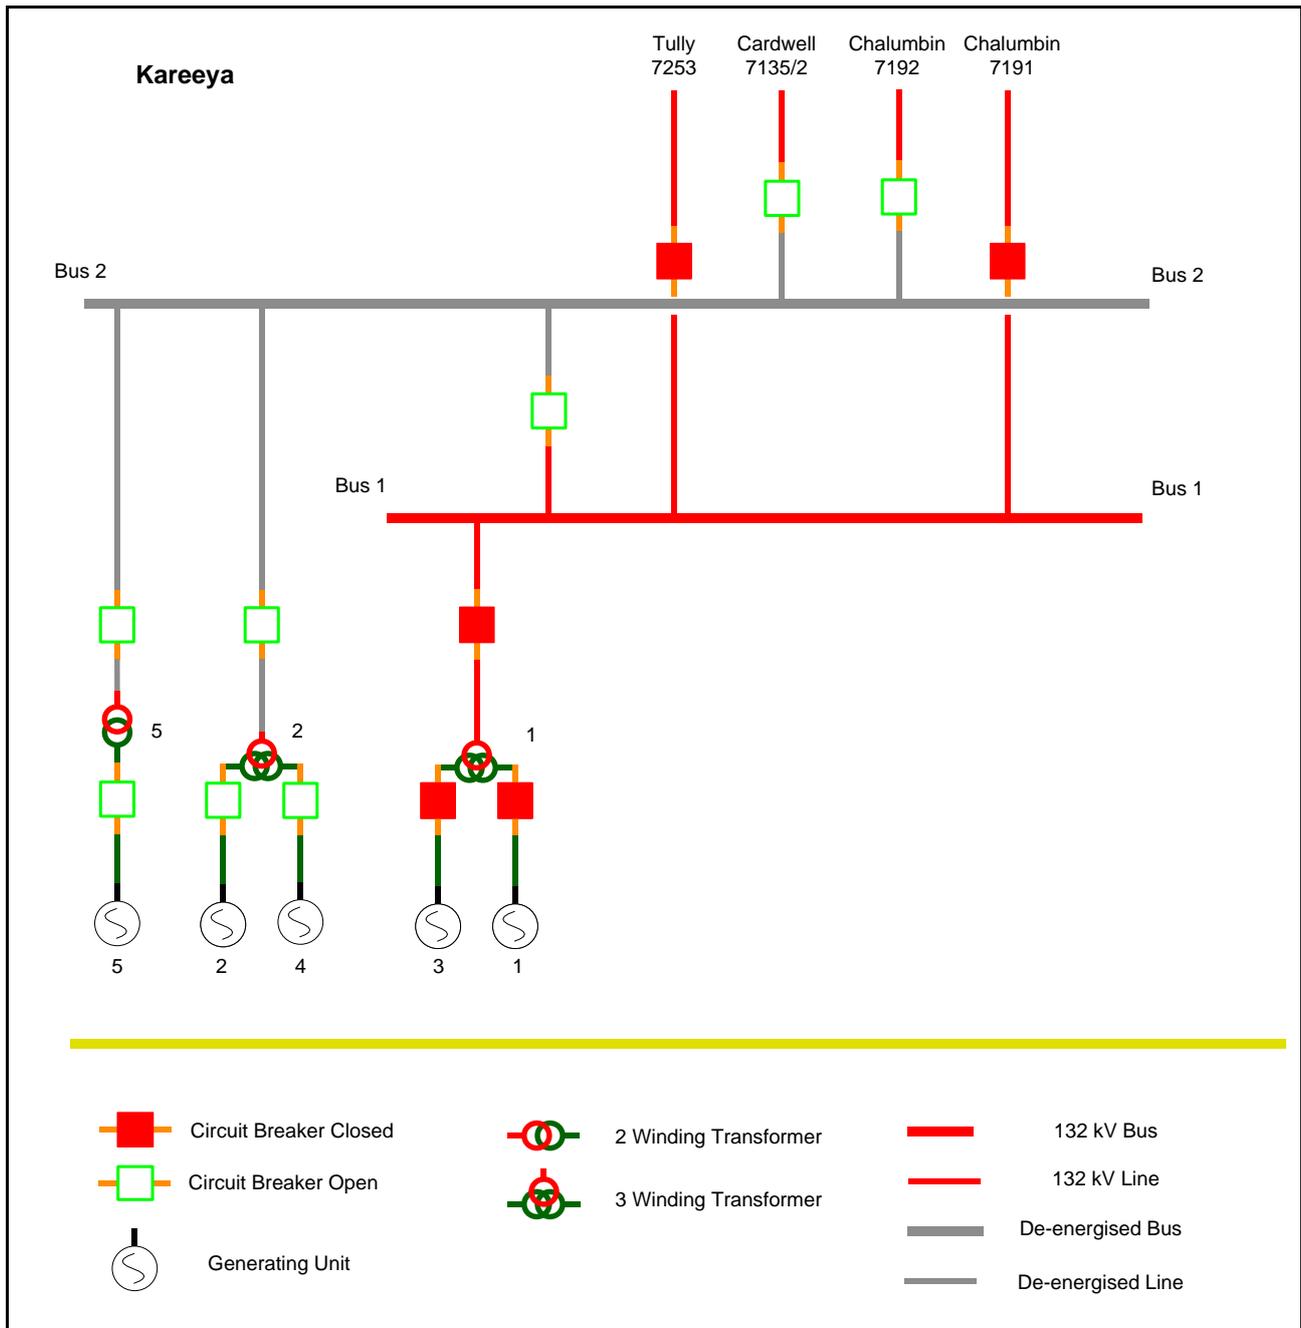
The trip resulted in the off-loading of the 7135/2 Kareeya – Cardwell and 7192 Kareeya – Chalumbin 132 kV lines at the Kareeya end, and the loss of approximately 44 MW of generation following the disconnection of the Kareeya No.2 and No.4 generating units. The Kareeya No.5 generating unit was not in service at the time of this incident.

Figure 2 - Status of Kareeya power station immediately after the incident

Powerlink investigated the incident and found that the circuit breakers connected to the Kareeya No.2 132 kV busbar tripped due to the unexpected operation of the busbar multi-trip relay. The operation of the busbar multi-trip relay was attributed to an error while following correct work practices adopted during planned maintenance work on busbar protection systems at the Kareeya 132 kV switchyard. A high voltage fault was not present and there was no initiation of protection systems at the time of the incident.

At 1006 hrs Powerlink returned the Kareeya No.2 132 kV busbar to service. At 1007 hrs Powerlink returned the 7135/2 Kareeya – Cardwell and 7192 Kareeya – Chalumbin 132 kV lines to service. Kareeya generating units No.2 and No.4 were returned to service at 1042 hrs and 1051 hrs respectively.

The work on protection systems at Kareeya resumed after correct work practices had been re-emphasised to the relevant staff.
