# POWER SYSTEM OPERATING INCIDENT REPORT – SHUT DOWN OF MT PIPER POWER STATION ON 8 NOVEMBER 2011

PREPARED BY: Electricity System Operations Planning and Performance

DATE: 2 March 2012

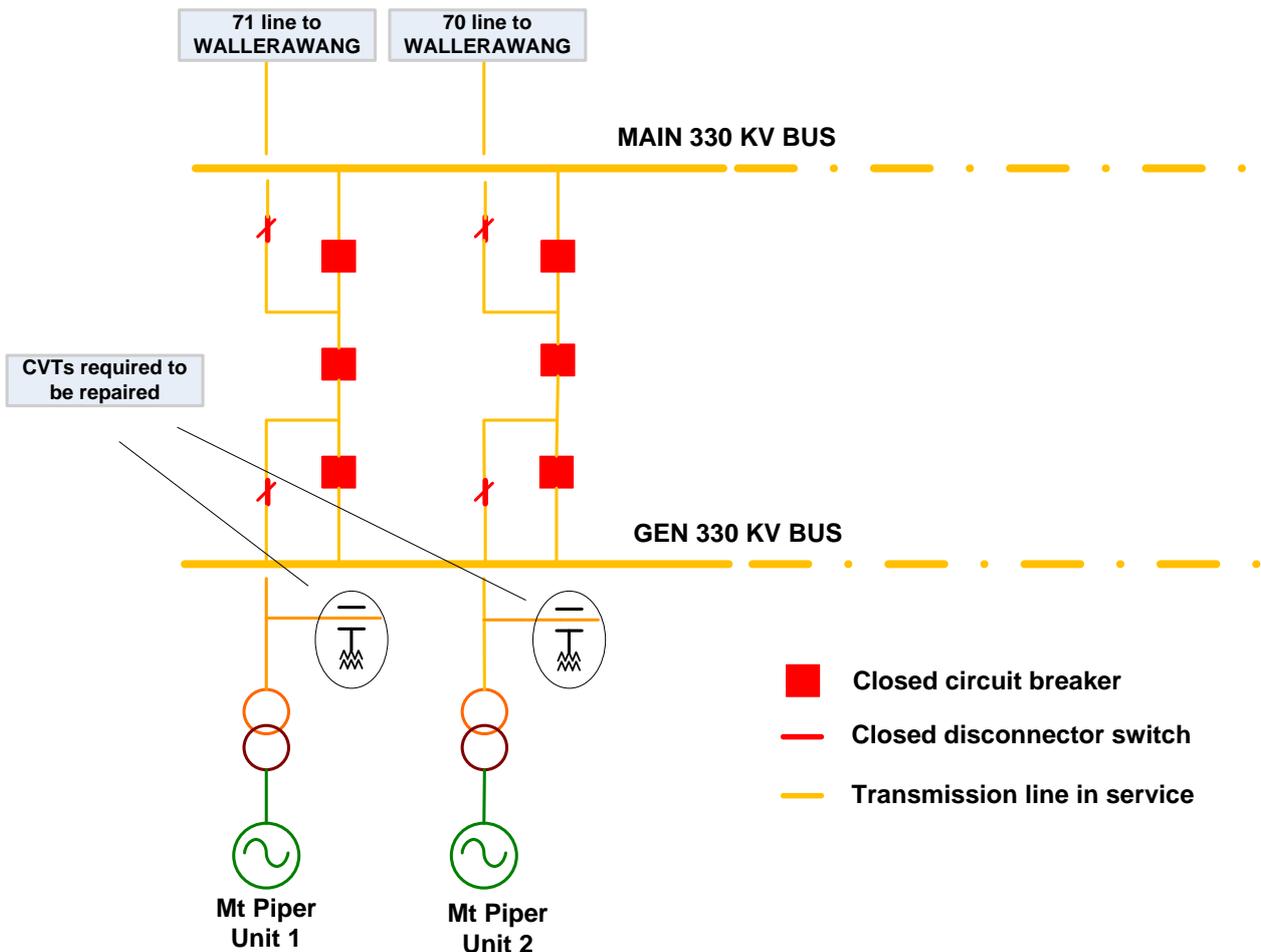
Figure 1 - Status of the power system prior to the incident

The configuration of Mt Piper 330 kV power station switchyard is shown in Figure 1. For clarity only equipment relevant to this incident has been included in the diagram.
