# POWER SYSTEM OPERATING INCIDENT REPORT TRIP OF MULTIPLE TRANSMISSION LINES ON 30 NOVEMBER 2011

PREPARED BY: Electricity System Operations Planning and Performance

DATE: 27 March 2012

FINAL

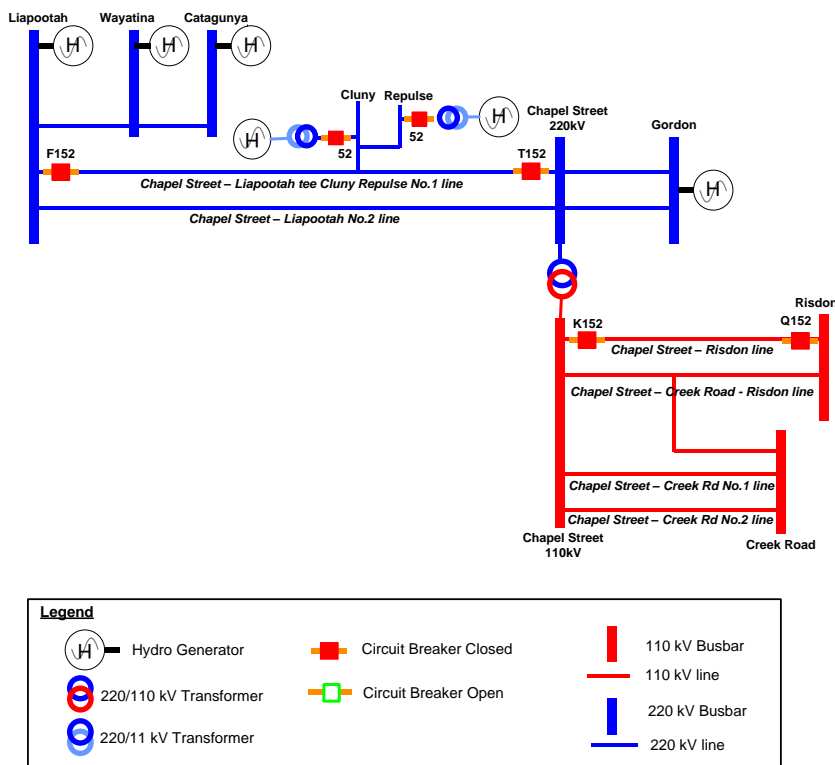
Figure 1 – Network topology prior to the incident

The status of the power system prior to the incident is shown in Figure 1. For clarity only equipment relevant to this incident has been included in the diagram.

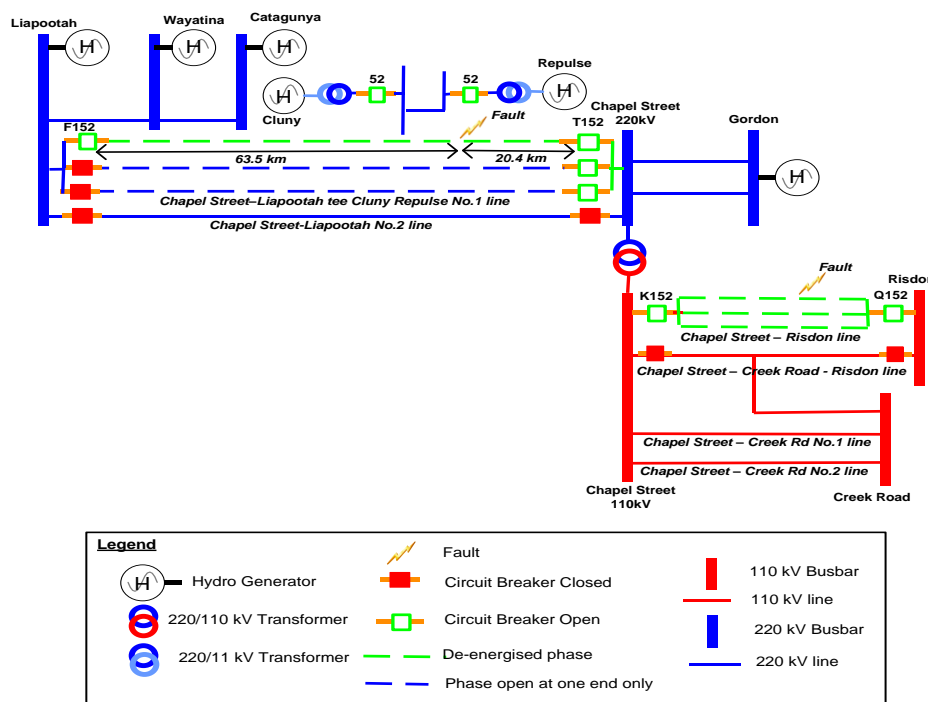
Figure 2 – Network topology following the incident

The trip of the Chapel Street-Liapootah tee Repulse Cluny 220 kV No.1 line resulted in a loss of 43 MW of generation from Cluny and Repulse power stations. Cluny power station was generating 15 MW and Repulse power station was generating 28 MW respectively at the time.

The status of the power system immediately after the incident is shown in Figure 2.

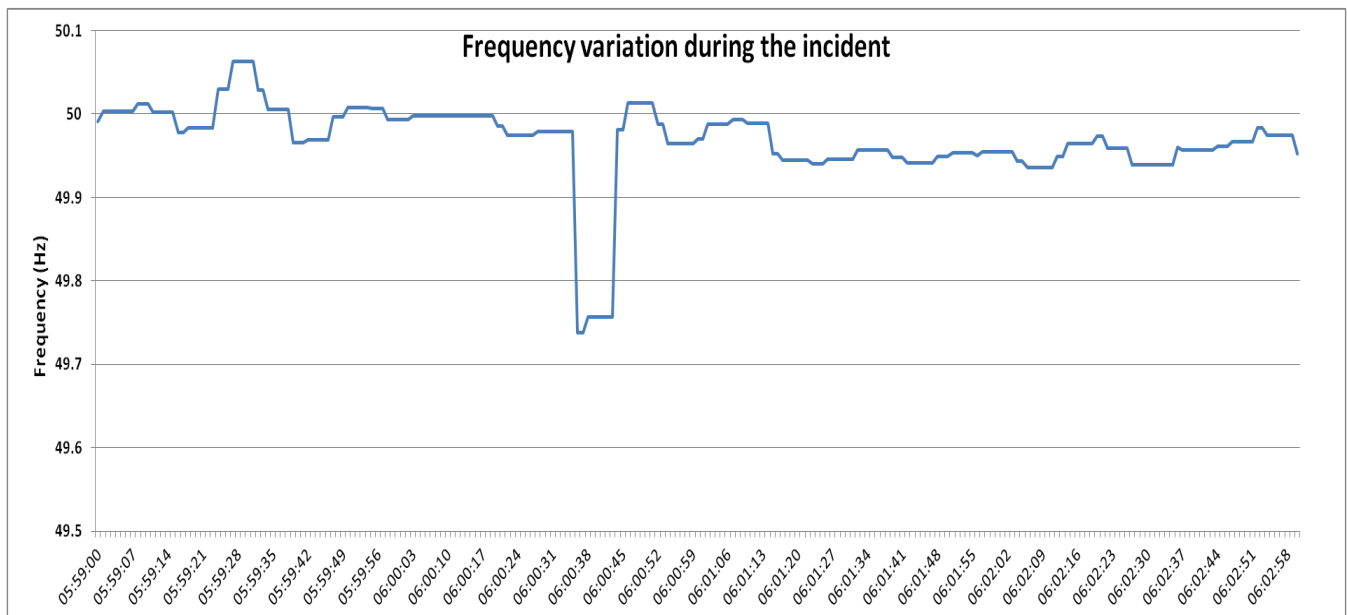
Figure 3 – Power system frequency operation in Tasmania

The Tasmanian frequency dropped to 49.73 Hz, below the normal operating band of 49.85 Hz – 50.15 Hz as a result of the incident. However, the frequency was well within the Tasmanian frequency operating standard of 47 Hz – 52 Hz for a multiple contingency event. The frequency returned to the normal operating band within 9 seconds.

The power system frequency variation in Tasmania is shown in Figure 3.
