POWER SYSTEM OPERATING INCIDENT REPORT: TRIP OF MURRAYLINK AND MONASH - NORTHWEST BEND NO.2 132 KV LINE ON 25 DECEMBER 2011

PREPARED BY: Electricity System Operations Planning and Performance

DATE: 17 April 2012

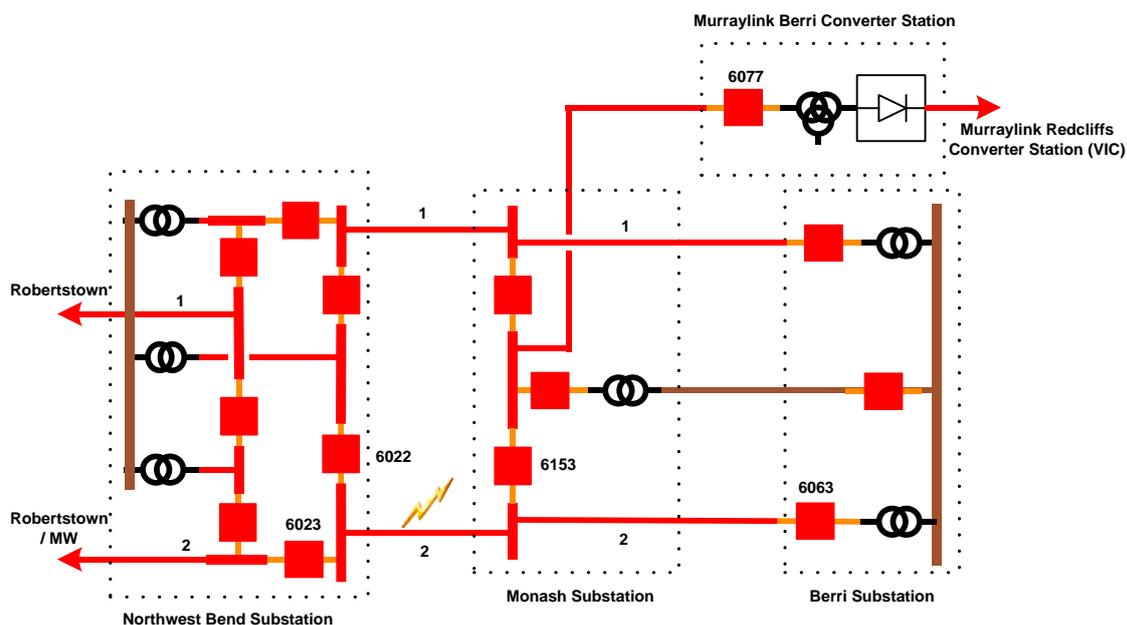
Figure 1 – Status of the power system prior to the incident

The status of the power system prior to the incident is shown in Figure 1. Immediately prior to this event Murraylink was transferring approximately 46 MW from South Australia to Victoria. The load at Berri was approximately 33 MW.

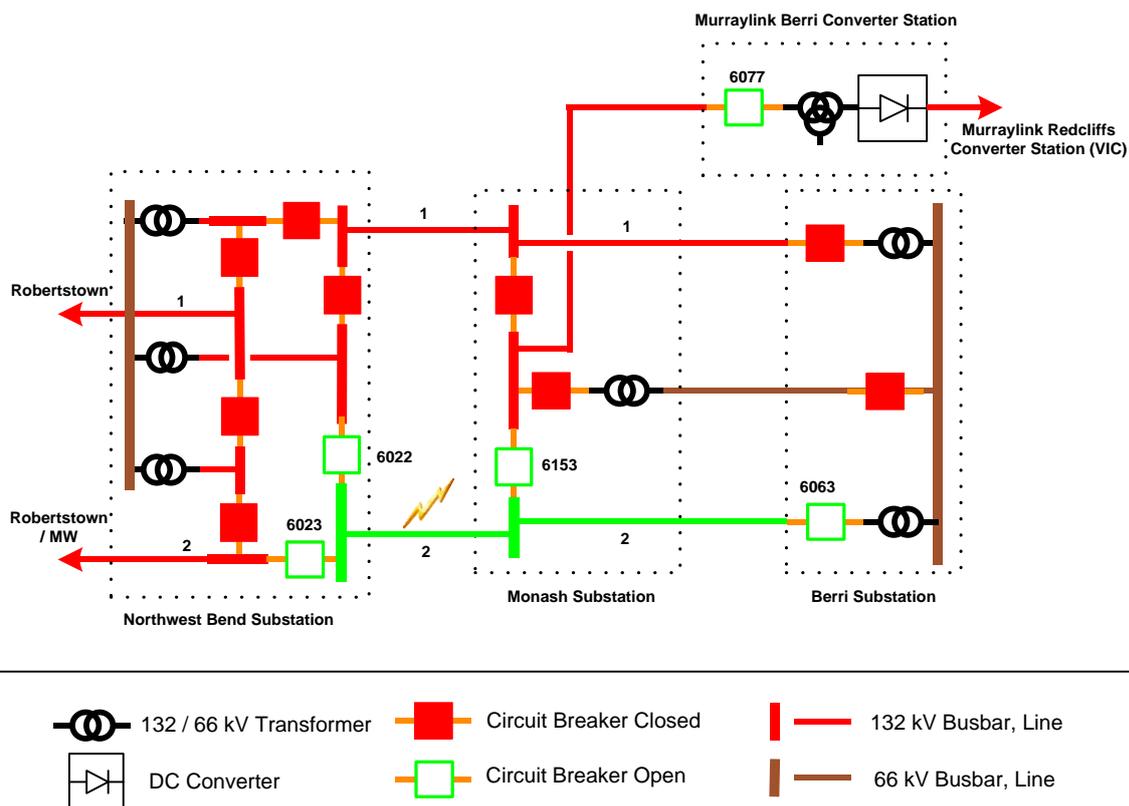
Figure 2 - Status of the power system immediately after the incident

At 2013 hrs on 25 December 2011, a fault occurred on the Monash-Northwest Bend No. 2 132 kV line. ElectraNet advised that the fault occurred approximately 42 km from Northwest Bend, and was correctly cleared in 86 ms. Because of the circuit breaker arrangement at Monash, clearing

this fault resulted in opening of the Monash-Northwest Bend No. 2 132 kV line and the Monash - Berri No 2 132 kV line.

Approximately 14 seconds after the initial fault on the Monash-Northwest Bend No. 2 132 kV line, 132 kV Circuit Breaker 6077 opened at the Murraylink Berri converter station, resulting in disconnection of the Murraylink Berri converter station from the power system.
