# POWER SYSTEM OPERATING INCIDENT REPORT: TRIP OF 837 TARONG – MT. ENGLAND 275 KV LINE AND MT. ENGLAND NO.1 275 KV BUSBAR ON 30 OCTOBER 2011

PREPARED BY: Electricity System Operations Planning and Performance

DATE: 20 April 2012

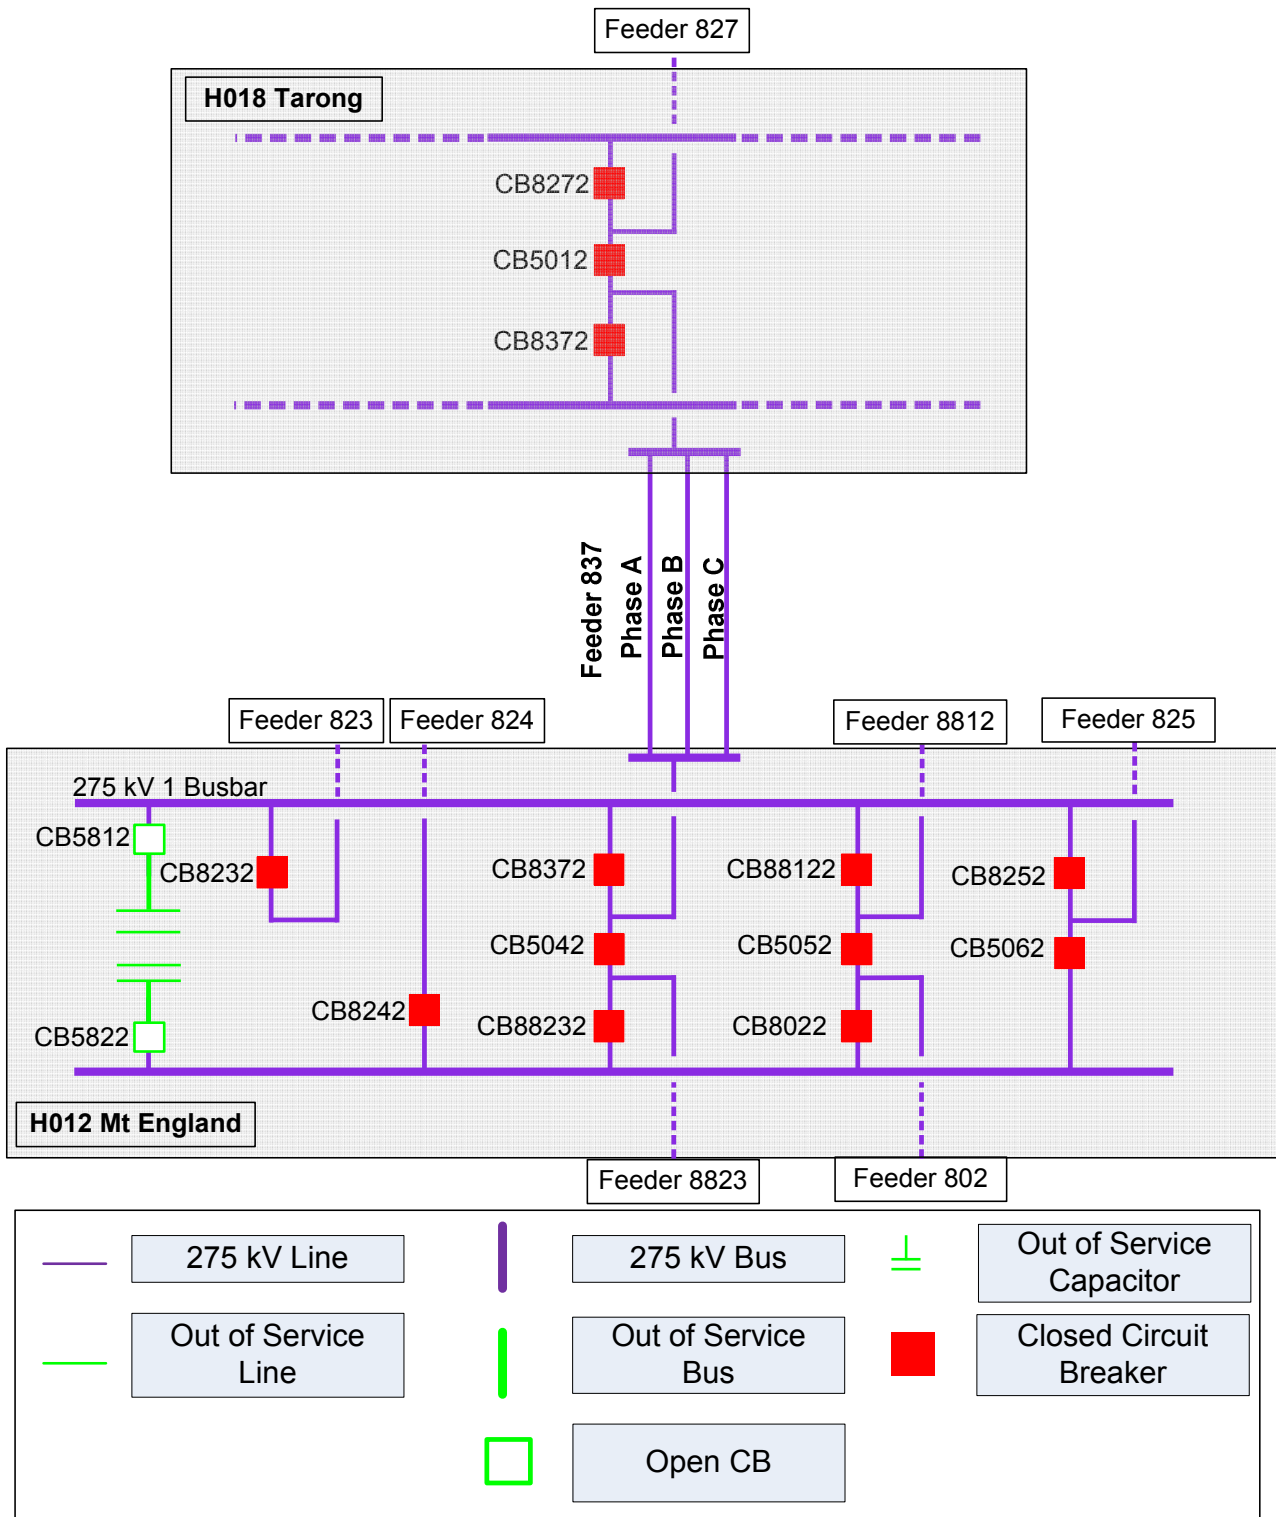
Figure 1 – Status of the power system prior to the incident

The status of the power system prior to the incident is shown in Figure 1. For clarity, only equipment relevant to this incident has been included in the diagram.

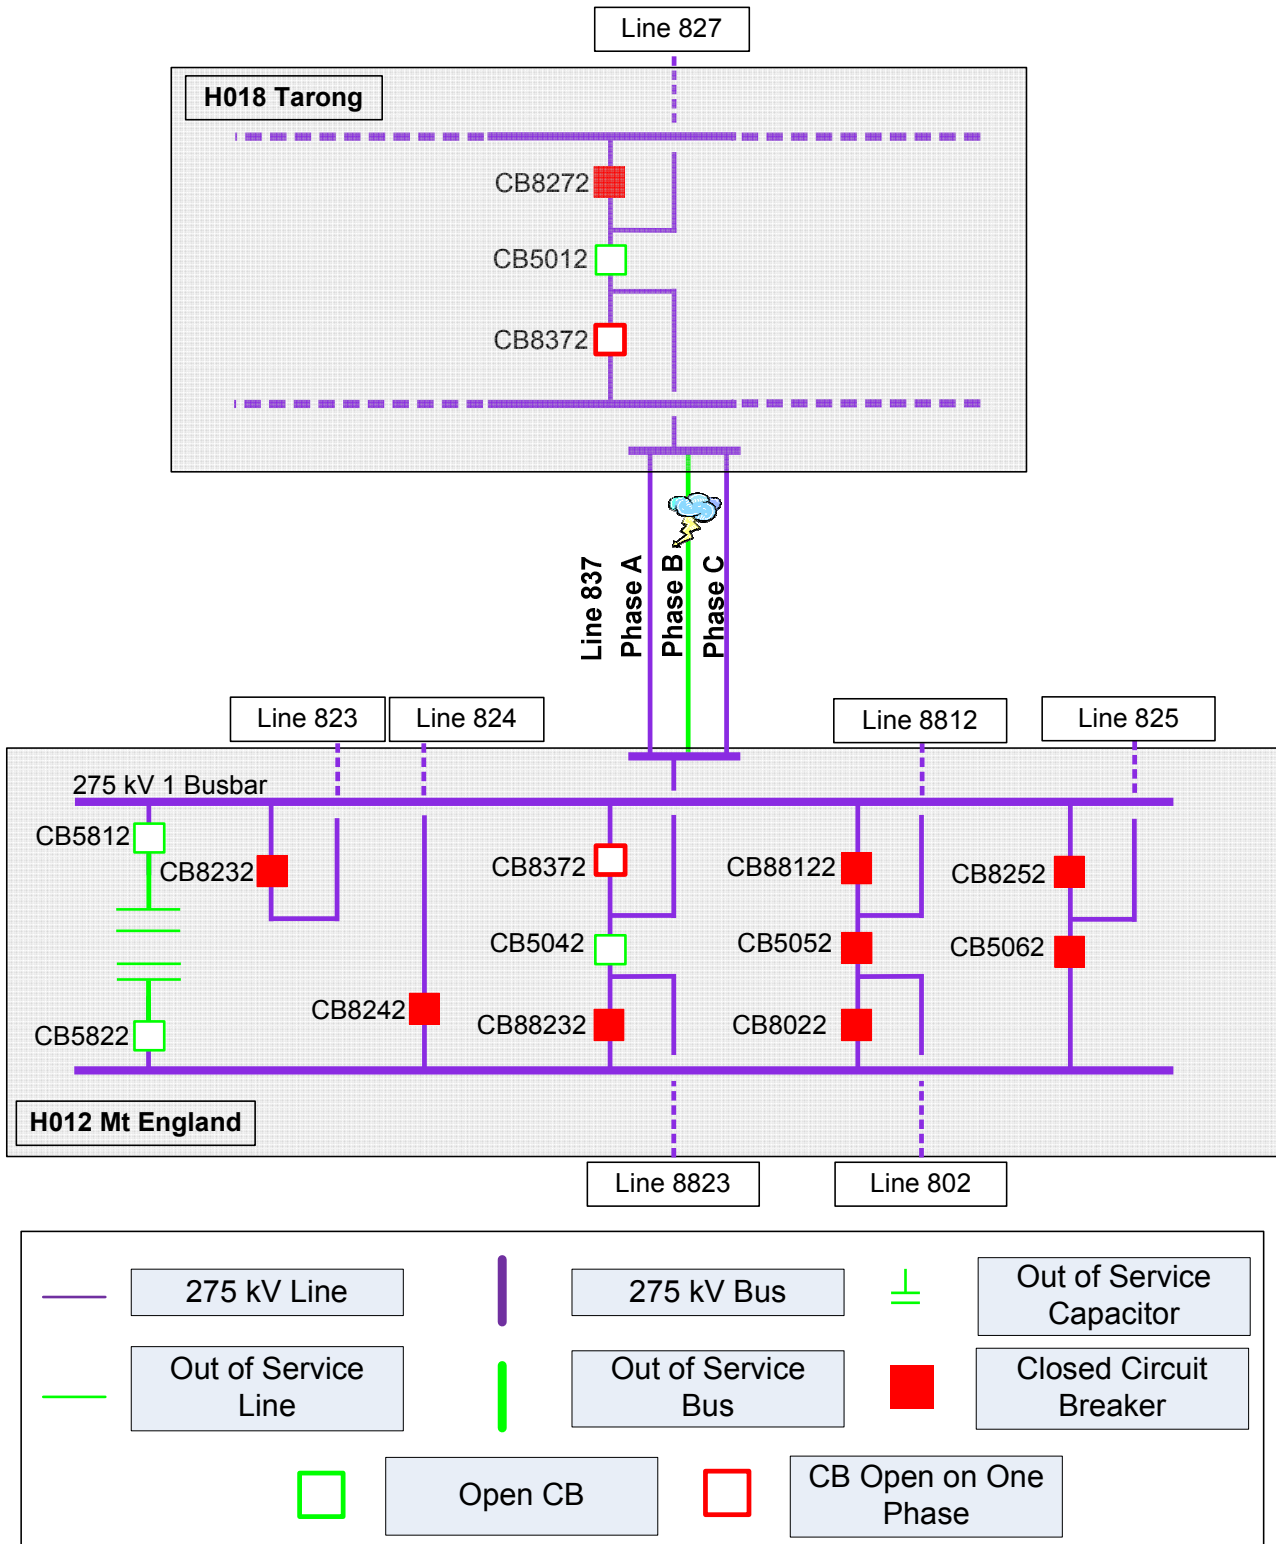
Figure 2 - Status of the power system after the one phase to ground trip of 837 Tarong – Mt. England 275 kV line

At 21:34:58 on 30 October 2011, a one phase to ground fault occurred on the B phase of the 837 Tarong – Mt. England 275 kV line during lightning activity in the area. Protection systems operated to trip the faulted phase at Tarong and Mt. England substations.

The detailed information acquired by Powerlink showed evidence that a lightning strike caused the one phase to ground fault. Initially, the following CBs operated and cleared the fault from the power system:

- H018 Tarong CB 8372 B phase only
- H018 Tarong CB 5012
- H012 Mt. England CB 8372 B phase only
- H012 Mt. England CB 5042

Figure 2 shows the status of the relevant CBs immediately following the incident.

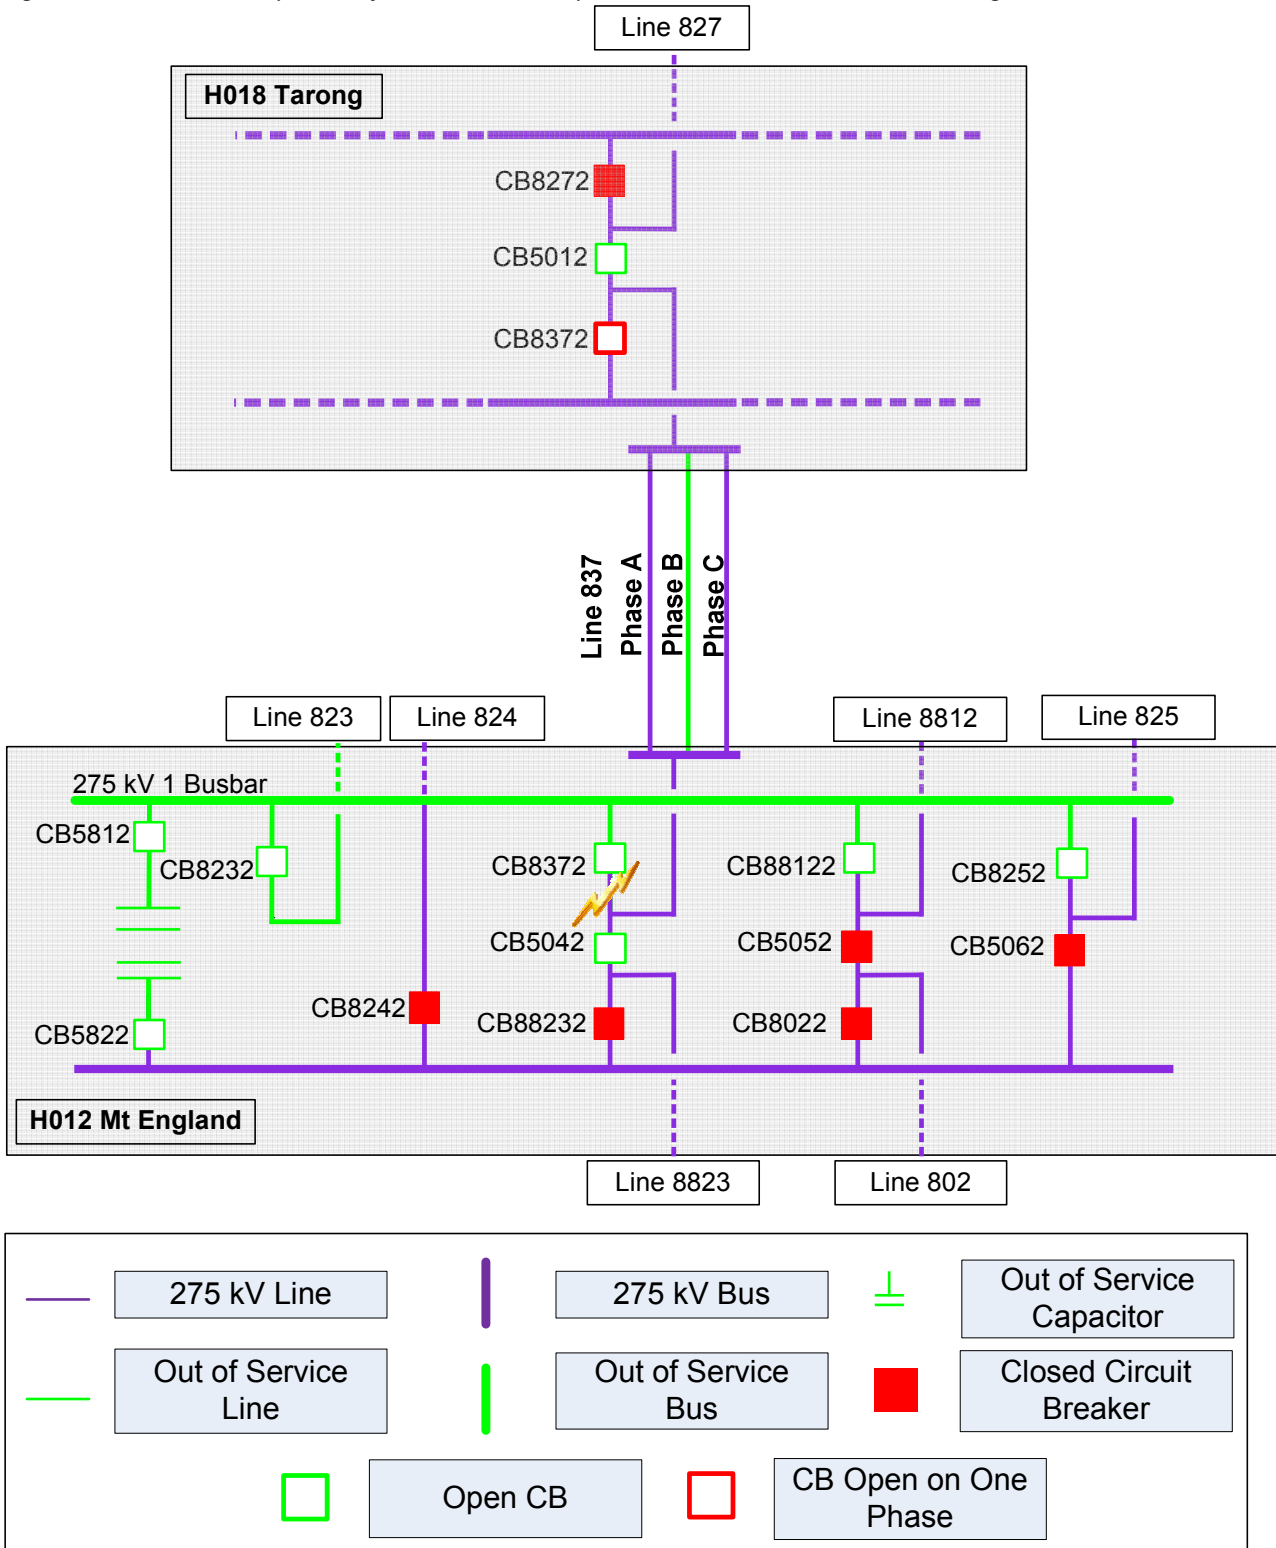
Figure 3 - Status of the power system after the trip of No. 1 275 kV Busbar at Mt. England

Approximately 500 milliseconds after the initial fault on the B phase of 837 line, and during the time 837 line B phase was open, an insulation flashover occurred internal to the B phase of 275 kV CT associated with CB 8372 at Mt. England substation and within the zone protected by the No.1 275 kV busbar protection systems. The insulation flashover was most likely due to lightning activity in the vicinity of the 837 line. The faulted CT triggered the operation of the Mt. England No.1 275 kV busbar protection systems.

As a result of the busbar protection system operation, the Mt. England No.1 275 kV busbar was de-energised with the following CBs at Mt. England opening:

- 275 kV CB 8372 A and C phases, which off-loaded the 837 Tarong – Mt. England 275 kV line (B phase was already open)
- 275 kV CB 8232, which de-energised the 823 Mt. England – Wivenhoe / Wivenhoe Unit 1 275kV line. Wivenhoe Unit 1 was not in service at the time of the event.
- 275 kV CB 8252.
- 275 kV CB 88122.

Figure 3 shows the status of the CBs after the trip of No. 1 275 KV busbar at Mt. England.

Powerlink identified and replaced the faulty 275 kV CT equipment associated with CB 8372 at Mt. England substation. The 837 Tarong – Mt. England 275 kV line was reconnected to No.1 275 kV busbar at Mt. England and re-energised at 1632 hrs on 2 November 2011.

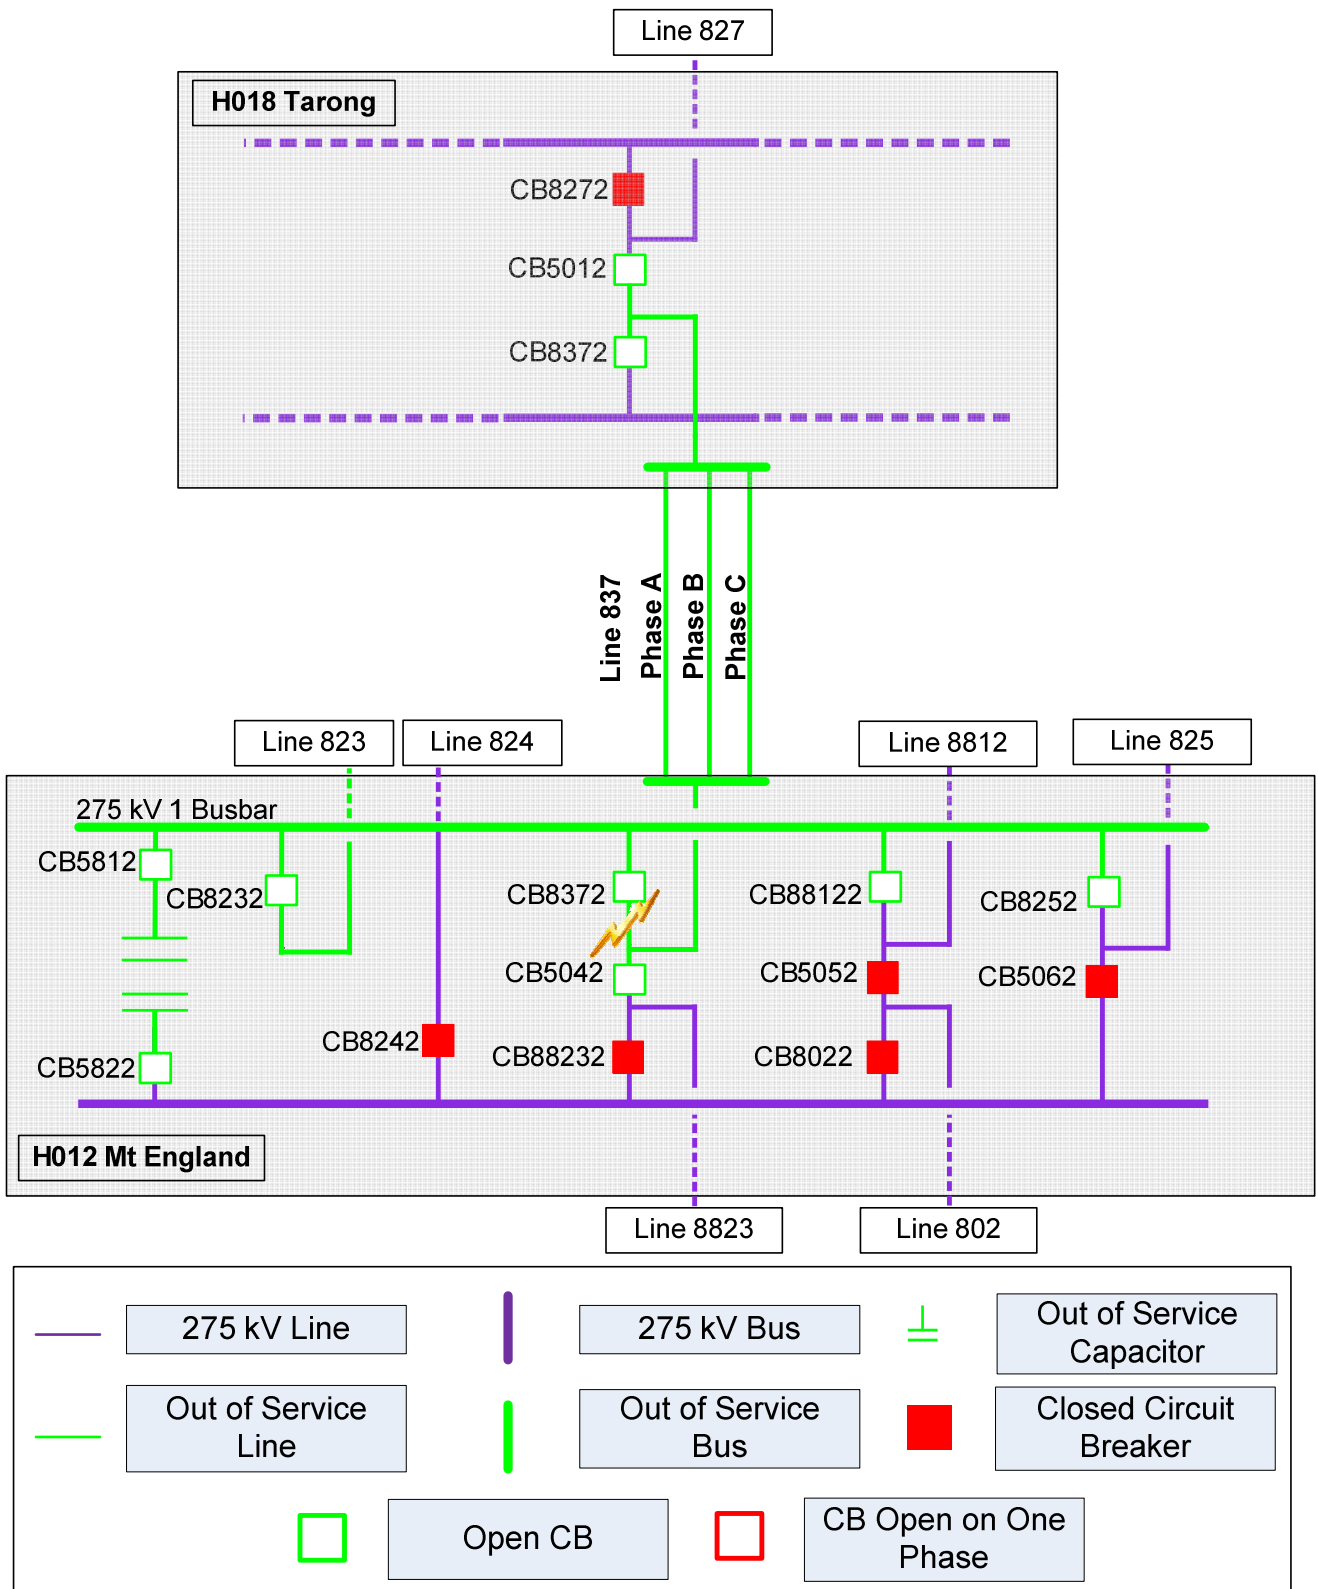
Figure 4 - Status of the power system after trip of 837 Tarong – Mt. England 275 kV line

At 21:34:59, the 837 line autoreclose function at Tarong operated to re-energise B phase of the 837 line from Tarong substation. The high voltage fault was still present due to the insulation flashover internal to the 275 kV CT associated with CB 8372 at Mt. England substation. This caused the protection systems of the 837 line at Tarong to operate, resulting in the trip and lockout of CB 8372 at Tarong and, consequently, de-energisation of the 837 line

Figure 4 shows the status of the CBs after the de-energisation of the 837 line.
