POWER SYSTEM OPERATING INCIDENT REPORT: TRIP OF MULTIPLE TRANSMISSION LINES IN QUEENSLAND ON 28 JANUARY 2012

PREPARED BY: Electricity System Operations Planning and Performance

DATE: 16 May 2012

FINAL

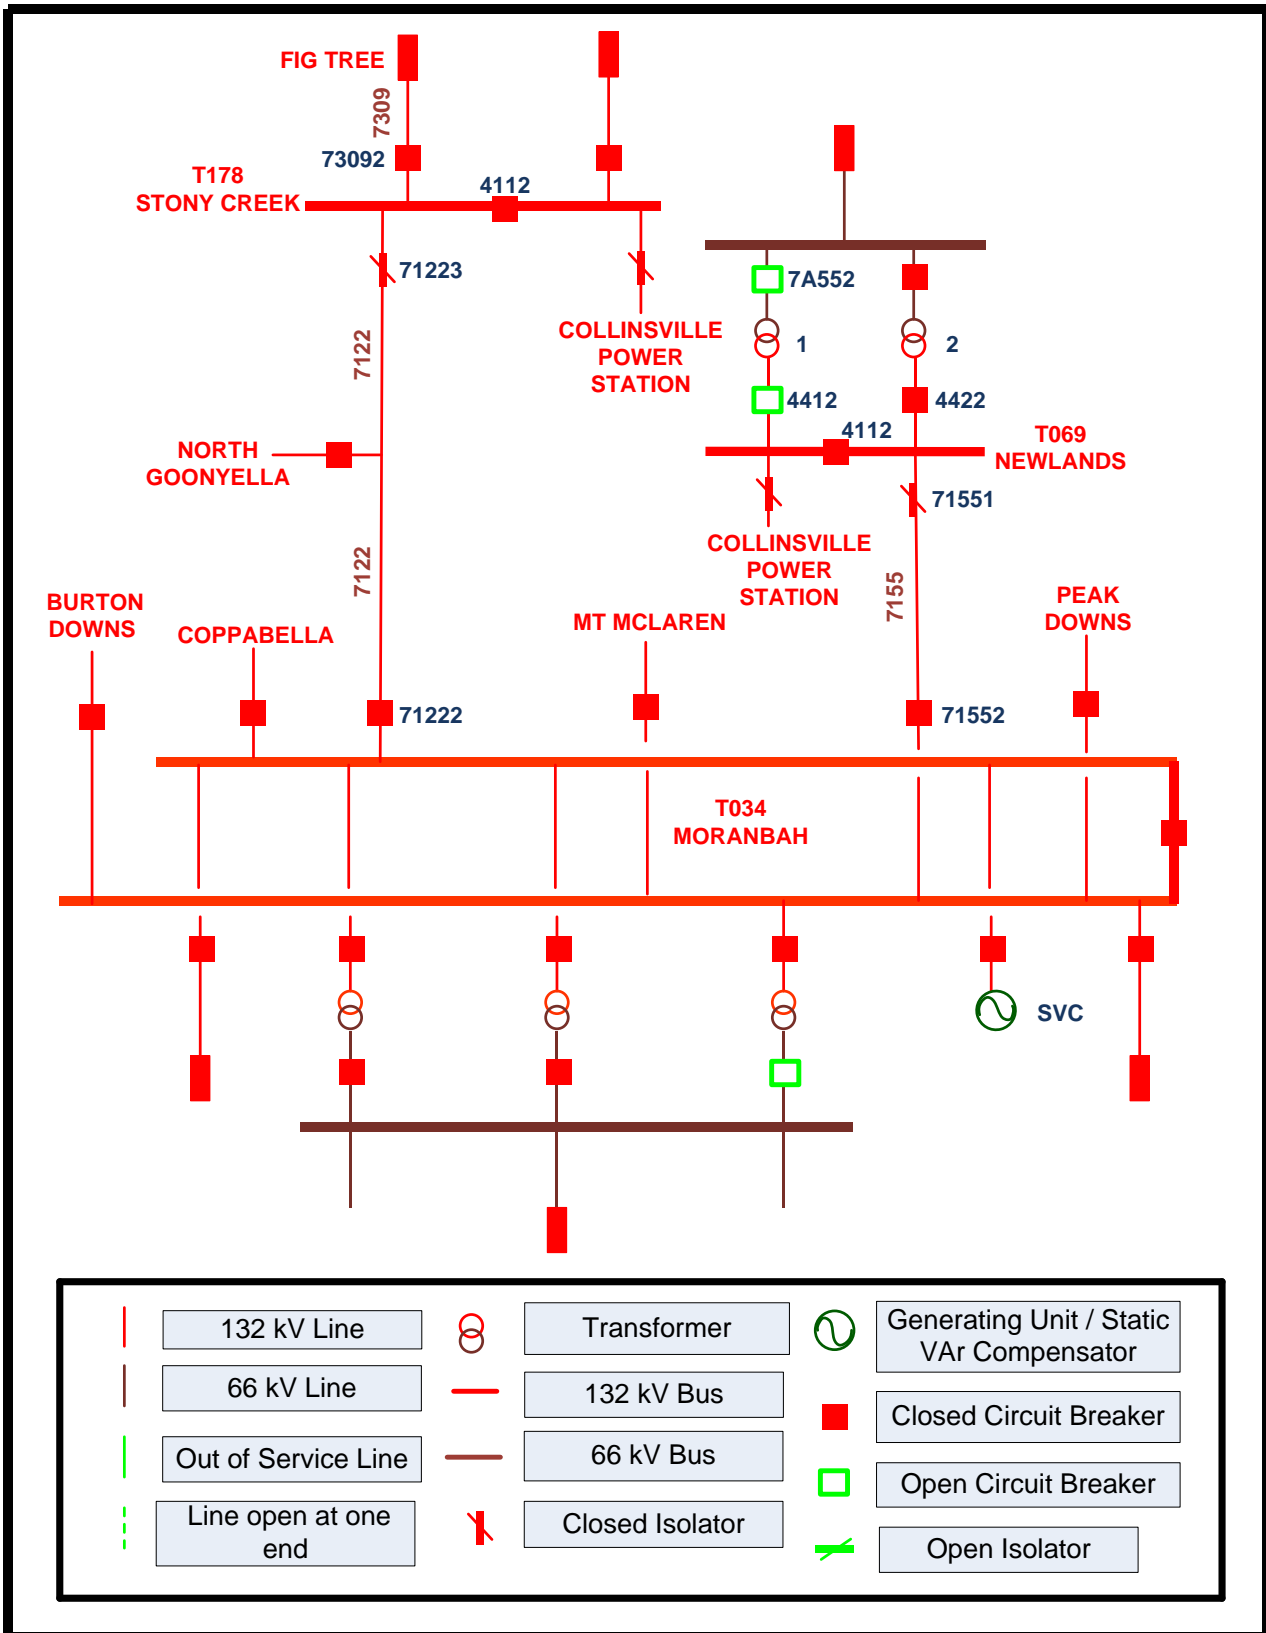
Figure 1 - Status of the power system prior to the incident

Prior to the incident, the No.1 132/66 kV transformer at NLDS was out of service and circuit breakers 4412 and 7A552 at NLDS were open. The status of the power system prior to the incident is shown in Figure 1. For clarity only equipment relevant to this incident has been included in the diagram.
