POWER SYSTEM OPERATING INCIDENT REPORT – TRIP OF ALL GENERATING UNITS AT URANQUINTY POWER STATION ON 05 OCTOBER 2012.

PREPARED BY: System Performance & Commercial

DATE: 13 December 2012

FINAL

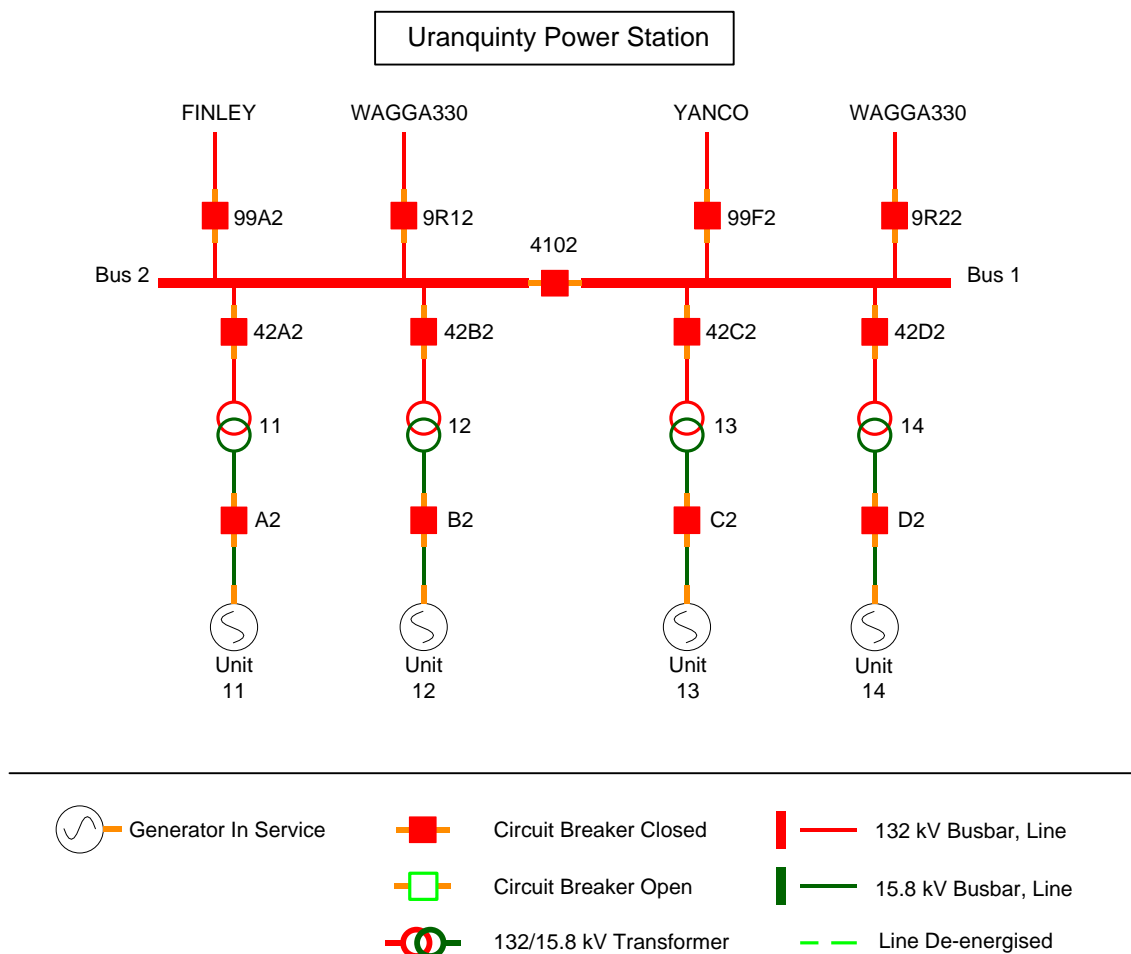
Figure 1 - Status of the power system prior to the incident

Prior to the incident, all four generating units at Uranquinty Power Station were generating 166 MW respectively to give a combined output of 664 MW.

The status of the power system prior to the incident is shown in Figure 1. For clarity only equipment relevant to this incident has been included in the diagram.

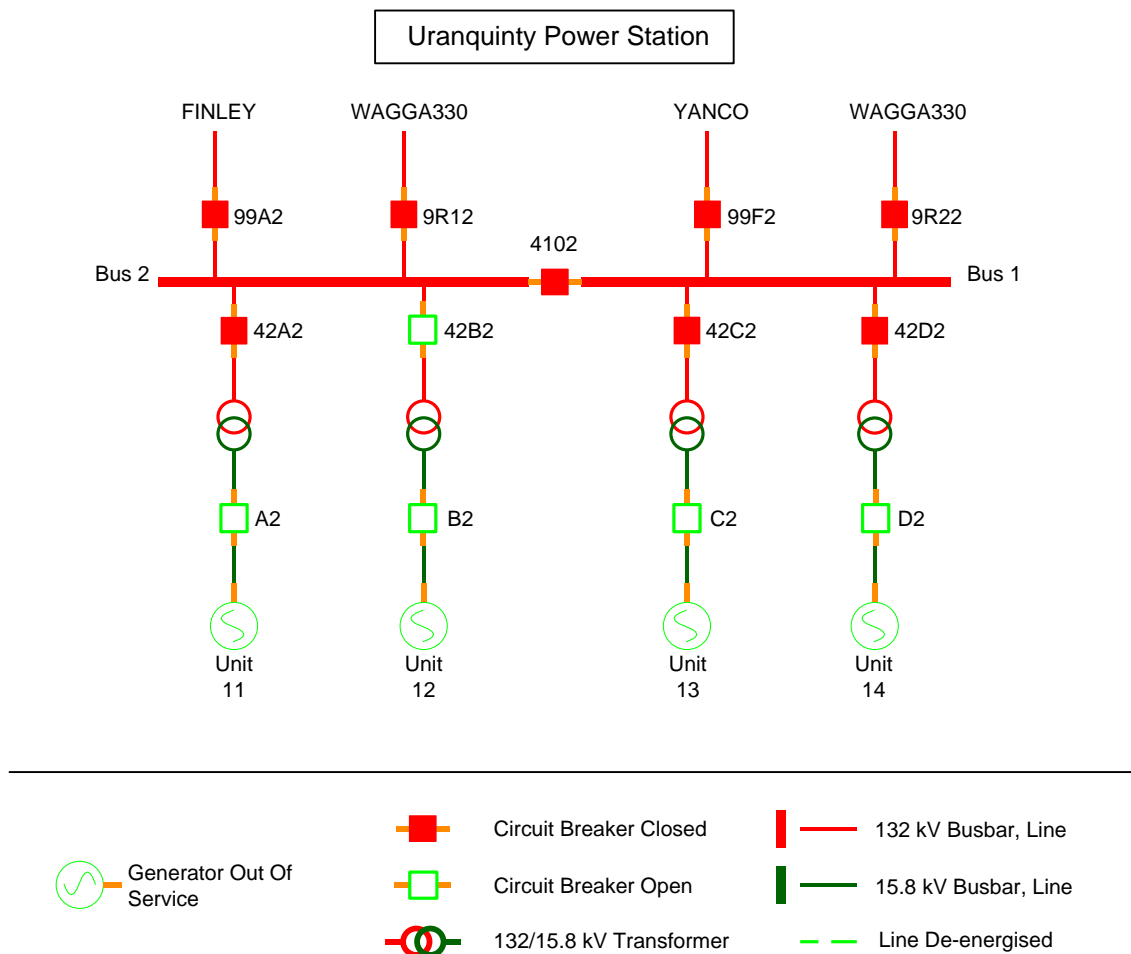
Figure 2 - Status of the power system immediately after the incident

The status of the power system immediately after the incident is shown in Figure 2.

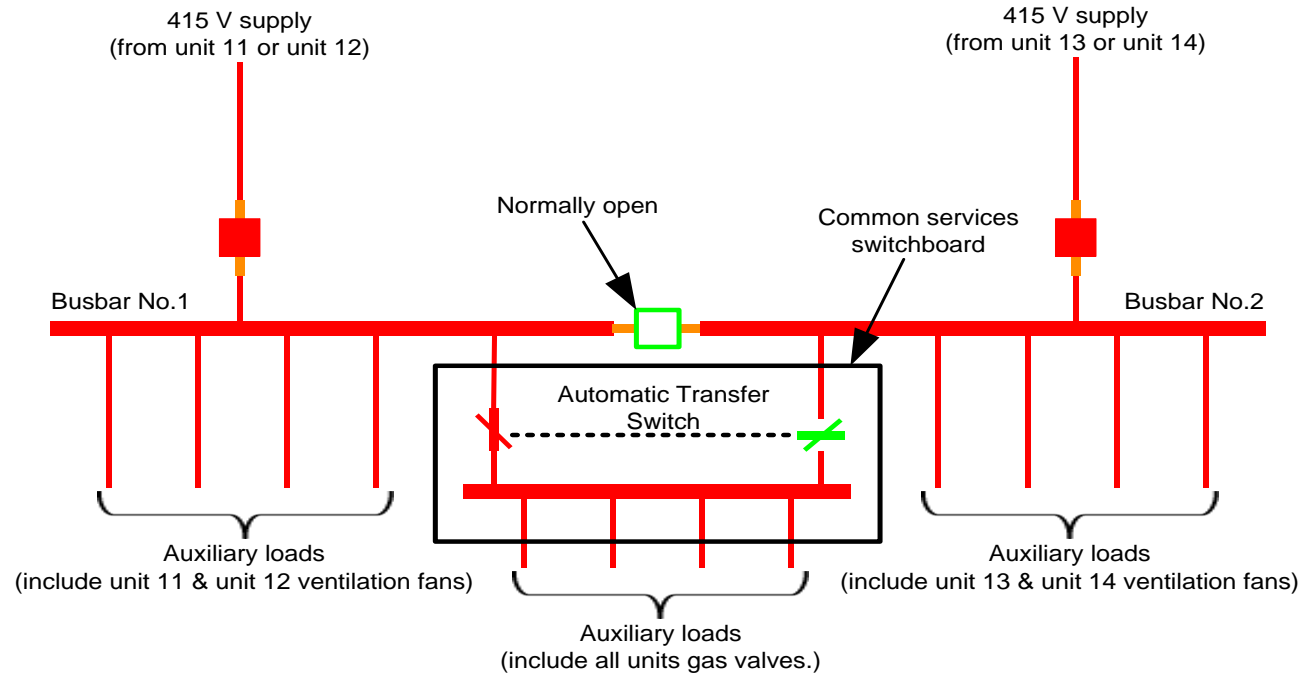
Figure 3 - Auxiliary supply configuration at Uranquinty Power Station at the time of the incident.

Some critical unit auxiliary loads are supplied from a Main Source Selection Switchboard (MSSS) (refer Figure 3) which consists of 415V Busbar's No.1 and No.2 and a Common Services Switchboard. The two busbars are separated by a bus tie breaker which is normally in the open position. The normal operating mode is to supply Busbar No.1 from either unit 11 or unit 12, and Busbar No.2 from either unit 13 or unit 14. That is, unit 11 or 12 are unable to supply Busbar No.2 and units 13 and 14 are unable supply Busbar No.1, when the bus tie breaker is open.

The Common Services Switchboard can be supplied from either Busbar No.1 or Busbar No.2 with the default being Busbar No.1. In the event that supply is lost to the Common Services Switchboard, there is an automatic changeover system in place to switch the auxiliary loads over to Busbar No.2.

Prior to the incident, the auxiliary supply configuration at Uranquinty Power Station was as follows:

- Unit 12 was supplying Busbar No.1 and the Common Services Switchboard.
(Note: Busbar No.1 was supplying the Ventilation fans for units 11 and 12, and the Common Services Switchboard was supplying the Gas Valves for units 11, 12, 13 and 14.)
- Unit 14 was supplying Busbar No.2.
(Note: Busbar No.2 was supplying the Ventilation fans for units 13 and 14.)

With the trip of unit 12, supply was lost to Busbar No.1 and the Common Services Switchboard resulting in the loss of supply to units 13 and 14 gas valves, causing them to commence closing. While this was happening, the auxiliary supply changeover for the Common Services Switchboard operated to restore the supply from Busbar No.2, but due to the time of the changeover the gas valves for these units closed completely before this changeover occurred. With no gas supply, the units eventually tripped on low inlet gas pressure.

With the trip of unit 12, supply was lost to Busbar No.1 and the Common Services Switchboard resulting in the loss of supply to unit 11 gas valve causing it to commence closing. Unlike for units 13 and 14, the auxiliary supply changeover took place before the gas valve had closed completely (i.e. the gas valve for unit 11 took longer to close than for units 13 and 14) thus the unit remained being supplied with gas and consequently the unit remained in service. Unit 11 eventually tripped (130 seconds later as designed) as a result of there being no supply to its Ventilation fans.

- Unit gas valves – All the units' gas valves were supplied from a single source. Although there was an automatic supply changeover system in place to provide alternative supply, the changeover operation took longer than the required changeover time. Thus the gas valve would close completely before the changeover operation was completed and subsequently cause the unit gas turbine to trip due to low inlet gas pressure. This was what happened to units 13 and 14 during the incident.
- Unit Ventilation fan system – Each units ventilation fan system consists of two fans and both fans were supplied from the same auxiliary supply. Thus loss of the shared auxiliary supply would stop the unit's entire Ventilation fan system to operate and subsequently cause the unit to trip. This was what happened to unit 11 during the incident.

To resolve the auxiliary supply configuration issues, Origin completed the following actions:

- Unitised the auxiliary supply for the gas valves so that they are supplied directly from their respective units.
- Supply one fan for each unit Ventilation fan system from different sources of supply. Origin Energy has advised that each unit only requires one ventilation fan to operate.

Origin Energy has also identified that the gas valve closure time for unit 11 was longer than the other units and has rectified this problem.

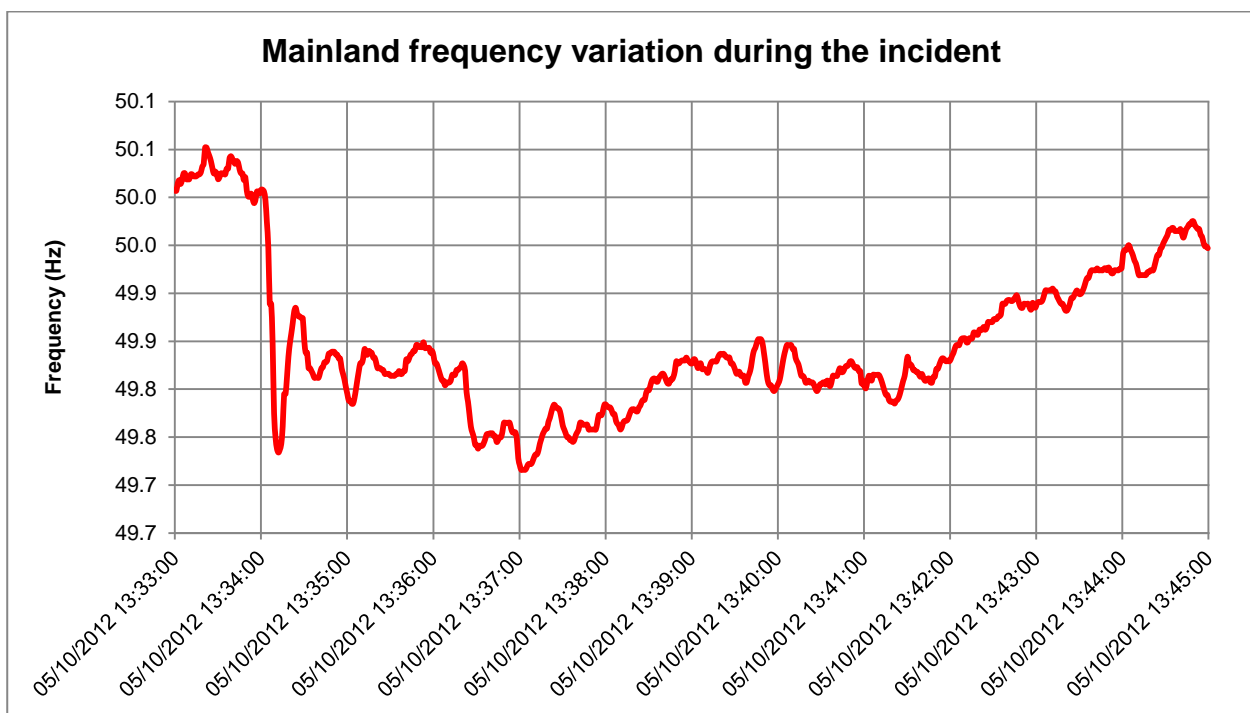
Figure 4 – Mainland frequency variation during the incident

The incident was classified as a multiple contingency event and the Mainland Frequency Operating Standard specifies a frequency containment range of 47.0 Hz - 52.0 Hz, a frequency stabilisation range of 49.50 Hz - 50.50 Hz (within 2 minutes) and a frequency recovery range of 49.85 - 50.15 Hz (within 10 minutes) for such an incident

During the incident the Mainland frequency dropped to a minimum of 49.72 Hz. A review of the Mainland frequency response was undertaken and it was concluded that its response satisfied the Mainland Frequency Operating Standard for all 3 categories as detailed above.

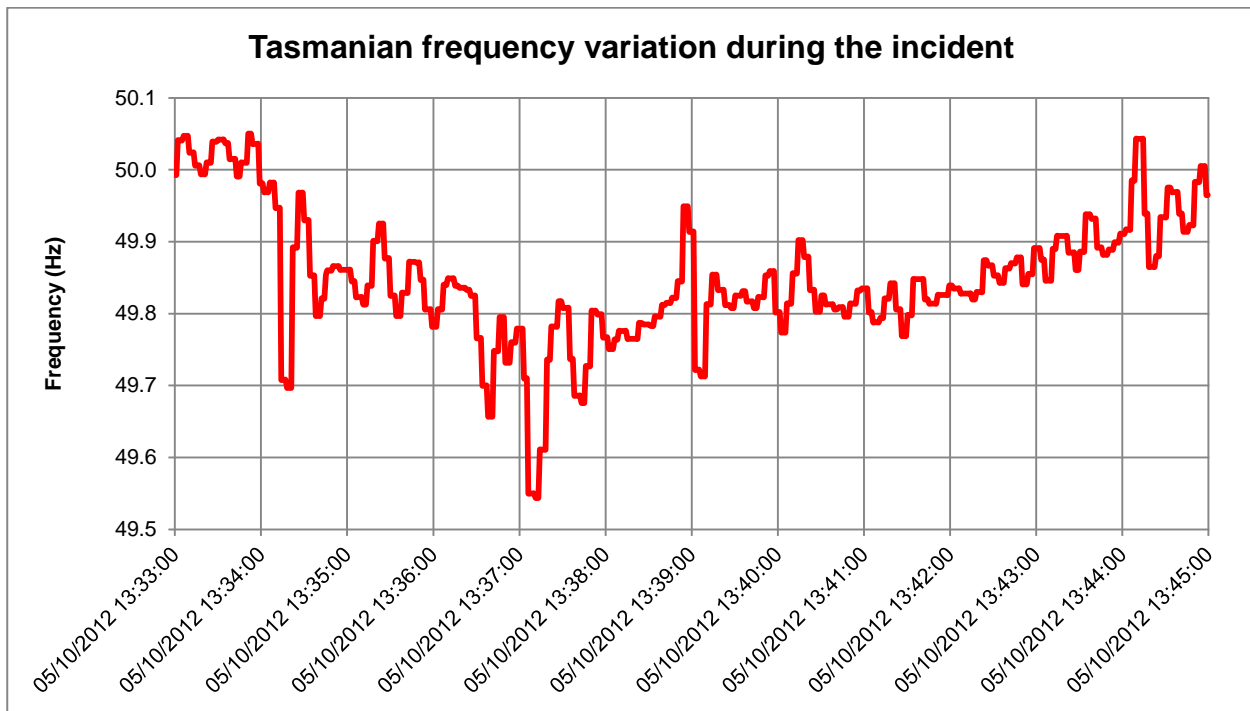
Figure 5 - Power system frequency variation during the incident

In relation to the Tasmanian Frequency Operating Standard it specifies a frequency containment range of 47.0 Hz - 55.0 Hz, a frequency stabilisation range of 48.0Hz - 52.0Hz (within 2 minutes) and a frequency recovery range of 49.85 - 50.15Hz (within 10 minutes) for such an incident.

During the incident the Tasmanian frequency dropped to a minimum of 49.54 Hz. A review of the Tasmanian frequency response was undertaken and it was concluded that Tasmanian frequency response satisfied the Tasmanian Frequency Operating Standard for all 3 categories as detailed above.
