POWER SYSTEM OPERATING INCIDENT REPORT: TRIP OF MULTIPLE TRANSMISSION LINES IN QUEENSLAND ON 22 FEBRUARY 2012

PREPARED BY: Electricity System Operations Planning and Performance

DATE: 15 June 2012

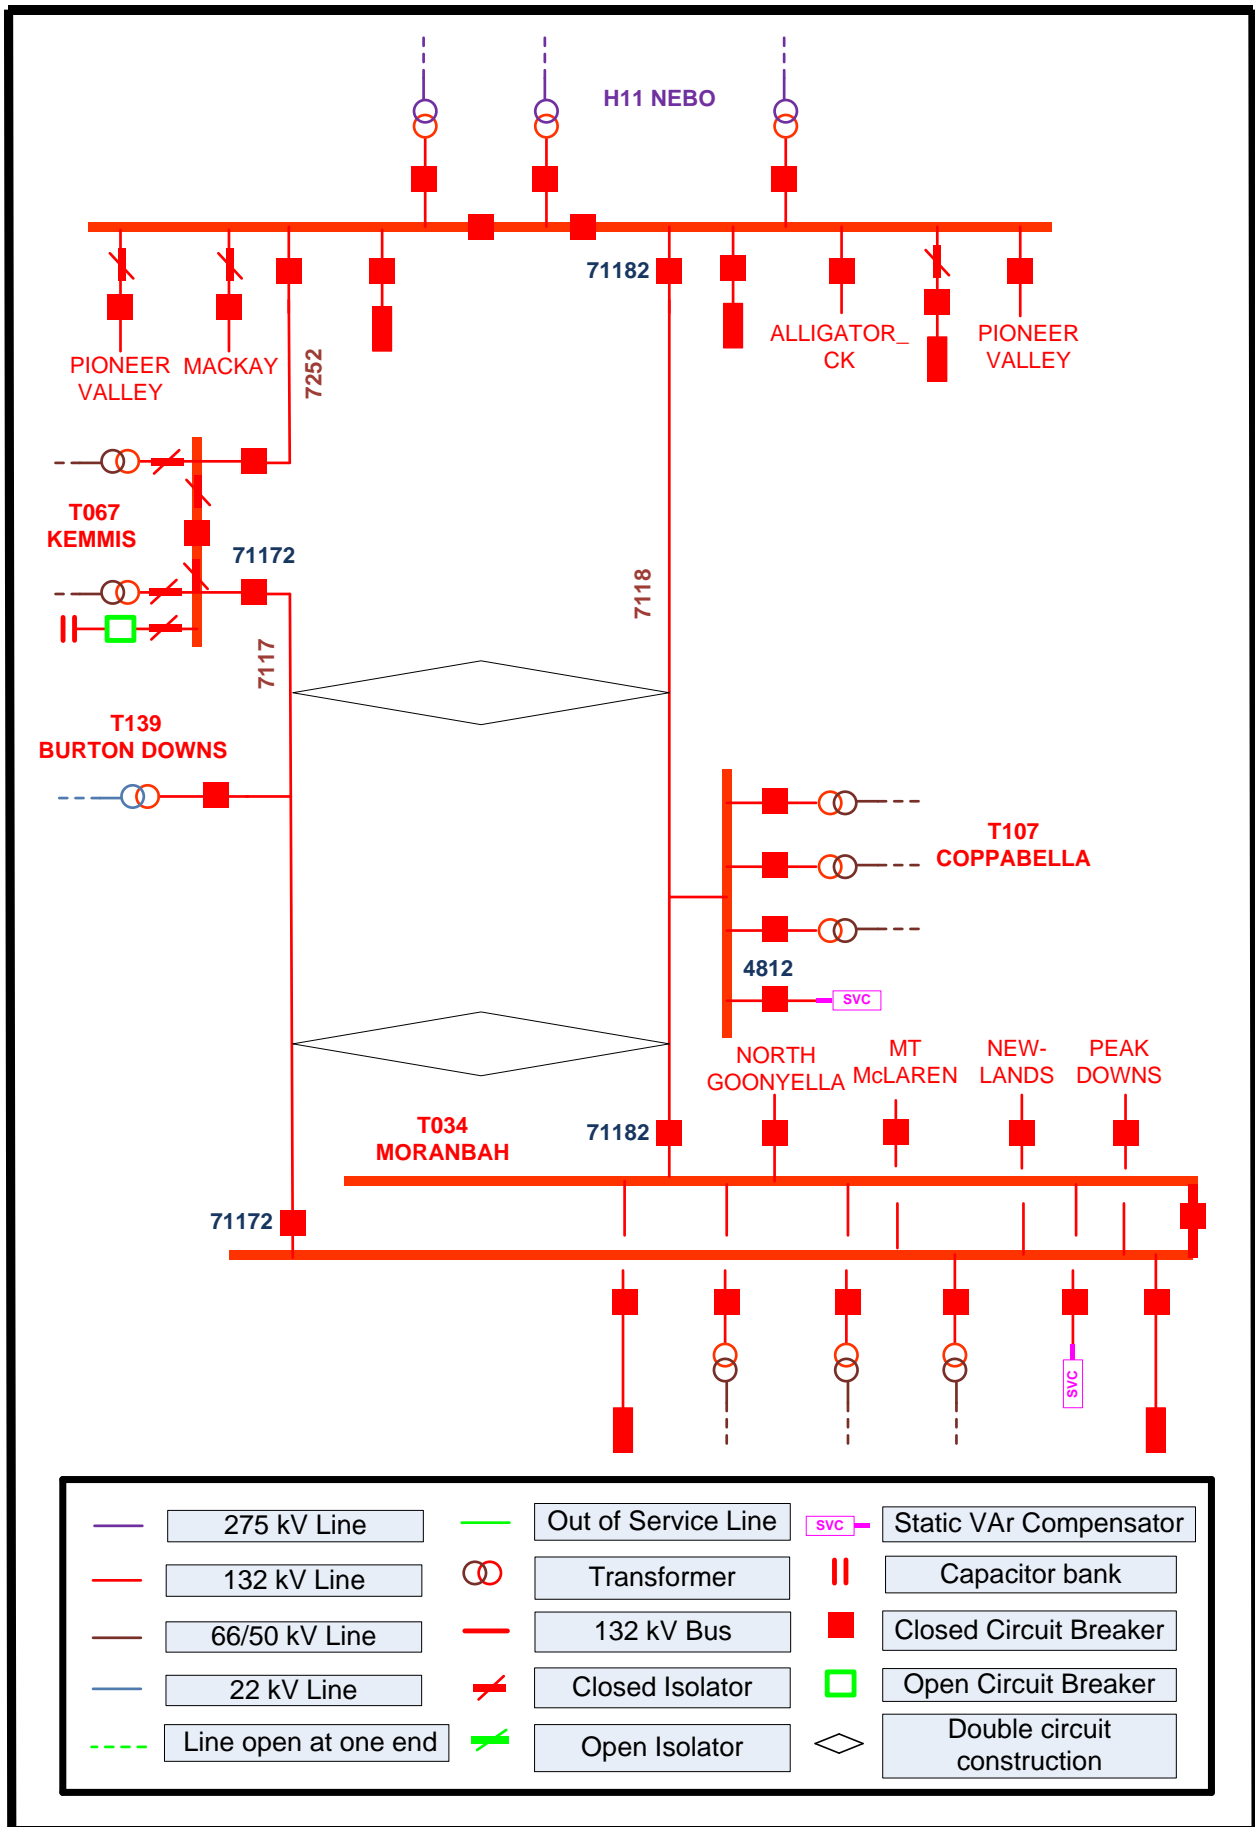
Figure 1 - Status of the power system prior to the incident

The status of the power system prior to the incident is shown in Figure 1. For clarity only equipment relevant to this incident has been included in the diagram.

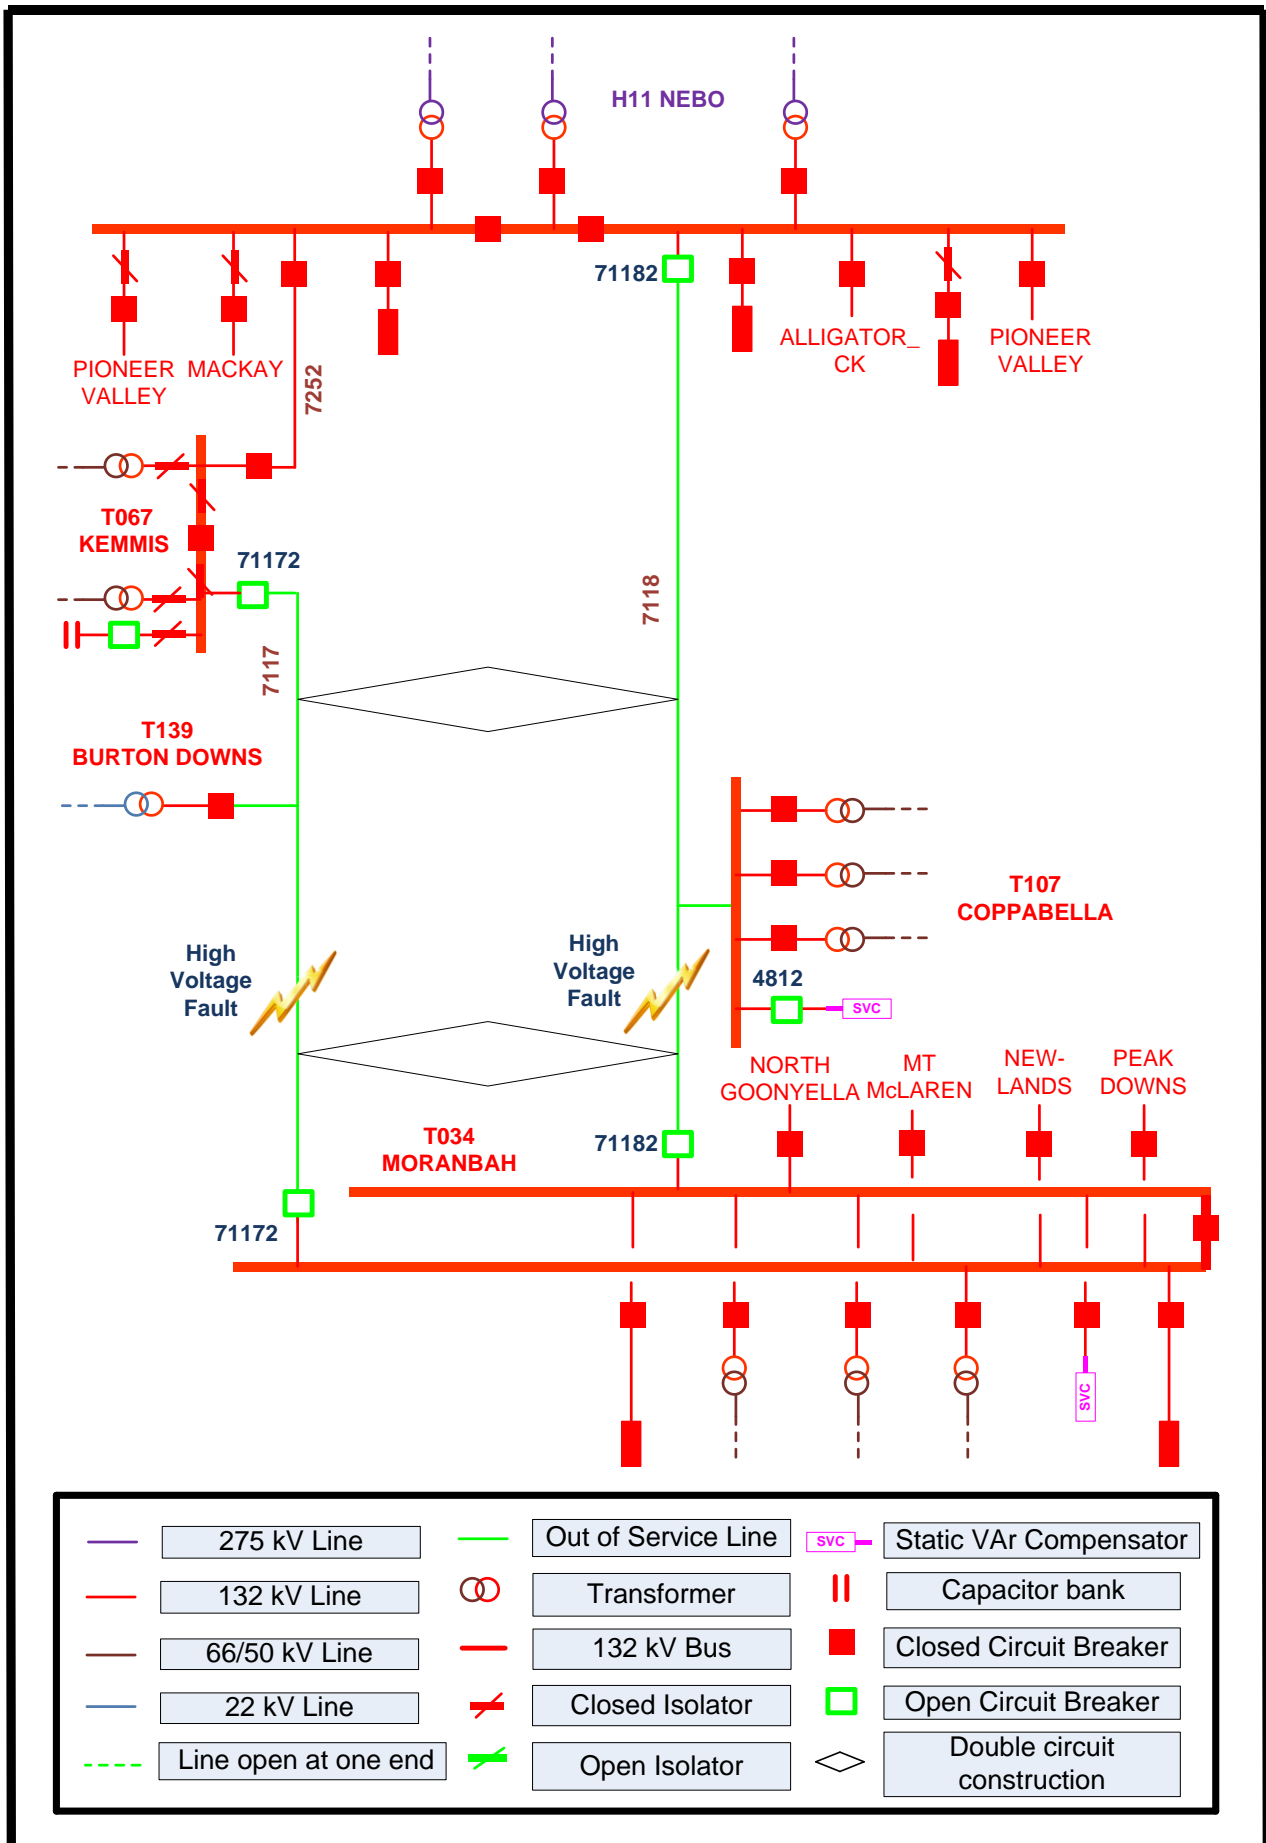
Figure 2 - Status of the power system immediately after trip of the two lines

At 13:36:15 on 22 February 2012, the protection systems of the 7117 and 7118 lines operated to clear high voltage faults on both lines, tripping both lines out of service. Refer to Figure 2 for the status of the power system immediately after the lines tripped.

Approximately 11 MW of load, comprising of load supplied from the BDN and COP substations, was interrupted when the two lines tripped. The SVC at COP substation also tripped out of service due to the loss of its auxiliary supplies when the 7118 line tripped.

The high voltage faults occurred at the time of an electrical storm in the vicinity of the 7117 and 7118 lines. The line protection systems indicated the faults occurred at similar physical locations on each line. The faults on 7117 and 7118 lines were cleared in 70 ms from the KMIS and NEBO ends respectively, and in 150 ms from the MRNB end. The fault clearance times were within the required time frames specified in the NER¹.

At 1344 hrs, Powerlink closed the circuit breaker 71182 at MRNB substation, placing on load the 7118 line section from MRNB.

At 1458 hrs, Powerlink returned the SVC at COP substation to service.
