POWER SYSTEM OPERATING INCIDENT REPORT – TRIP OF RINGWOOD NO.1 220 KV BUSBAR ON 18 APRIL 2012

PREPARED BY: Systems Capability

DATE: 2 October 2012

FINAL

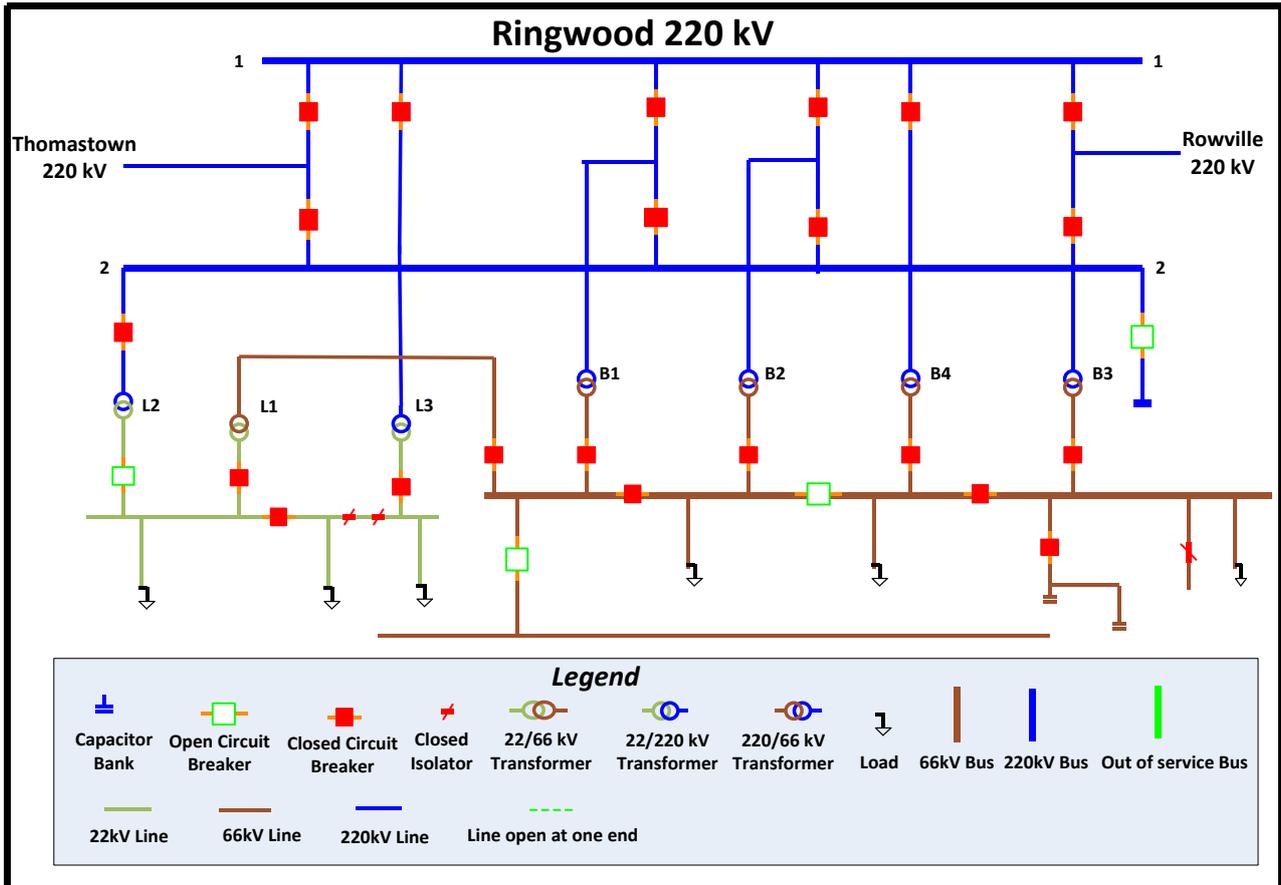
Figure 1 – Status of Ringwood Terminal Station and its connections prior to the incident

The Ringwood No.1 220 kV busbar and the status of its connections prior to the incident are shown in Figure 1. Only the equipment relevant to this incident has been included in the diagram for clarity.

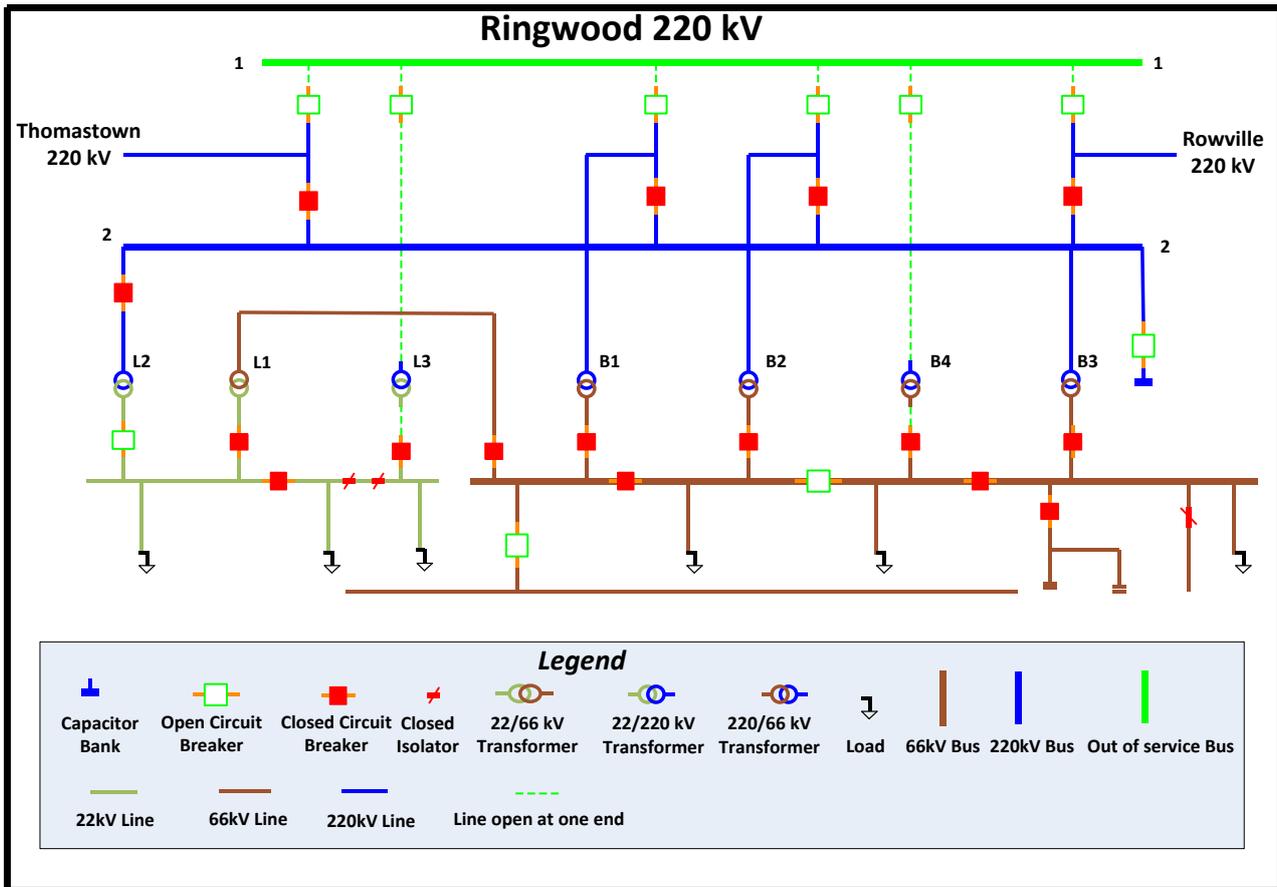
Figure 2 - Status of Ringwood Terminal Station and its connections immediately after the incident

At 1401 hrs on 18 April 2012, during routine maintenance work on the Ringwood B4 220/66 kV transformer, the Ringwood No.1 220 kV busbar tripped inadvertently on operation of busbar protection. This caused the off-loading of the Ringwood B4 220/66 kV and L3 220/22 kV transformers.

The status of Ringwood Terminal Station and its connections immediately after the incident are shown in Figure 2.

Investigation by SP AusNet confirmed the cause of the busbar trip to be the multimeter being in the "continuity" mode instead of "DC voltage" mode.
