# POWER SYSTEM OPERATING INCIDENT REPORT – TRIP OF SYDNEY WEST A1 AND A2 132 KV BUSBARS ON 18 DECEMBER 2012

PREPARED BY:       Systems Capability

DATE:                 15 March 2013

FINAL

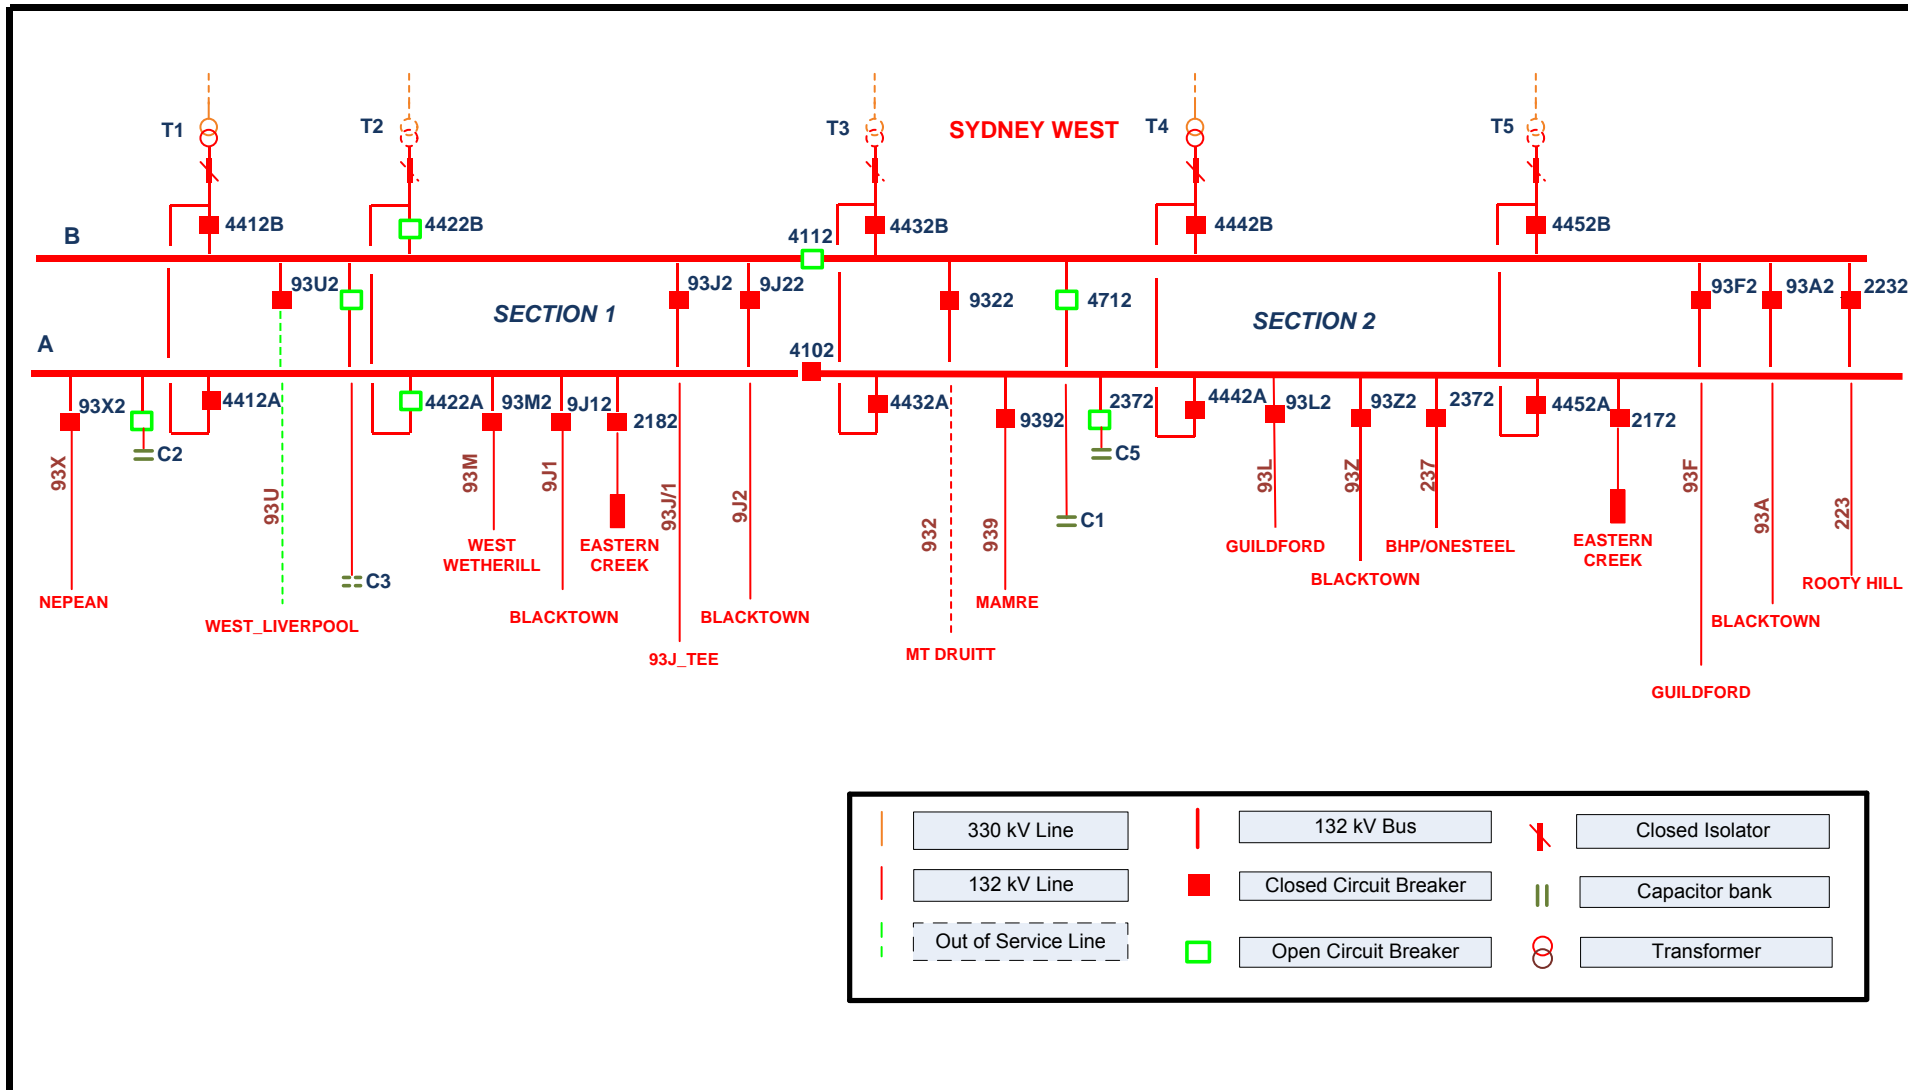
Figure 1 - Status of the power system prior to the incident

Prior to the incident, the T2 330/132 kV transformer at Sydney West was offloaded for a planned outage. And the four capacitor banks connected to the 132 kV busbars at Sydney West were also not in service.

The status of the power system prior to the incident is shown in Figure 1. For clarity only equipment relevant to this incident has been included in the diagram.

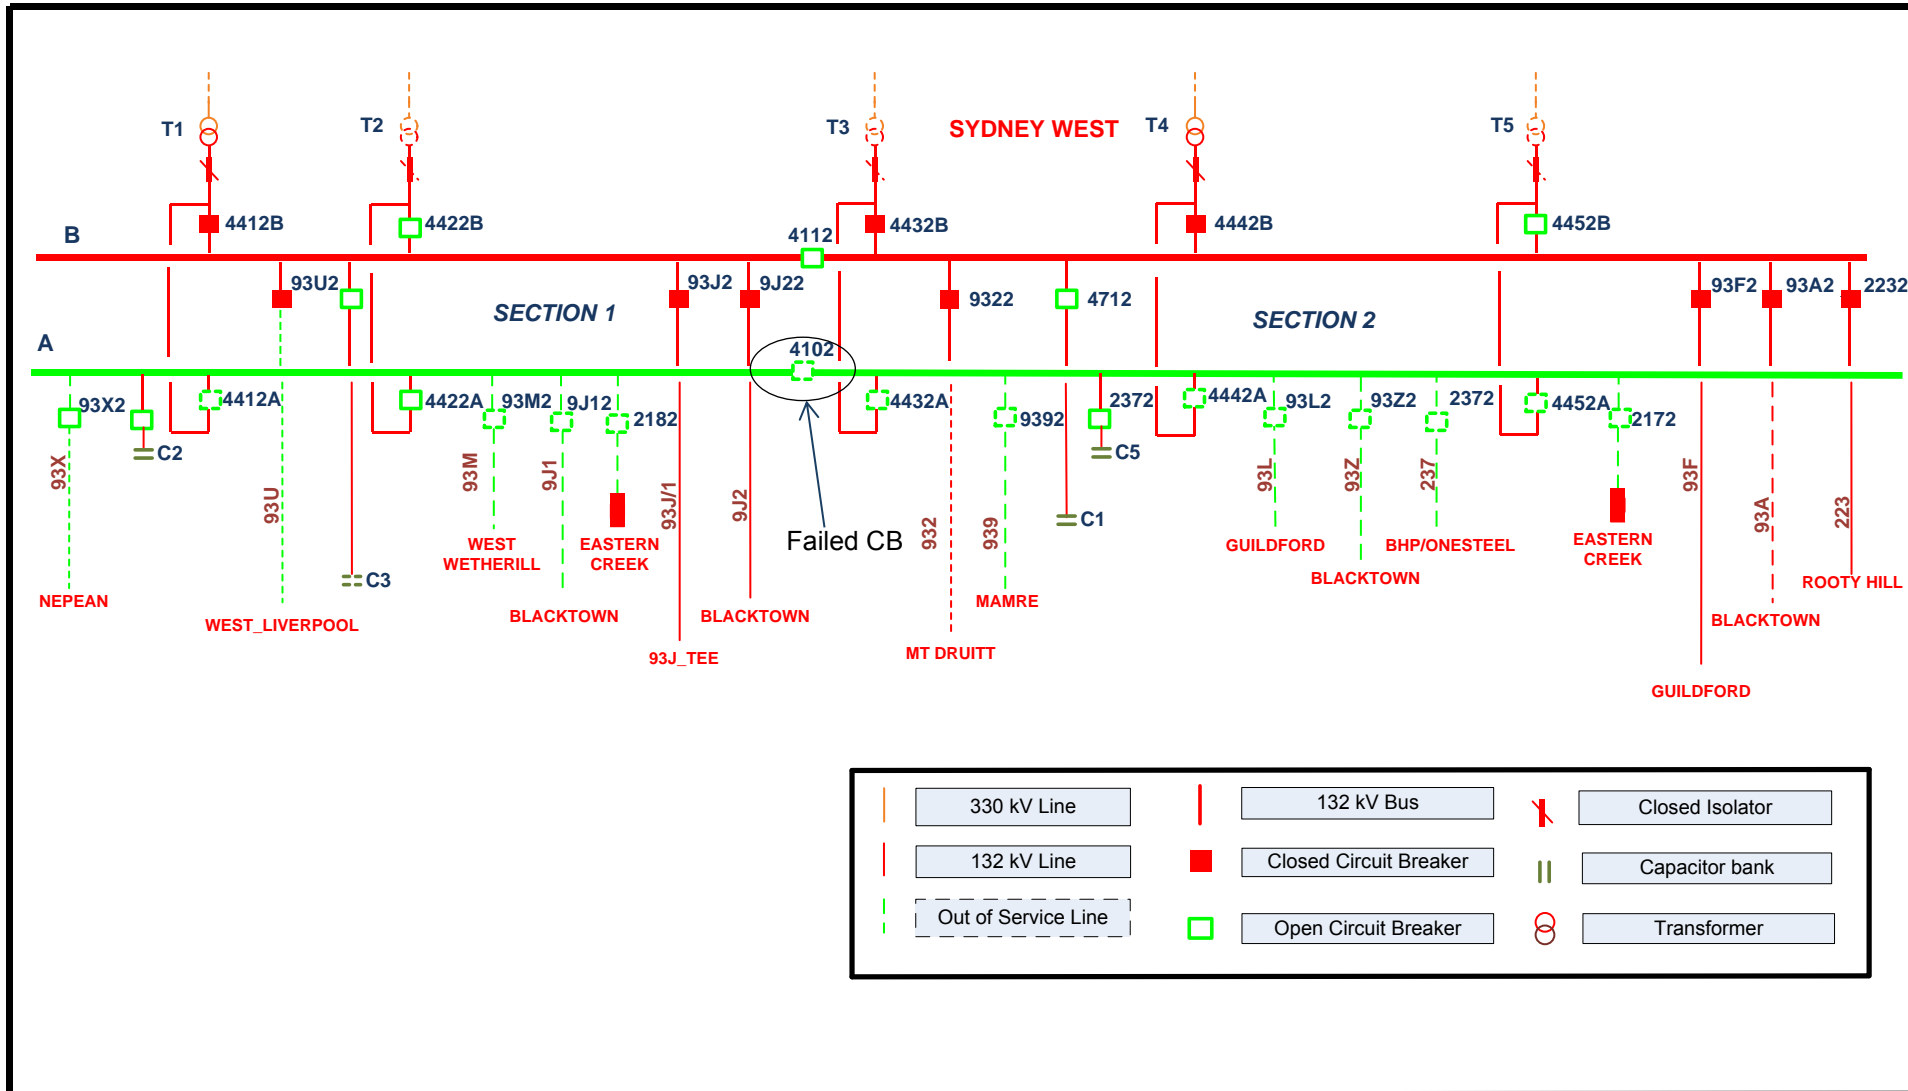
Figure 2 - Status of the power system immediately after the incident

TransGrid advised that the 132 kV A1 and A2 Busbars at Sydney West tripped on operation of busbar protection following the explosive failure of CB 4102.

The T5 330/132 kV transformer at Sydney West tripped on the operation of local backup protection opening the connected circuit breakers, CB 4452A and CB 4452B. Subsequently, the instantaneous overcurrent protection relay of the T5 330/132 kV transformer at Sydney West was found to be faulty; hence the local back-up protection system operated.

There was interruption to supply of approximately 33 MW of load supplied from Eastern Creek Zone Substation and OneSteel as a result of the tripping of the 132 kV A1 and A2 Busbars at Sydney West.

The status of the power system immediately after the incident is shown in Figure 2.
