# Power System Operating Incident Report – Trip of Brinkworth-Davenport 275 kV Transmission Line at Brinkworth End on 14 October 2013

PREPARED BY: AEMO Systems Capability

DATE: 6 January 2014

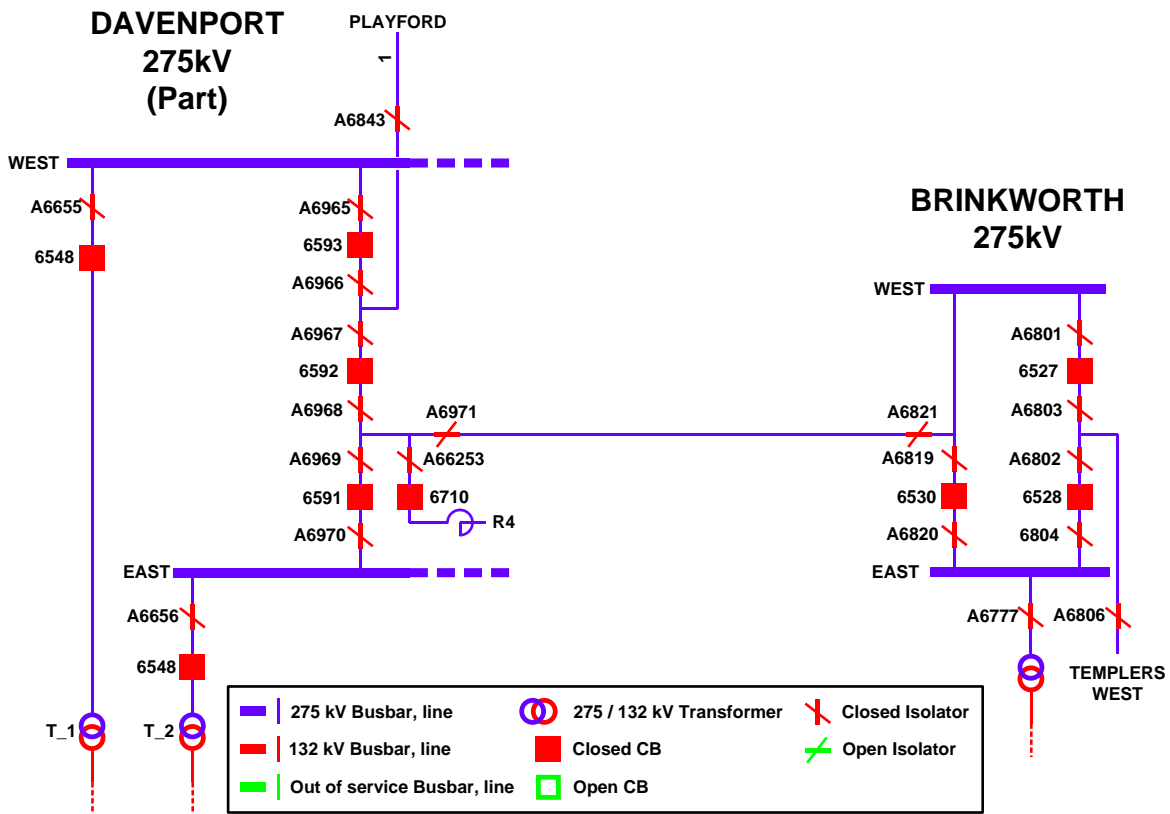
Figure 1 - Status of the power system before the incident

The status of the power system before the incident is shown in Figure 1 and following the incident in Figure 2. For clarity only sections of substations relevant to this incident have been included in the diagram. The diagram shows Brinkworth-Davenport 275 kV Transmission Line in service in Figure 1 and off-loaded and open at the Brinkworth end in Figure 2.

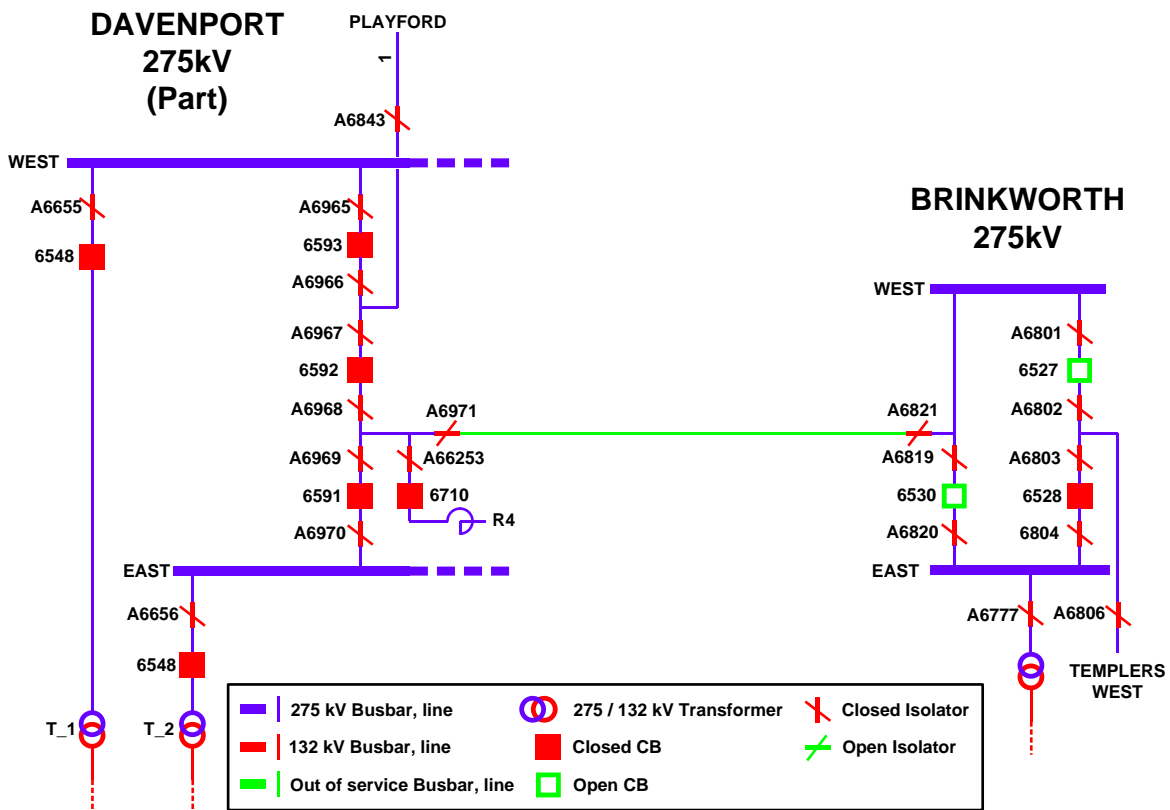
Figure 2 - Status of the power system after the incident

ElectraNet investigated the incident and found that faulty protection signalling (communication) equipment caused the opening of the transmission line. The faulty protection signalling equipment triggered 275 kV Circuit Breakers 6527 and 6530 at Brinkworth Substation to open. A manual reclose<sup>4</sup> was attempted shortly afterwards at 0230 hrs, however the transmission line once again tripped at the Brinkworth end.

The faulty protection signalling equipment was later identified and replaced. The transmission line was returned to service on Thursday 17 October at 1046 hrs.
