Power System Operating Incident Report – Trip of Ross 275 kV No. 2 Busbar on 14 November 2013

PREPARED BY: AEMO Systems Capability

DATE: 10 January 2014

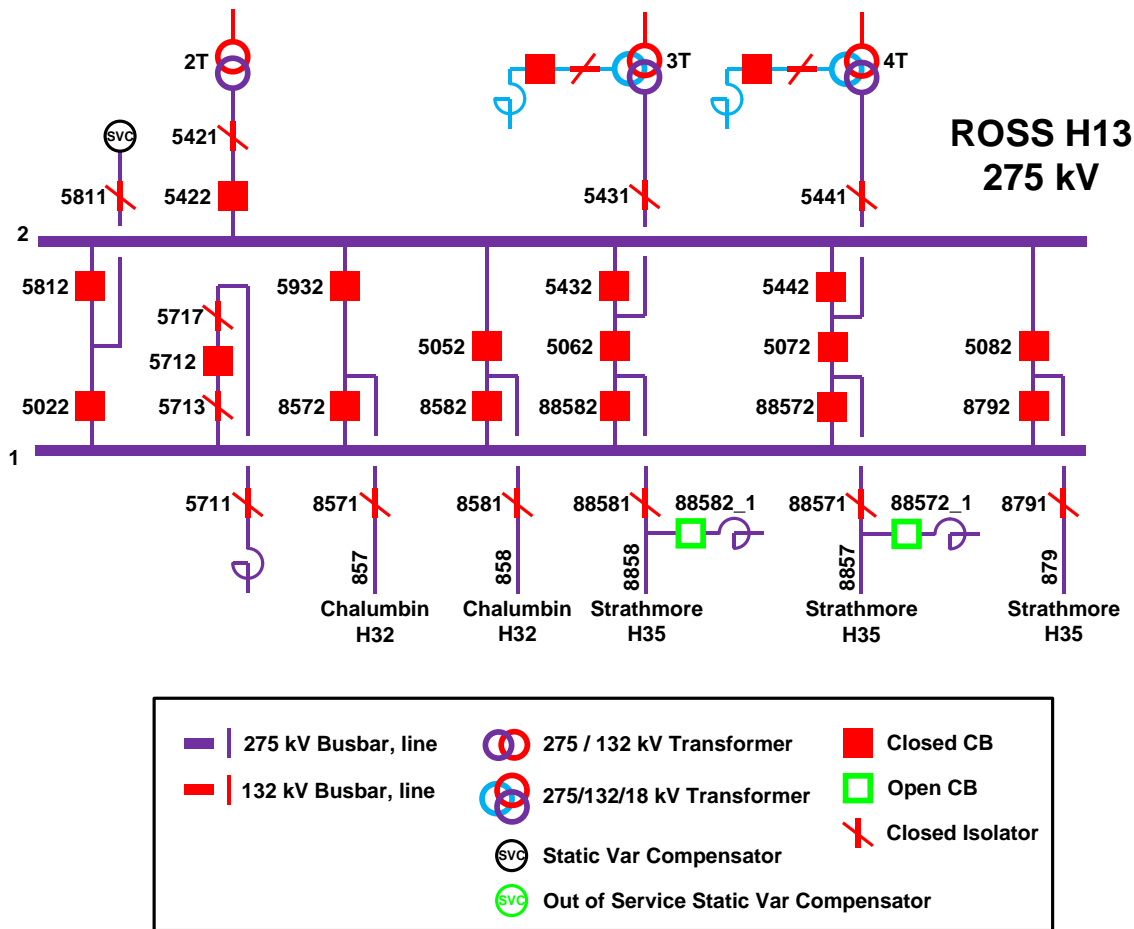
Figure 1 – Power system at Ross 275 kV Substation before the incident

The status of the power system before the incident is shown in Figure 1 and after the incident in Figure 2. For clarity only equipment relevant to this incident has been included in the diagrams. Figure 1 show Ross No.2 275 kV Busbar, Ross SVC and 2T 275/132 kV transformer in service, and Figure 2 shows the same plant out of service or off-loaded.

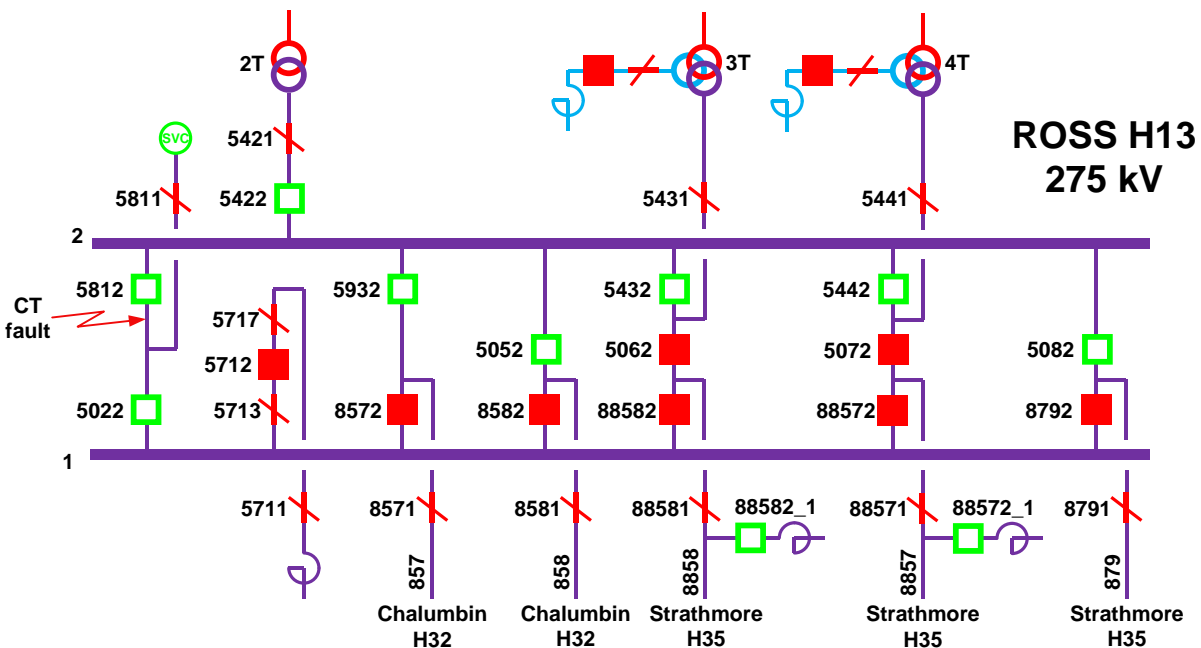
Figure 2 – Power system at Ross 275 kV Substation after the incident

On Thursday 14 November 2013, at 1523 hrs, the No.2 275 kV Busbar at Ross Substation tripped. The cause of the event was a high voltage fault internal to a current transformer (CT) on the line side of a busbar circuit breaker (CB). The fault also tripped the SVC at Ross Substation and off-loaded a 275/132 kV transformer as a result of the busbar trip. The failed CT and its associated CB were then isolated, and the busbar, SVC and transformer were returned to service at 1630 hrs approximately one hour after the trip.

The failed CT and associated CB 5812 were then isolated, and the busbar, SVC and transformer were subsequently returned to service. The failed CT was later replaced and, together with CB 5812, was returned to service on 30 November 2013.
