POWER SYSTEM OPERATING INCIDENT REPORT – SIMULTANEOUS TRIP OF ALL DARLING DOWNS POWER STATION UNITS ON 13 FEBRUARY 2013

PREPARED BY: Systems Performance and Commercial

DATE: 3 April 2013

FINAL

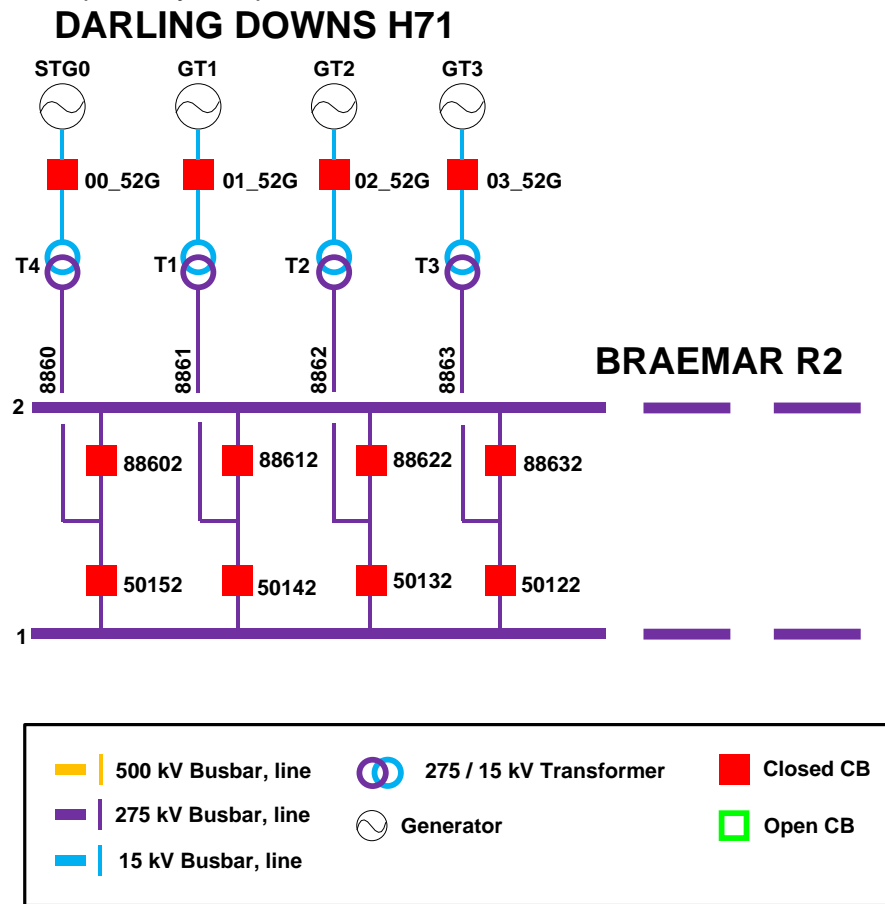
Figure 1 - Status of the power system prior to the incident

The status of the power system prior to the incident is shown in Figure 1. For clarity only equipment relevant to this incident has been included in the diagram.

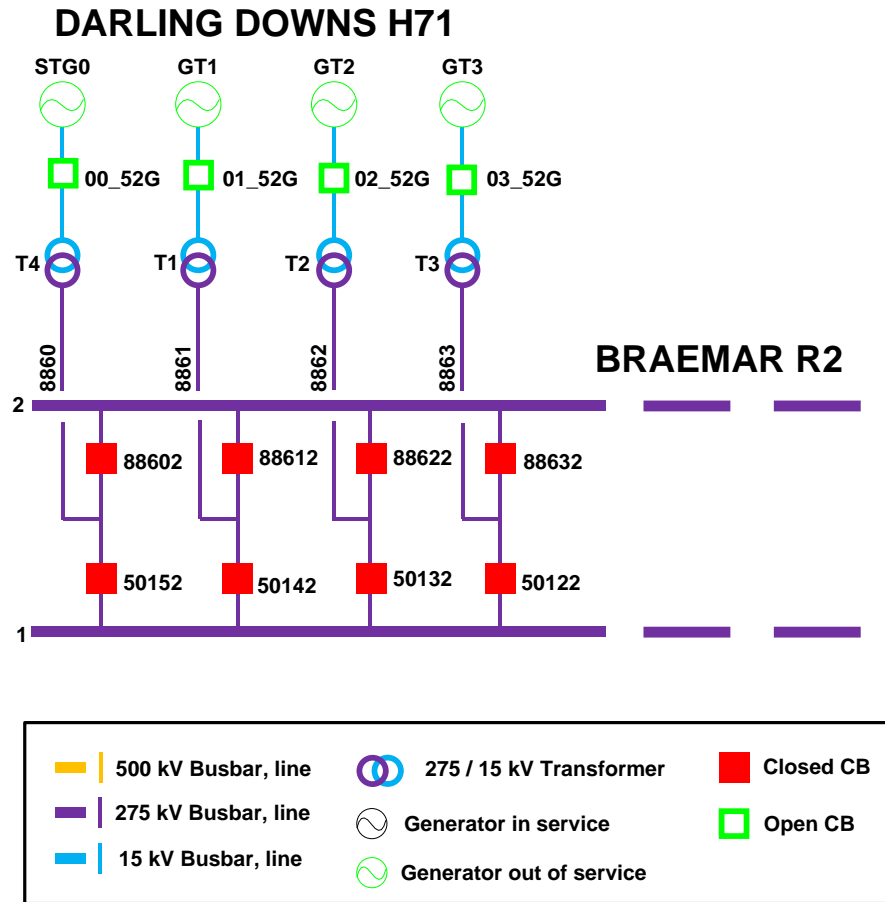
Figure 2 - Status of the power system immediately after the incident

At 0505 hrs on 13 February 2013, Darling Downs Power Station Units (GT1, GT2, GT3 and STG0) tripped simultaneously from a total of 340 MW.

The status of the power system immediately after the incident is shown in Figure 2.
