POWER SYSTEM OPERATING INCIDENT REPORT – TRIP OF MULTIPLE GENERATING UNITS AT MILLMERRAN POWER STATION ON 9 MARCH 2013

PREPARED BY: Systems Capability

DATE: 1 May 2013

FINAL

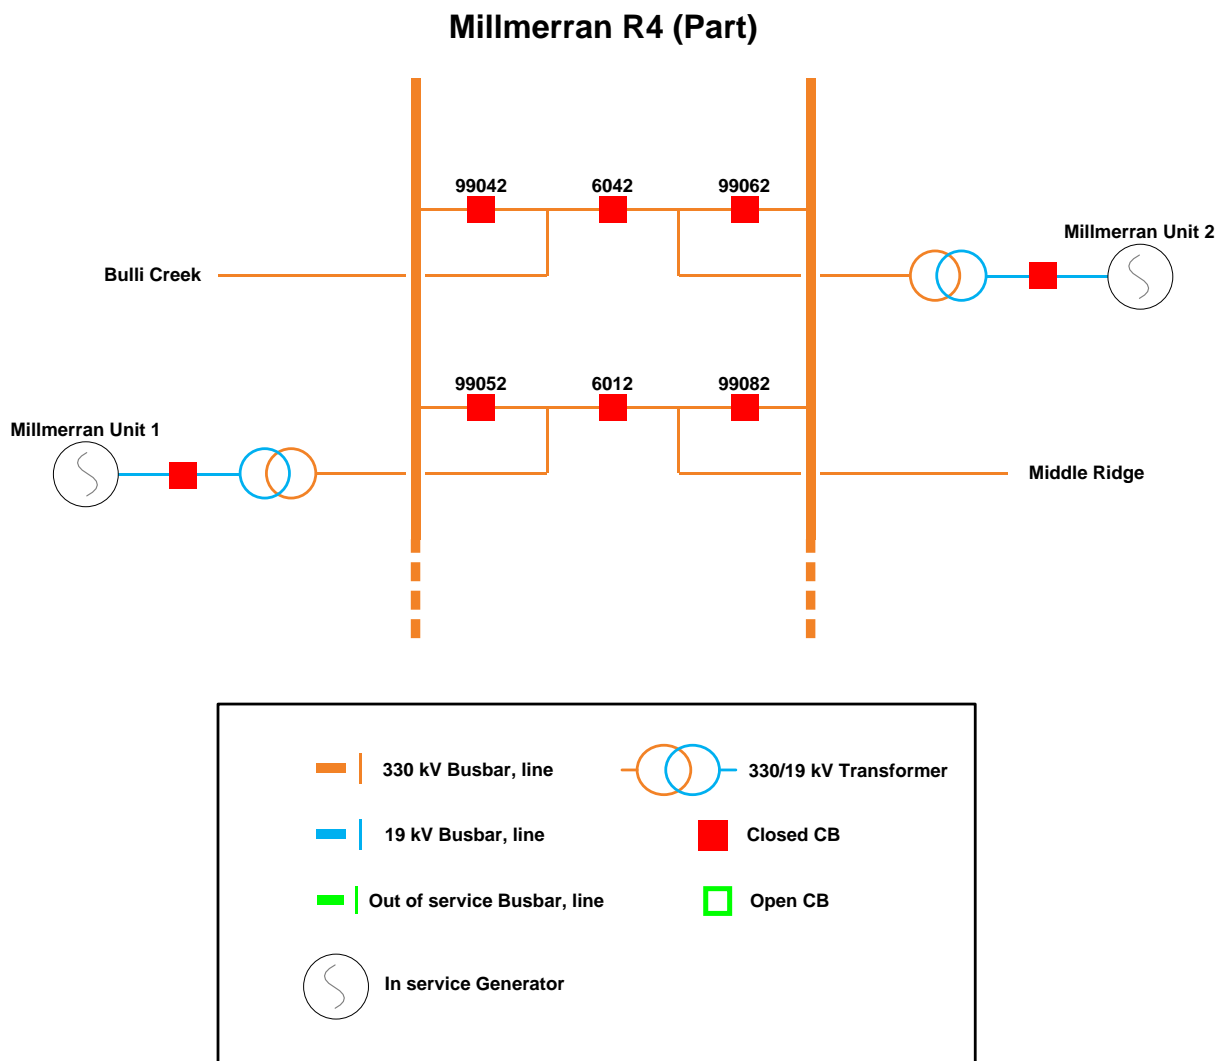
Figure 1 - Status of the power system prior to the incident

Prior to the incident, Units 1 and 2 at Millmerran Power Station were generating 399 MW and 424 MW respectively to give a combined output of 823 MW.

The status of the power system prior to the incident is shown in Figure 1. For clarity only equipment relevant to this incident has been included in the diagram.

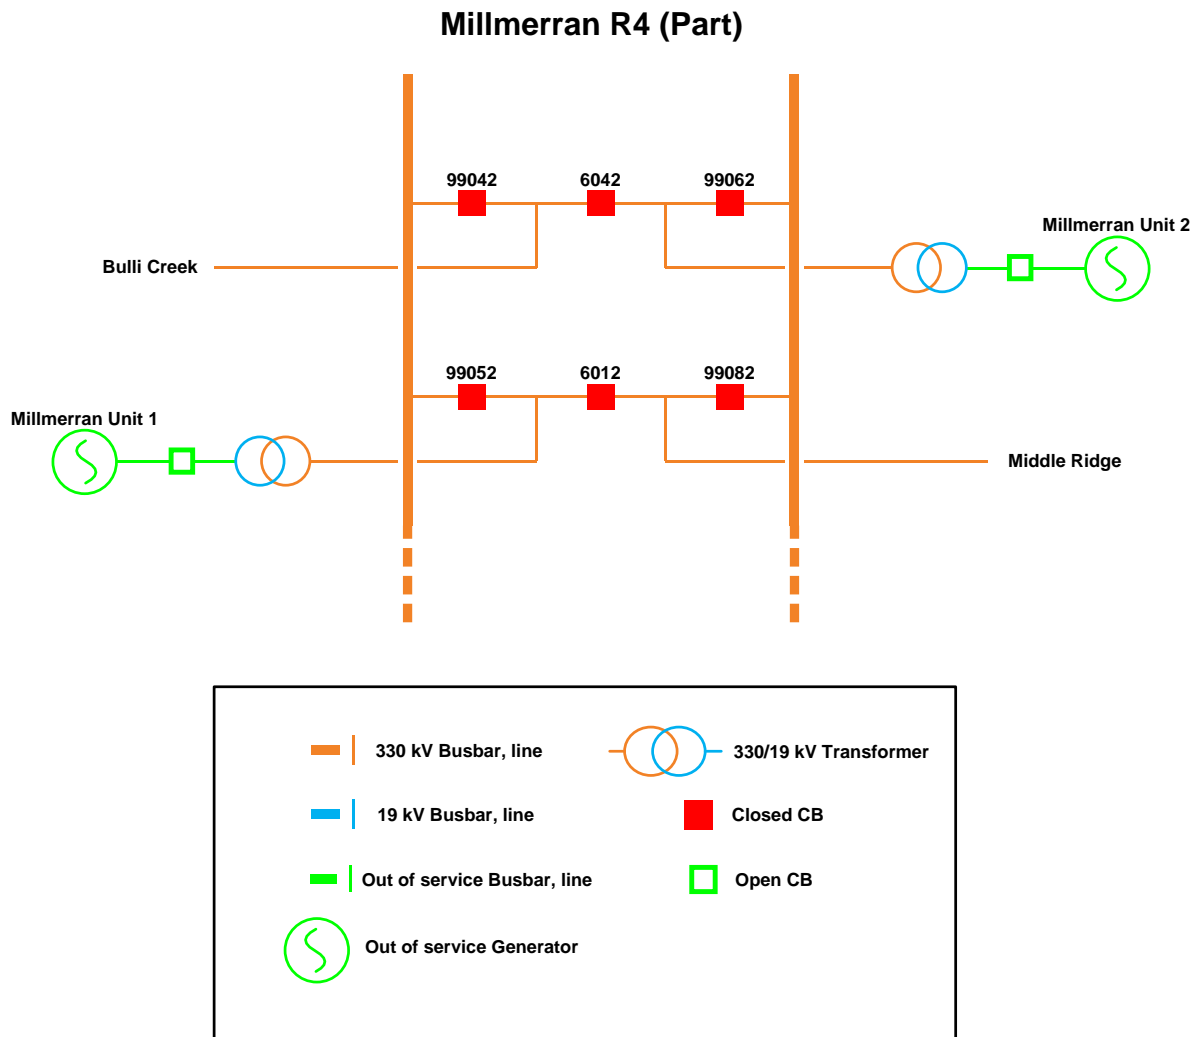
Figure 2 - Status of the power system immediately after the incident

At 2207 hours on 9 March 2013, Units 1 and 2 at Millmerran Power Station in Queensland Region tripped simultaneously resulting in a total of 823 MW loss of generation.

The status of the power system immediately after the incident is shown in Figure 2.
