POWER SYSTEM NOT IN A SECURE OPERATING STATE IN NSW ON 28 NOV 2016

REVIEWABLE OPERATING INCIDENT REPORT UNDER THE
NATIONAL ELECTRICITY RULES

Published: **13 July 2017**

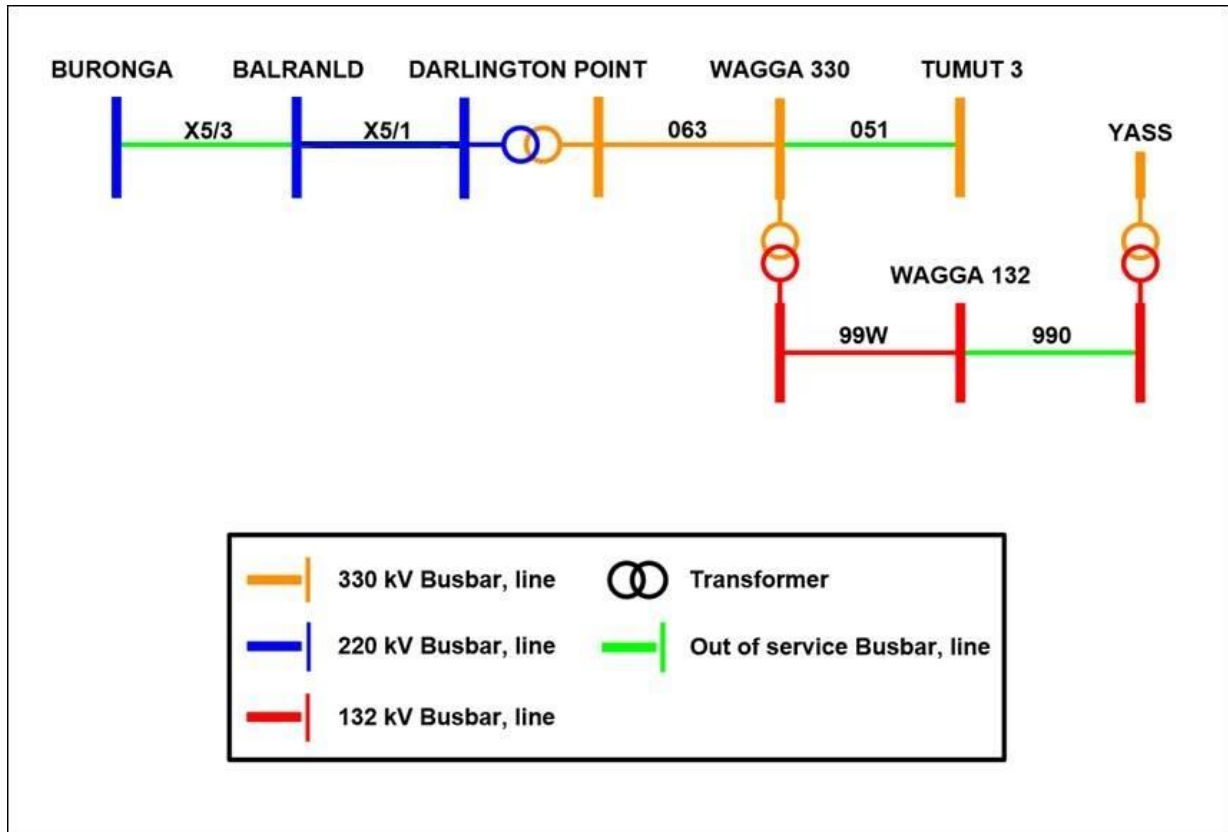
Figure 1 Power system following the incident

From 0727 hrs, AEMO's real time contingency analysis (RTCA) tools indicated that, for the loss of the Buronga X5 reactor, the 330kV voltage levels at Darlington Point would exceed the allowable limit of 362kV. As a result of the high post-contingent voltage, the power system was not in a secure operating state.

An additional error in the studies was modelling the X5 line as opened at both ends. This was due to an incorrect assumption AEMO made based on typical network configuration for a planned outage of X5 line. However, for the outage on 28 November, the X5 line was open at one end only.

The power system immediately after the incident is indicated in Figure 1
