# POWER SYSTEM INSECURE IN QUEENSLAND ON 13 OCTOBER 2015

AN AEMO POWER SYSTEM OPERATING INCIDENT REPORT FOR THE NATIONAL ELECTRICITY MARKET

Published: July 2016

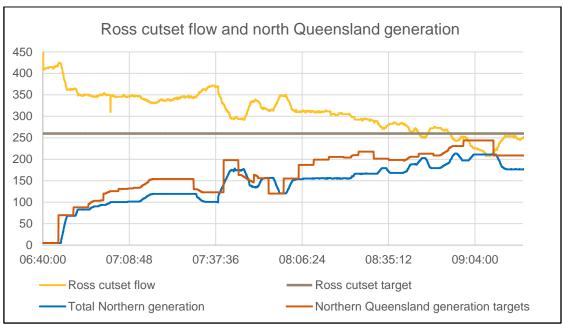
Figure 1 - Ross cut-set flow

At 0855 hrs, about 85 minutes after issuing the first Direction, the Ross cut-set flow was reduced to 260 MW and power system in north Queensland returned to a secure operating state. The power system was not in a secure operating state for 135 minutes. Figure 1 details the Ross cut-set flow and generation response during this time. Appendix D provides information on the response of individual generating units to the directions.

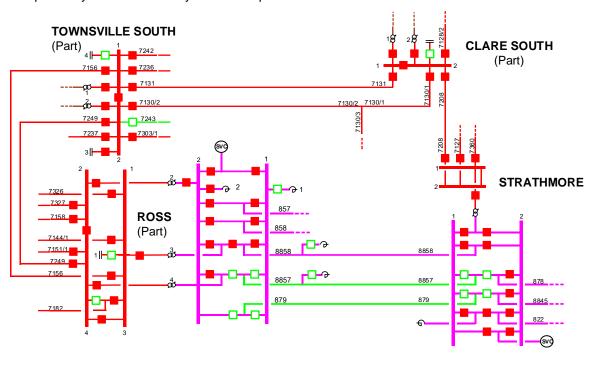
#### APPENDIX A. POWER SYSTEM DIAGRAM

The power system immediately after the trip of Line 879.
