Trip of Broken Hill 220 kV Busbar on 15 February 2018

October 2018

Reviewable operating incident report under the
National Electricity Rules

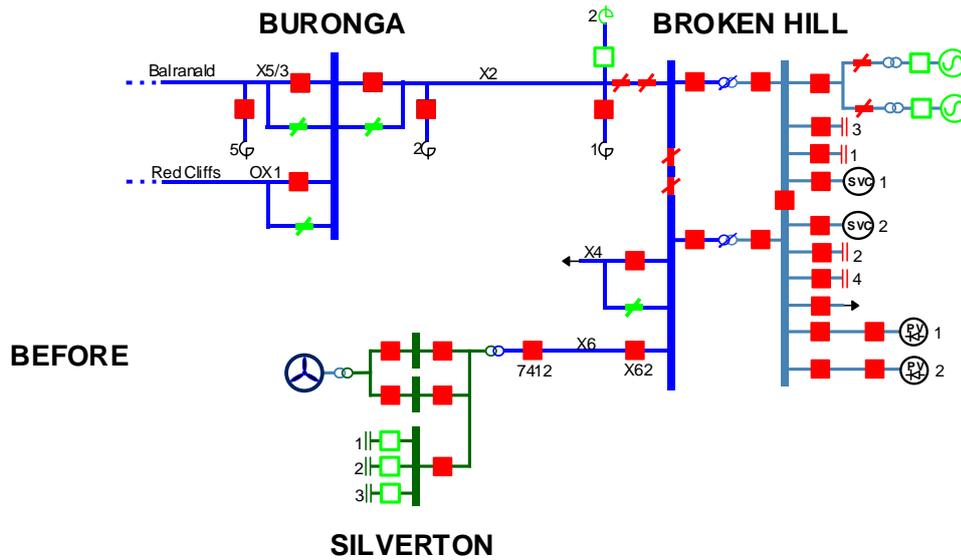
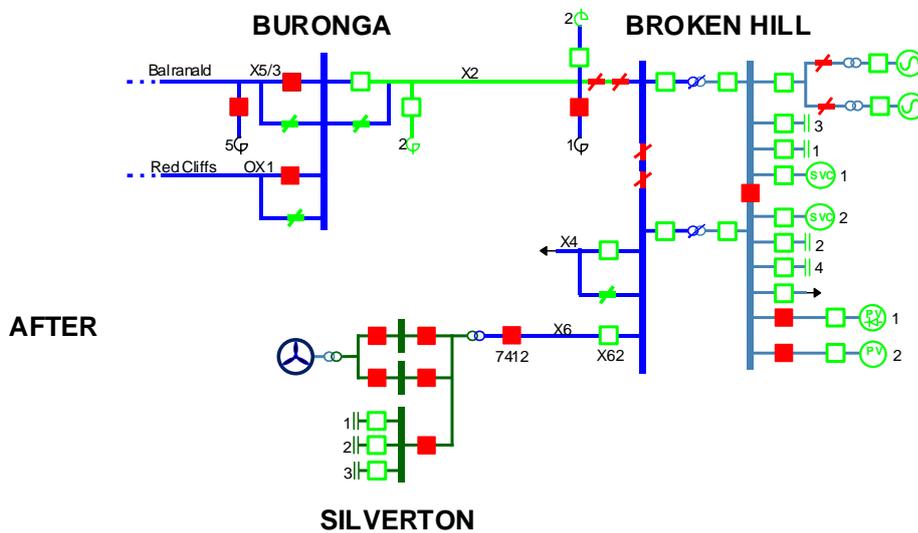
A1. Power system diagram

Refer to Appendix A1 for network diagrams showing switchgear status before and immediately after the incident.

The diagrams below show the power system in the Broken Hill area before and immediately after this incident.
