Final Report – South Australia and Victoria Separation Event, 16 November 2019

A reviewable operating incident report for the National Electricity Market

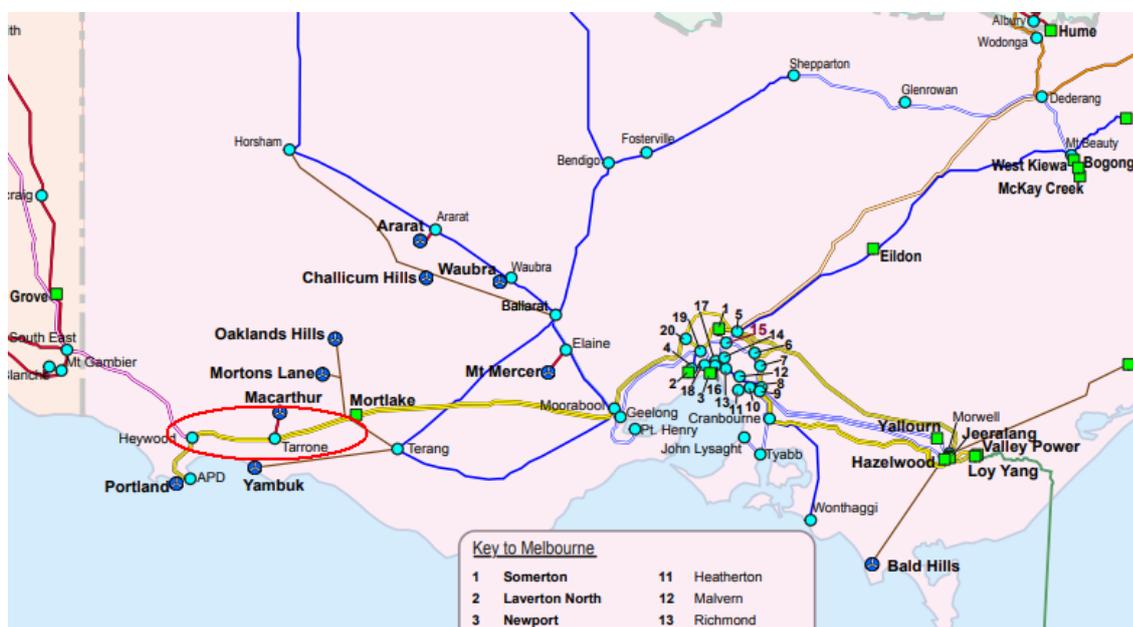
Figure 1 Victoria transmission system

At 1806 hrs on 16 November 2019, two 500 kV transmission lines in Victoria were disconnected simultaneously due to malfunction of telecommunications equipment that caused operation of protection equipment on both circuits. This non-credible contingency event resulted in the disconnection of the South Australia region from the rest of the NEM power system for nearly five hours, and disconnection of electrical supply to the Alcoa Portland (APD) aluminium smelter in Victoria for nearly three hours.

Figure 1 shows the location of the affected 500 kV lines in Victoria (area circled in red).

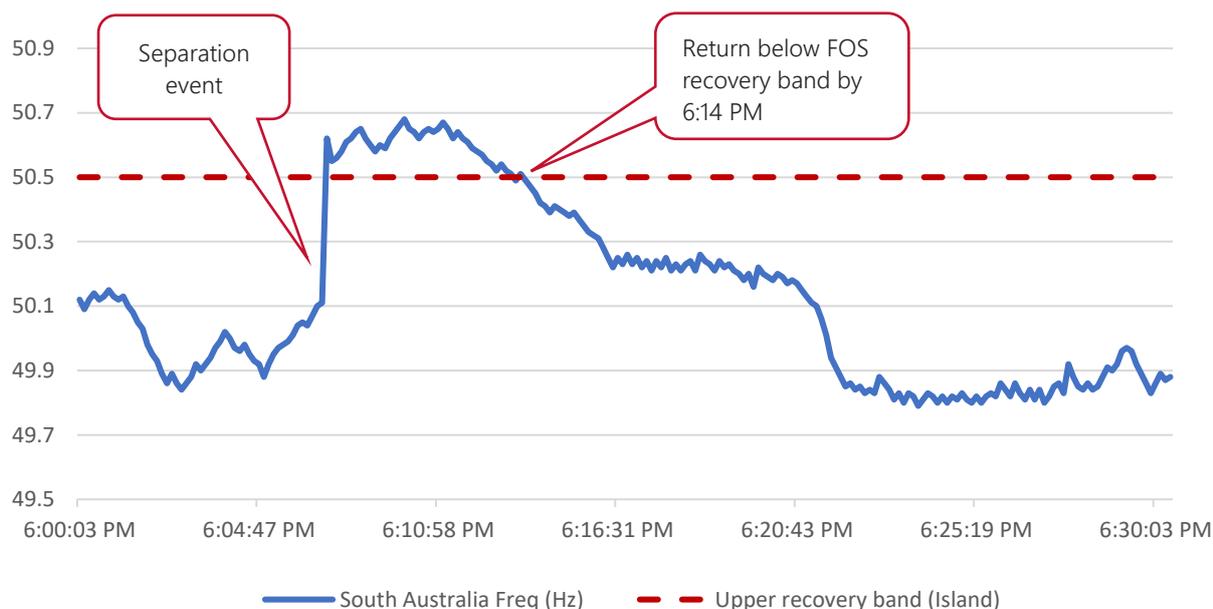
Figure 2 Frequency in the South Australia island

Figure 2 shows the frequency response in the South Australia island prior to and after the separation event.

For this event, the maximum frequency reached in the South Australia island was 50.7 Hz and did not exceed the FOS containment or stabilisation boundaries. Despite under-delivery of delayed lower FCAS from some FCAS-enabled facilities (refer to Section 5.2) the frequency in the South Australia island recovered to below 50.5 Hz within approximately five minutes. In the South Australia island the FOS was met but the frequency remained at approximately 50.15 Hz for a further 10 minutes. Refer to Section 0 for more information.

As the frequency did not exceed 51 Hz, there was no shedding of generation load as a result of OFGS operation.

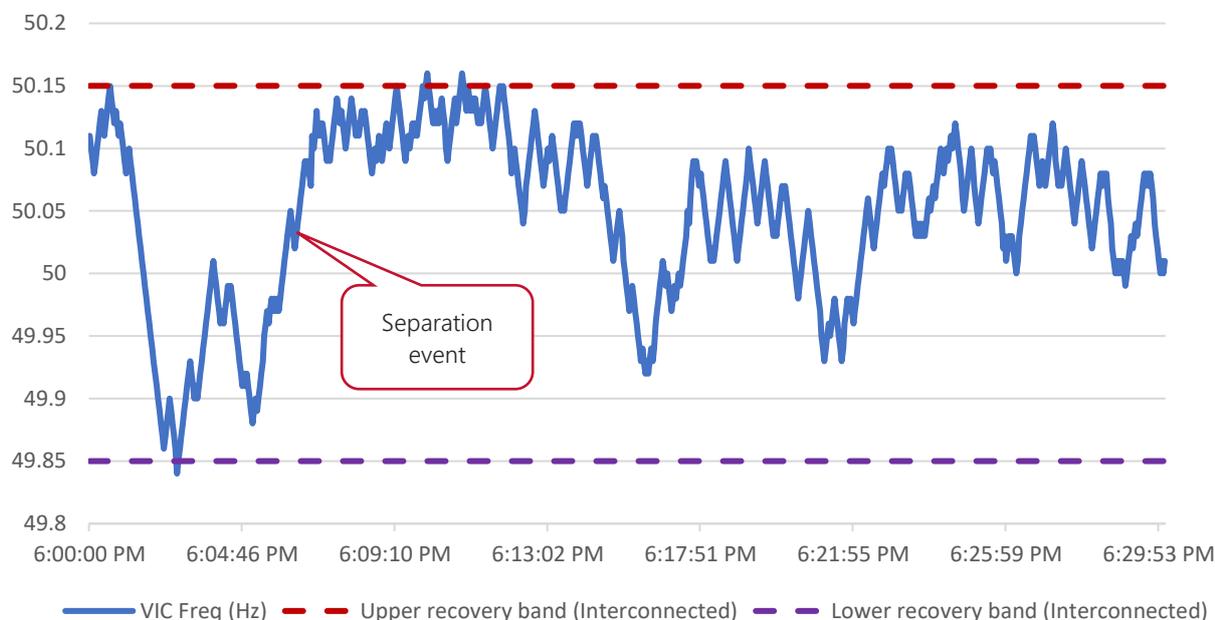
Figure 3 Frequency in the remainder of the mainland NEM

Figure 3 shows the frequency response in the other mainland regions prior to and after the separation event. The FOS for a separation event allows the frequency to range between 49 Hz and 51 Hz (containment) but the frequency must return to between 49.5 Hz and 50.5 Hz (stabilisation) within two minutes and to between 49.85 Hz and 50.15 Hz (recovery) within 10 minutes.

For this event, the frequency briefly exceeded the FOS upper recovery limit in the minutes following the separation of South Australia, with the loss of the APD load exceeding the reduced generation capacity from South Australia. A maximum frequency of 50.17 Hz was recorded in the mainland regions excluding South Australia. This is only marginally outside the FOS recovery limit and returned within the FOS limits within the 10-minute window. As such, an FCAS assessment was not conducted for units outside of South Australia.

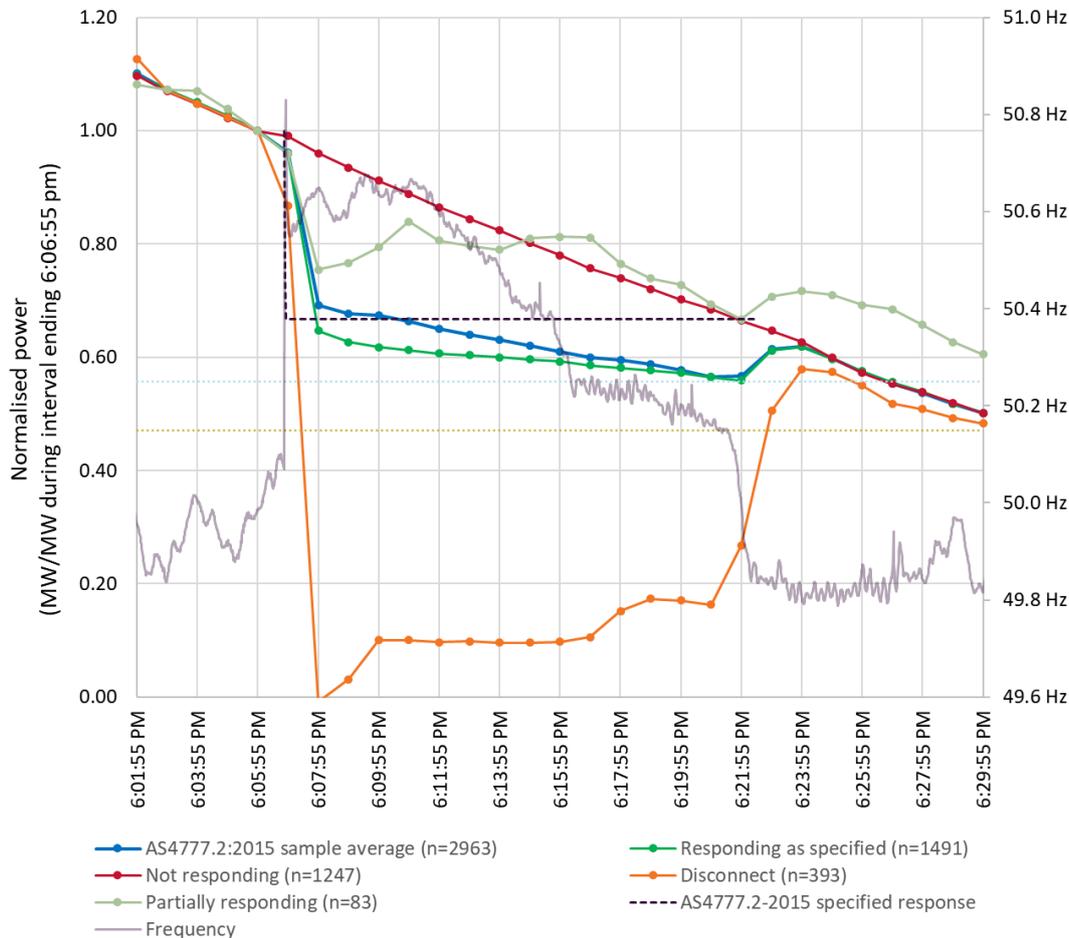
Figure 4 Categorised average responses of inverters installed after October 2016 in South Australia

Responses of inverters on the 2015 standard were analysed to determine whether they were providing this response as specified; 43% of the sampled systems were assessed to be providing the over-frequency droop as specified in the standard, with a further 2% partially responding. However, 35% of systems did not respond according to the specified requirement, and a further 11% of systems appear to have disconnected (also inconsistent with behaviour specified in the standard). Figure 4 shows the normalised response of inverters in these categories. The black dotted line indicates the "specified response", based upon the maximum frequency reached in South Australia during this event (50.8 Hz).

UNSW’s bench testing¹³ of 16 inverters on the 2015 standard (representing around 66 MW, or 8%, of the installed capacity of distributed PV in South Australia) found that all inverters tested delivered the over-frequency droop response¹⁴. This suggests that the 35% of systems not delivering the over-frequency droop response in the field is more likely to be related to installer error than to manufacturer settings and design.
