# Trip of Farrell to Reece No. 1 and No. 2 220 kV Transmission Lines in Tasmania on 6 November 2019

**June 2020**

Reviewable Operating Incident Report under the  
National Electricity Rules

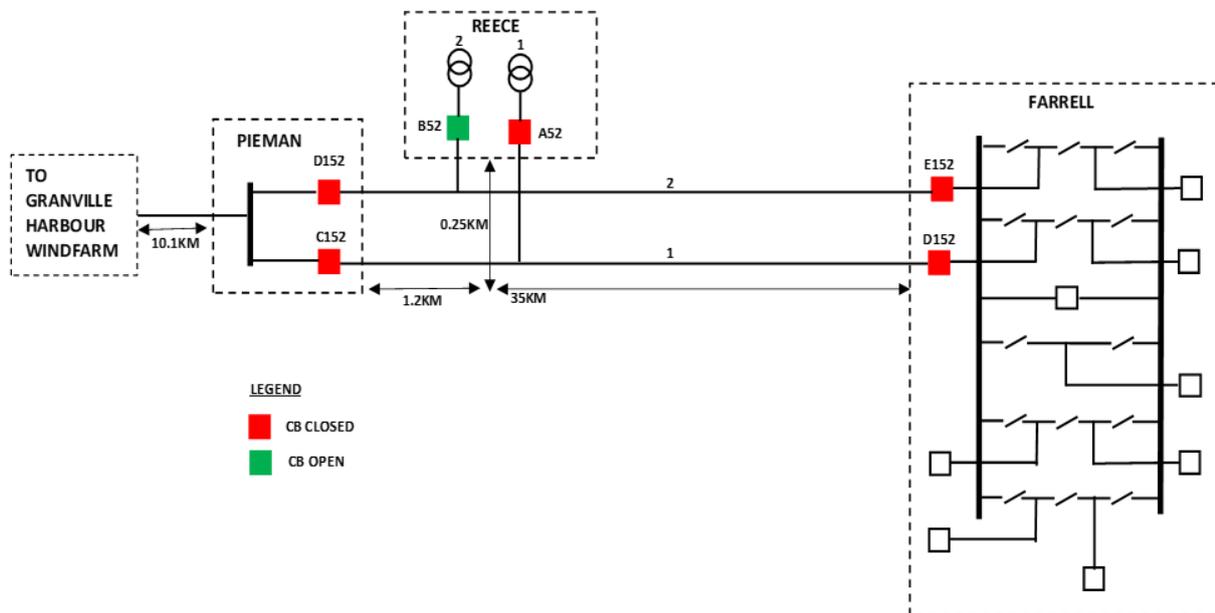
**Figure 2 Pre-trip Farrell–Reece–Pieman 220 kV transmission No. 1 and No. 2 circuits**

Figure 2 shows the switching configuration and status of the circuit breakers (CBs) for the No. 1 and No. 2 transmission line circuits immediately prior to the trip event.

- Reece Power Station No. 2 generating unit was out of service, with the 220 kV line CB B52 open.
- Auto-reclose functions on the No. 1 and No. 2 Farrell–Reece–Pieman 220 kV transmission line circuits at Farrell and Pieman were disabled, for commissioning activities on the Pieman switching station protection systems. It is noted that there is no auto-reclose on the Hydro Tasmania 220 kV CBs.
- The 220 kV Bus at Pieman switching station was energised only (with CBs C152 and D152 closed), and the Granville Harbour wind farm was not commissioned.

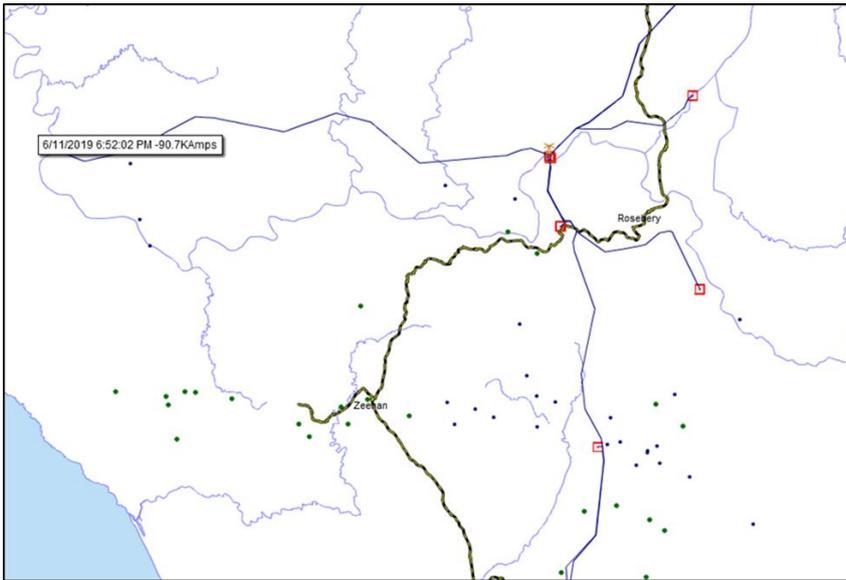
**Figure 3 GPATS lightning data near the Farrell–Reece–Pieman 220 kV double circuit line**

One high magnitude (-90.7 kA<sup>6</sup>) lightning strike was recorded in the Farrell–Reece–Pieman 220 kV transmission line corridor (as shown by Figure 3 Error! Reference source not found.).

TasNetworks identified this as the likely cause of the simultaneous faults on both circuits, with the possibility of a direct hit on one circuit and flashover on the adjacent circuit. The distance to fault readings indicate that the faults occurred approximately 4.5 km east of Reece Dam Substation (see Figure 3), within the area between towers T76 and T80. There is an overhead earth wire installed between these towers. Figure 4 shows the status of the relevant part of the power system immediately after the faults.

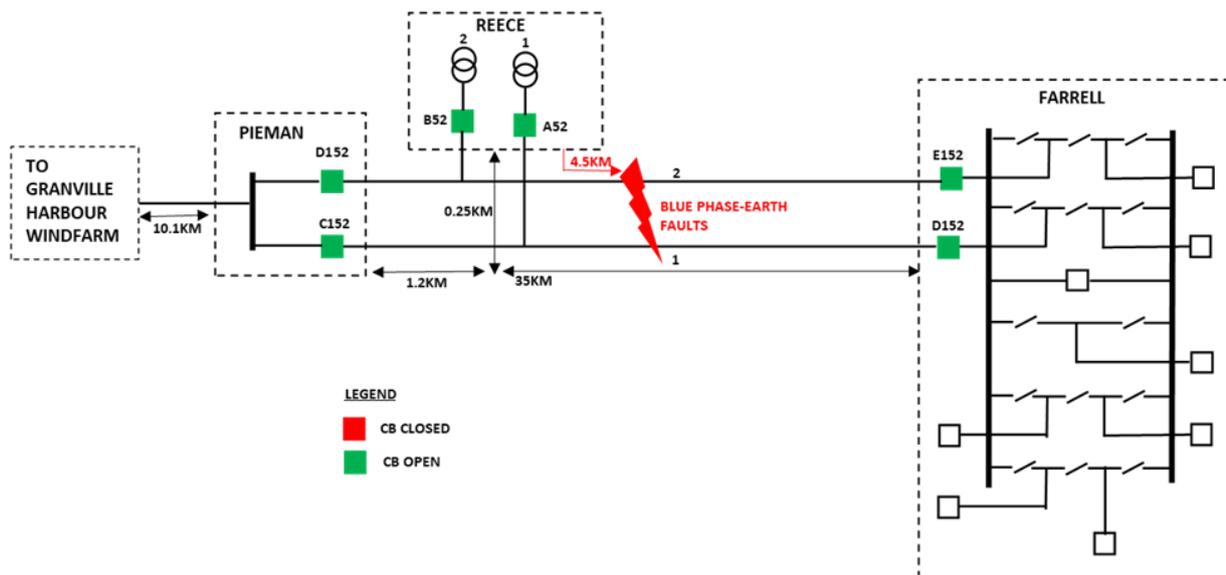
**Figure 4 Post fault status of the Farrell–Reece–Pieman 220 kV transmission line circuits**

18:52:02	Blue phase-to-earth faults occurred on both Farrell–Reece–Pieman 220 kV Transmission line circuits resulting in the operation of the line protection schemes at all three substations, tripping CBs Farrell D152 & E152, Reece A52, and Pieman C152 & D152 (shown in Figure 4Error! Reference source not found.).
	Reece unit 1 tripped, with output reduced from 111 MW to 0 MW.

The auto-reclose functions on both transmission line circuits at Farrell and Pieman were not operational, due to ongoing commissioning activities being undertaken at the new Pieman switching station. Auto-reclose is not installed on power station generator CBs, so manual closure of all CBs was required to re-establish 220 kV supply to the Pieman and Reece Dam substations from Farrell substation.

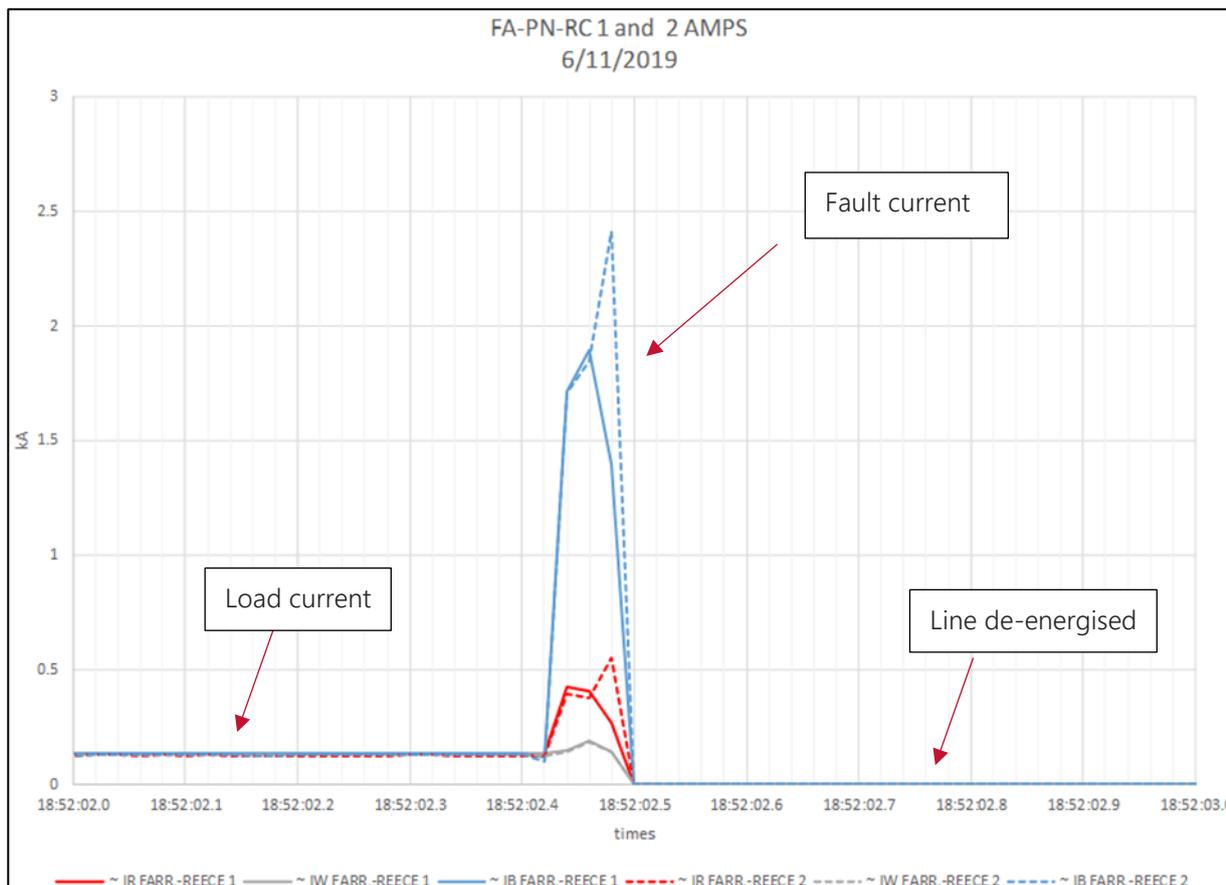
**Figure 5 TasNetworks Farrell–Reece–Pieman 220 kV transmission line fault data**

As shown by the TasNetworks fault data in Figure 5, simultaneous blue phase-to-ground faults occurred on both circuits of the Farrell–Reece–Pieman 200 kV transmission line, and the line protection systems

successfully cleared the faults within 80 ms from fault inception. This meets the total fault clearance times required by the NER<sup>7</sup> (maximum times of 120 ms near end and 220 ms remote end).
