Trip of the No. 1 220 kV Busbar at Jeeralang on 30 December 2019

May 2020

Reviewable Operating Incident Report under the
National Electricity Rules

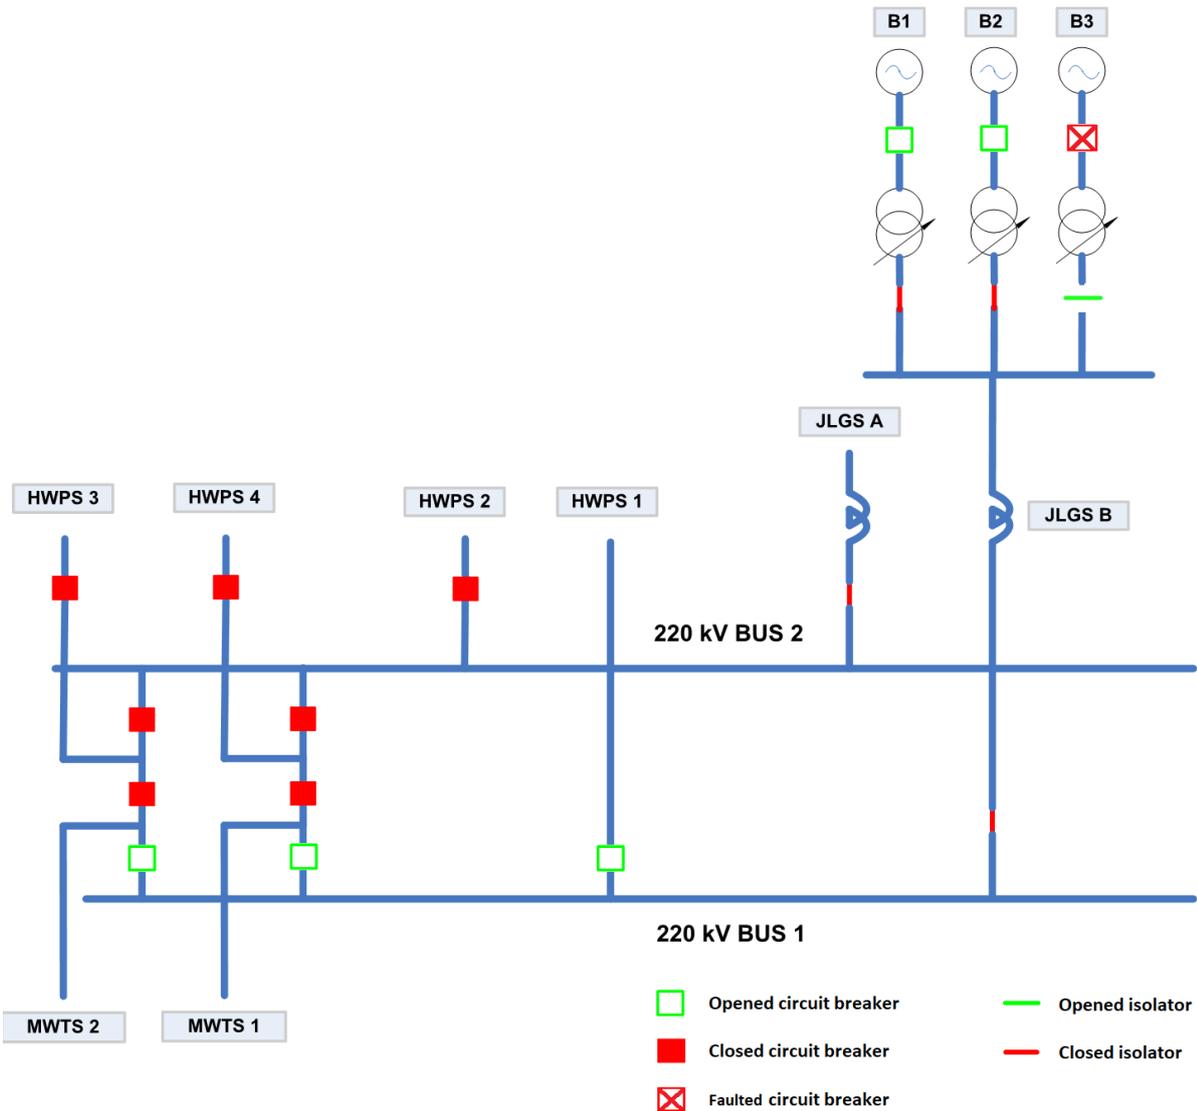
Figure 1 JLTS and JLGS status post-incident

Generation authorities at JLGS advised AusNet Services first responder that JLGS B3 generator's 10.5 kV CB failed to open. The B3 unit transformer, including its CB, was isolated at 2117 hours by AusNet Services for the generator authorities by opening the B3 unit transformer's 220 kV disconnect switch at JLTS. After confirming the JLGS B3 generator's 10.5 kV CB isolator was open, the B3 unit transformer's 220 kV disconnect switch was opened and the JLGS B3 generating unit was left isolated for EnergyAustralia Ecogen to identify the cause and repair. Refer Figure 1 for the status of the impacted equipment following the manual isolation of JLGS B3.

EnergyAustralia Ecogen investigated the CB failure over the course of the following day and determined it was caused by the securing screw for the CB secondary trip coil mounting plate working loose and allowing the trip lever pivot to move out of alignment and prevent the operation of the CB. The CB had been inspected in August 2019 and all screws were found to be secure and components in place.

With JLGS B3 unit isolated, AusNet restored the JLTS No. 1 220 kV Busbar to service at 2131 hours on 30 December 2019. The 220 kV CBs on the JLTS Busbar 1 (excluding B3 transformer CB) were progressively restored to service thereafter. The secondary trip coil on the B3 CB was replaced, the linkage pin holding the trip lever pivot re-inserted, and the secondary trip coil mounting plate re-secured by re-threading in the securing screw with Loctite used on the securing screw holding nut. The CB was tested multiple times by electrically operating its trip coils, and unit B3 was restored to service at 1500 hours on 31 December 2020. The B1 and B2 CBs were also inspected on 5 March 2020, with one of the two holding screws on the B2 CB secondary trip coil mounting plate found to be missing. The secondary coil and trip lever pivot were at the time still in alignment and functional and were re-secured with both holding screws using Loctite.
