Trip of the Wallerawang 330 kV Generation Busbar on 22 March 2019

October 2019

Reviewable Operating Incident Report under the
National Electricity Rules

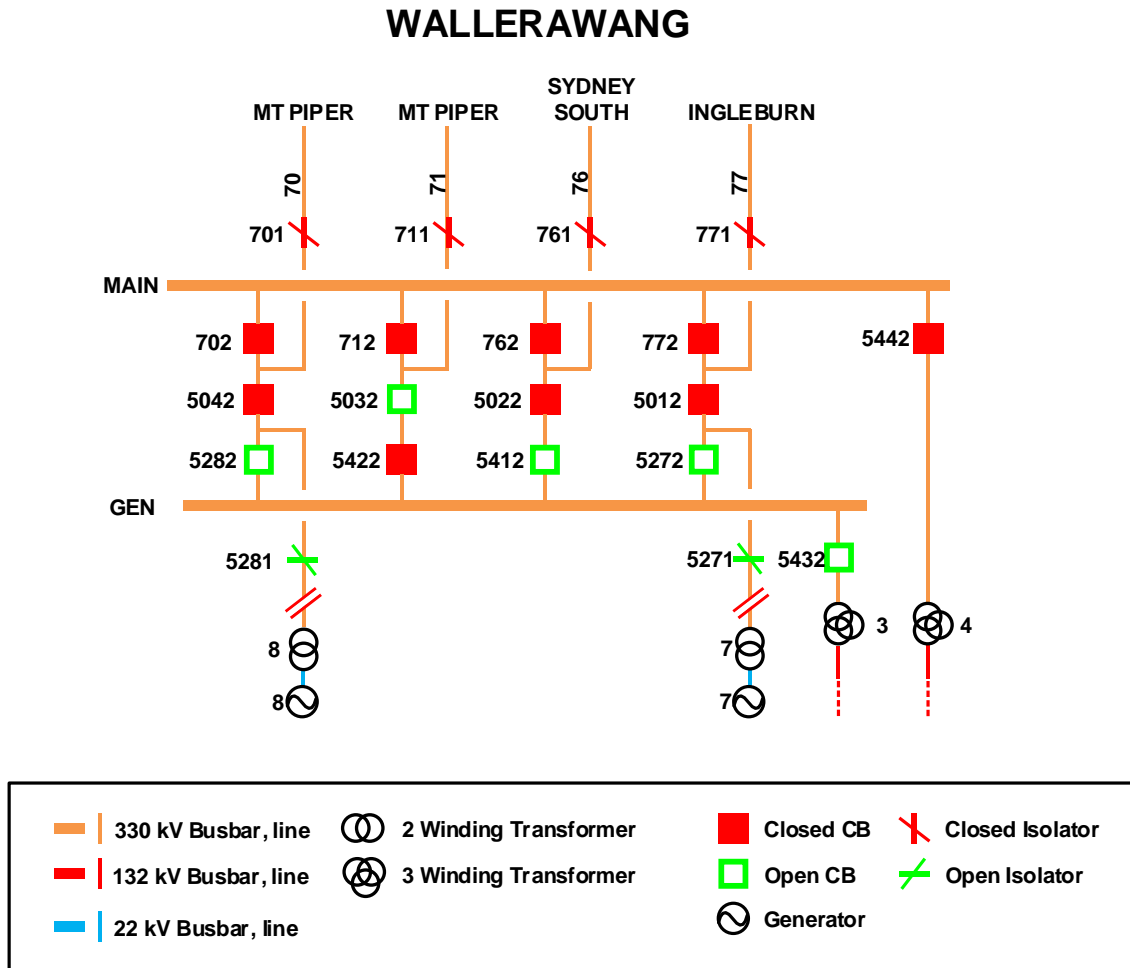
A1. System diagram

At 0628 hrs on 22 March 2019, the Wallerawang 330 kV Generation busbar tripped. Refer to Appendix A1 for a diagram of the Wallerawang substation immediately after the incident. Normally for a trip of this busbar, circuit breaker (CB) 5422 would be expected to open. However, after the recent de-commissioning of the No. 2 330/132 kV transformer, modifications were made to the busbar protection so that CB 5032 would trip instead of CB 5422.

The diagram below provides an overview of the Wallerawang substation immediately after the incident.
