Trip of 5A3 and 5A5 lines on 17 February 2020

August 2020

Reviewable Operating Incident Report under the
National Electricity Rules

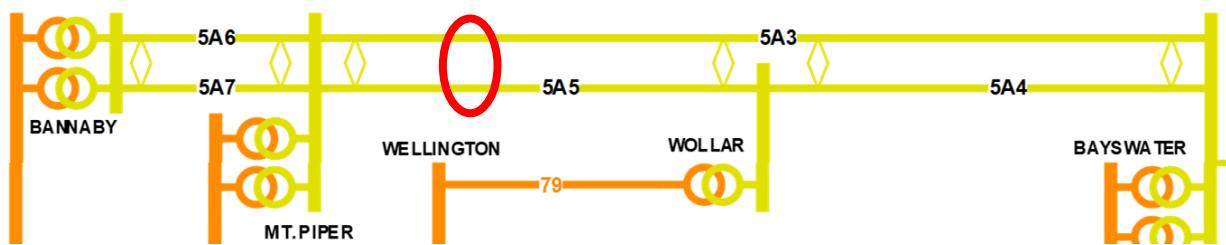
Figure 1 An overview of the 5A3 and 5A5 lines

Both faults on the 5A3 and the 5A5 lines were caused by a white phase to earth fault. Distance to fault locations indicated that the faults were at approximately 37 km from Mount Piper.

TransGrid advised that there was a single lightning strike near the fault location on the 5A3 and 5A5 lines at the time of the incident. The single lightning strike had an approximate magnitude of 45 kA, compared to typical magnitudes of 10 kA to 20 kA.

The diagram below provides an overview of the 5A3 and 5A5 lines and where the faults occurred due to the single lightning strike shown by a red oval.
