Trip of Davenport – Bungama 275 kV Line and Davenport East 275 kV Busbar on 23 October 2020

February 2021

Reviewable Operating Incident Report under the
National Electricity Rules

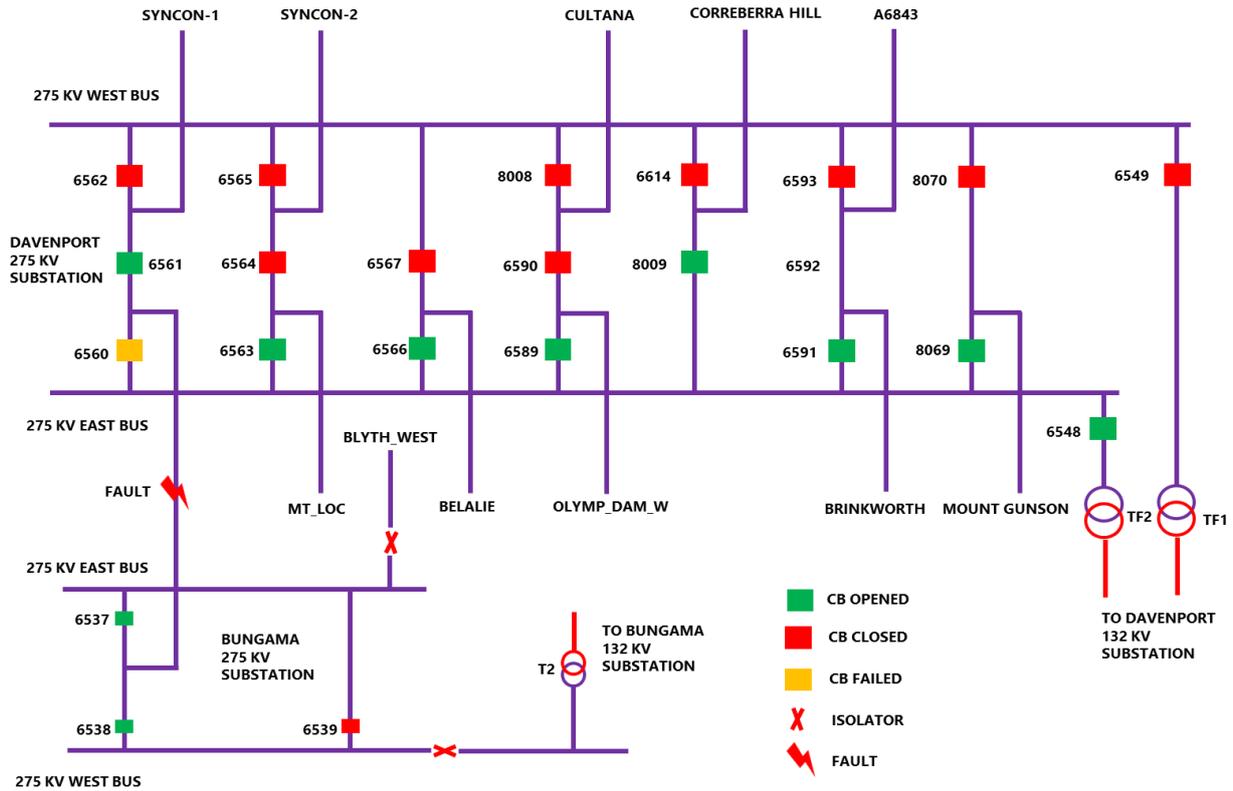
Figure 1 Simplified post-fault single line diagram 275 kV Davenport substation and Bungama substation

However, before the completion of the reclosure operation, CB Fail protection on Davenport CB 6560 operated, resulting in the three-phase tripping of CB 6561 and the 275 kV East Bus CBs at Davenport. This resulted in the tripping of Davenport 275 kV East Bus, which also offloaded the 275 kV connection to the No. 2 transformer. The CB Fail protection also sent a direct intertrip signal from Davenport to Bungama, which tripped the remaining in service phases of CB 6537. The operation of the CB Fail protection was not an expected outcome for the fault on the Davenport – Bungama line.

Analysis by ElectraNet determined the unexpected operation of the CB Fail protection of CB 6560 was due to incorrect wiring between the Davenport – Bungama line protection relays at Davenport and the trip coils for CB 6560. The 'U' and 'W' phase trips from the Bungama line protections were incorrectly connected to the 'W' and 'U' phase trip coils of CB 6560 respectively. Therefore, a 'U' phase fault on the Davenport – Bungama line would result in a 'W' phase trip of CB 6560.

During this event, 'U' phase on CB 6561 at Davenport opened correctly with fault current through the CB seen to cease after 40.6ms. However, on CB 6560 the 'W' phase opened instead of the 'U' phase which did not clear the fault on 'U' phase. As the fault was not cleared the CB Fail protection on CB 6560 was initiated resulting in the three-phase tripping of CB 6561, the CBs on the Davenport 275kV East Bus, and CB 6537 at Bungama.

The trip circuit for CB 6560 was corrected and tested for correct operation and CB 6560 was returned to service at 08:10 hrs on 24 October 2020.
