Trip of both Gordon – Chapel Street  
220 kV lines and unexpected operation  
of AUFLS on 31 October 2020, and  
unexpected operation of AUFLS  
on 8 December 2020

Reviewable Operating Incident Report under the  
National Electricity Rules

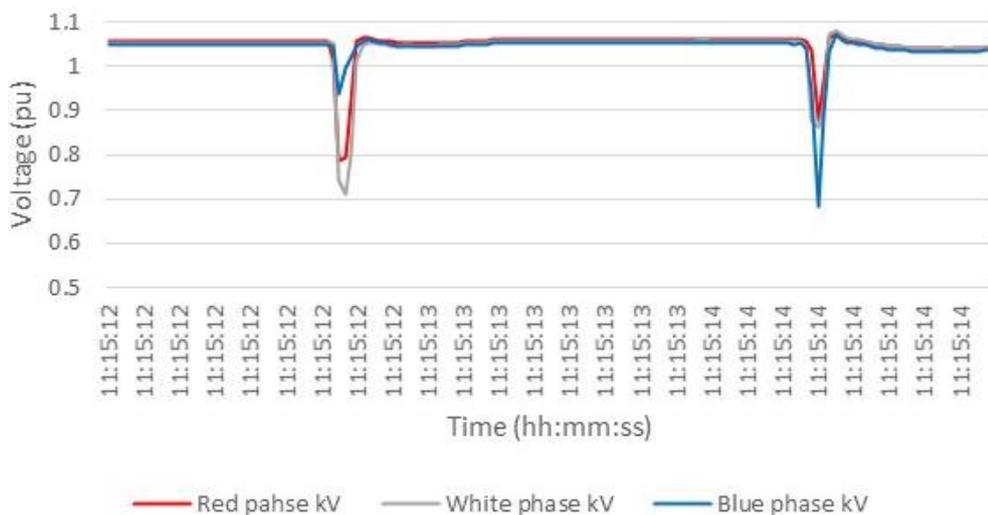
**Figure 1 Voltage at Palmerston 220 kV bus**

Despite the frequency trigger being met, the AUFLS should not have operated, as the voltage had not recovered to above 0.7 pu for a least 20 ms after the fault. Voltage measurements from Palmerston substation, as shown in Figure 1, show the voltage on 'W' phase falling to 0.71 pu. The AUFLS relay gets its voltage measurement from the Chapel Street substation which is much closer to the fault location so the voltage would likely have fallen below the 0.7 pu requirement.

Analysis by TasNetworks noted an error in the undervoltage masking logic, where a 5 ms delay was programmed instead of the required 20 ms delay. Therefore, the combination of a low frequency input and an insufficient delay to allow the voltage to recover sufficiently resulted in the AUFLS operating when it should not have.

1. Added hard limits of 48 Hz to 52 Hz added to the raw frequency measurement.
2. Added an 80 ms first order low pass filter to smooth the input frequency measurement.
3. Increased the undervoltage detection threshold from 0.7 pu. to 0.88 pu.
4. Increased the undervoltage detection time delay from 5 ms to 100 ms.

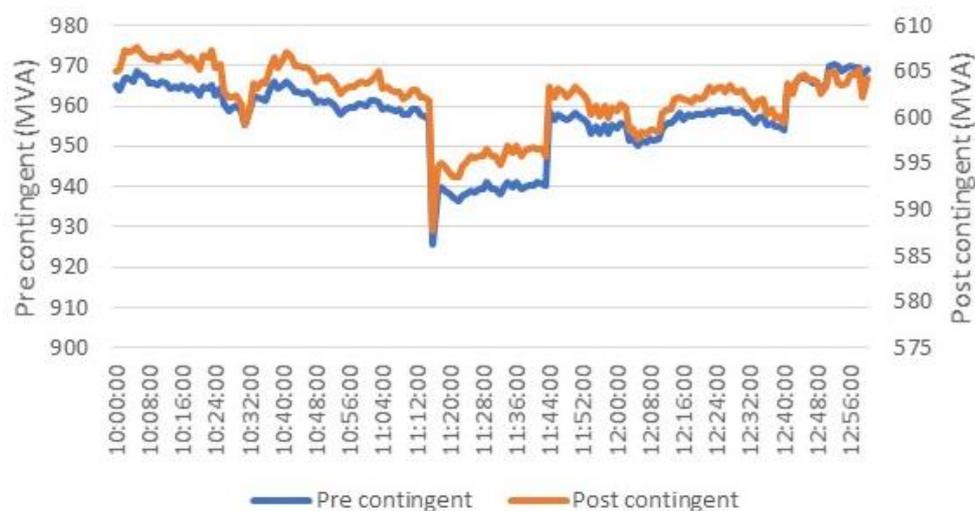
**Figure 2 Burnie 110 kV fault level**

The power system was in a secure operating state prior to the events of 31 October 2020. The loss of the Gordon Power Station generation resulted in the calculated post-contingent<sup>5</sup> fault level at Burnie substation falling to approximately 590 megavolt amperes (MVA), as shown in Figure 2. Based on information available at the time, a post-contingent fault level below 600 MVA indicated that the power system may not be in a secure operating state.

At 1139 hrs on 31 October 2020, AEMO enabled a generating unit at Poatina Power Station in accordance with contractual arrangements between TasNetworks and Hydro Tasmania to increase the post-contingent fault level at Burnie substation to above the 600 MVA limit to ensure the power system was in a secure operating state. Subsequent studies conducted by AEMO using updated system models have shown the power system would remain in a secure operating state for post contingent fault levels down to 560 MVA<sup>6</sup> at Burnie.

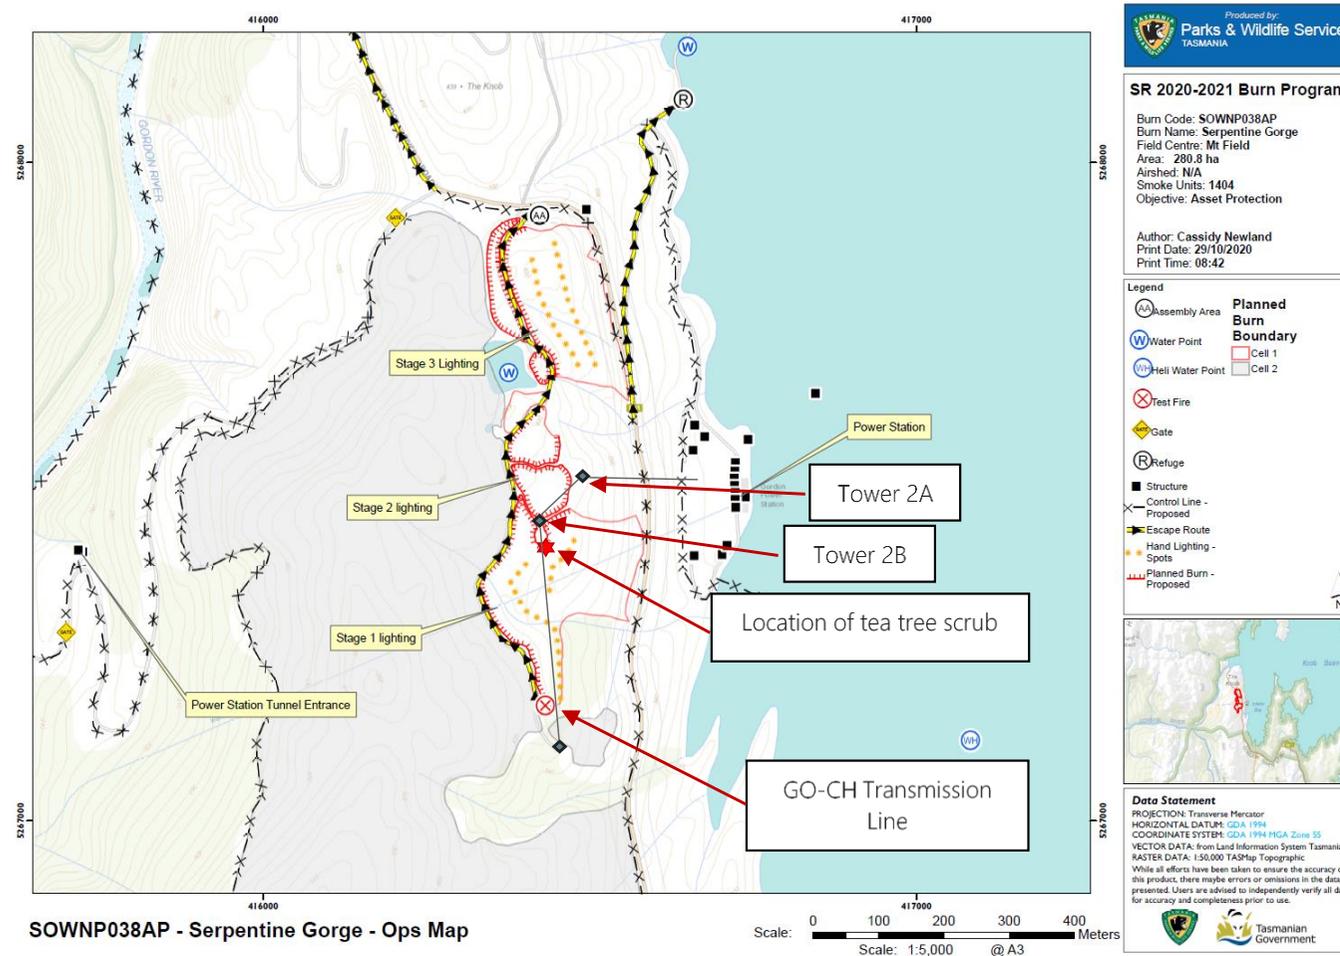
**Figure 3 Overview of part of the power system including planned burn boundary area**

At approximately 1045 hrs on 31 October 2020, the wind direction began to change from a predominant westerly to a south westerly resulting in the fire front moving northwards towards the GO-CS lines. At approximately 1110 hrs on 31 October 2020, the fire entered an area of highly flammable tea-tree scrub around 1.5 metres tall underneath the GO-CS lines resulting in increased flame height and very dense smoke. At this stage the TasNetworks staff on site attempted to contact the TasNetworks control room via both satellite telephone and trunked mobile radio (TMR) to advise the control room of the developing situation. The on-site staff were not able to contact the control room.

Although an assessment of vegetation around the planned burn was conducted, neither TasNetworks or the Parks and Wildlife Service Fire Operations identified the potential risk posed by the highly flammable tea-tree scrub located in a valley under the GO-CS lines.

To improve pre-burn assessments and manage any planned and unplanned fires, TasNetworks, Tasmania Parks and Wildlife Service, and the Tasmania Fire Services are developing an agreement to implement a framework for the coordination and management of planned fuel reduction burns and bushfire mitigation.
