Trip of Eildon – Mount Beauty  
No. 1 and No. 2 220 kV lines,  
10 January 2020

**November 2020**

Reviewable Operating Incident Report under the  
National Electricity Rules

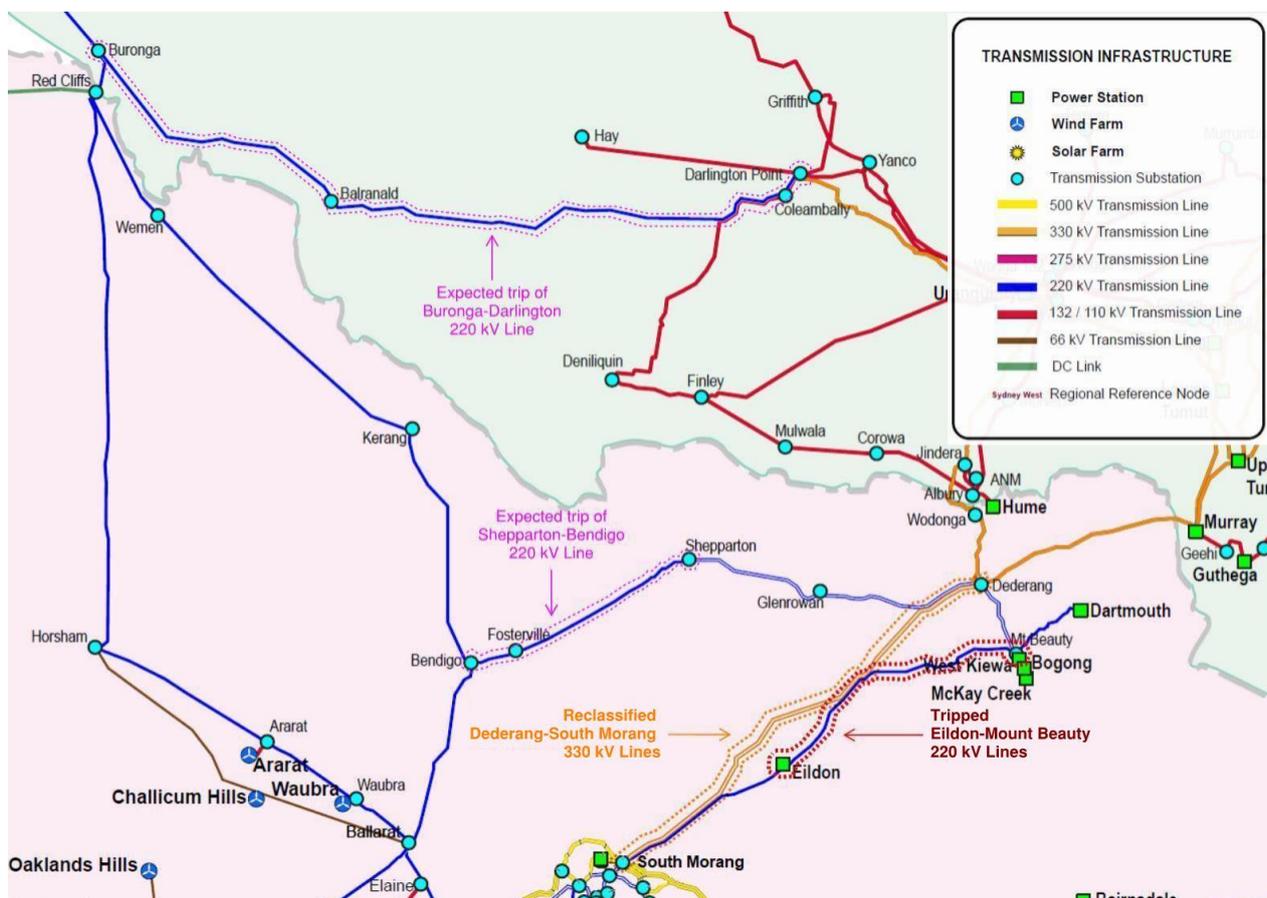
**Figure 1** Geographic map illustrating the reclassified lines, faulted lines and expected line trips following credible trip

On 8 January 2020, prior to this non-credible contingency, the loss of both DDTS-SMTS 330 kV lines had been classified as a credible contingency event due to bushfires in the area, as highlighted in orange in Figure 1. No reclassification was in place for the EPS-MBTS 220 kV lines. The power system was in a secure operating state prior to this incident.
