# Trip of the Kemps Creek A 330 kV Busbar on 27 January 2020

Reviewable Operating Incident Report under the  
National Electricity Rules

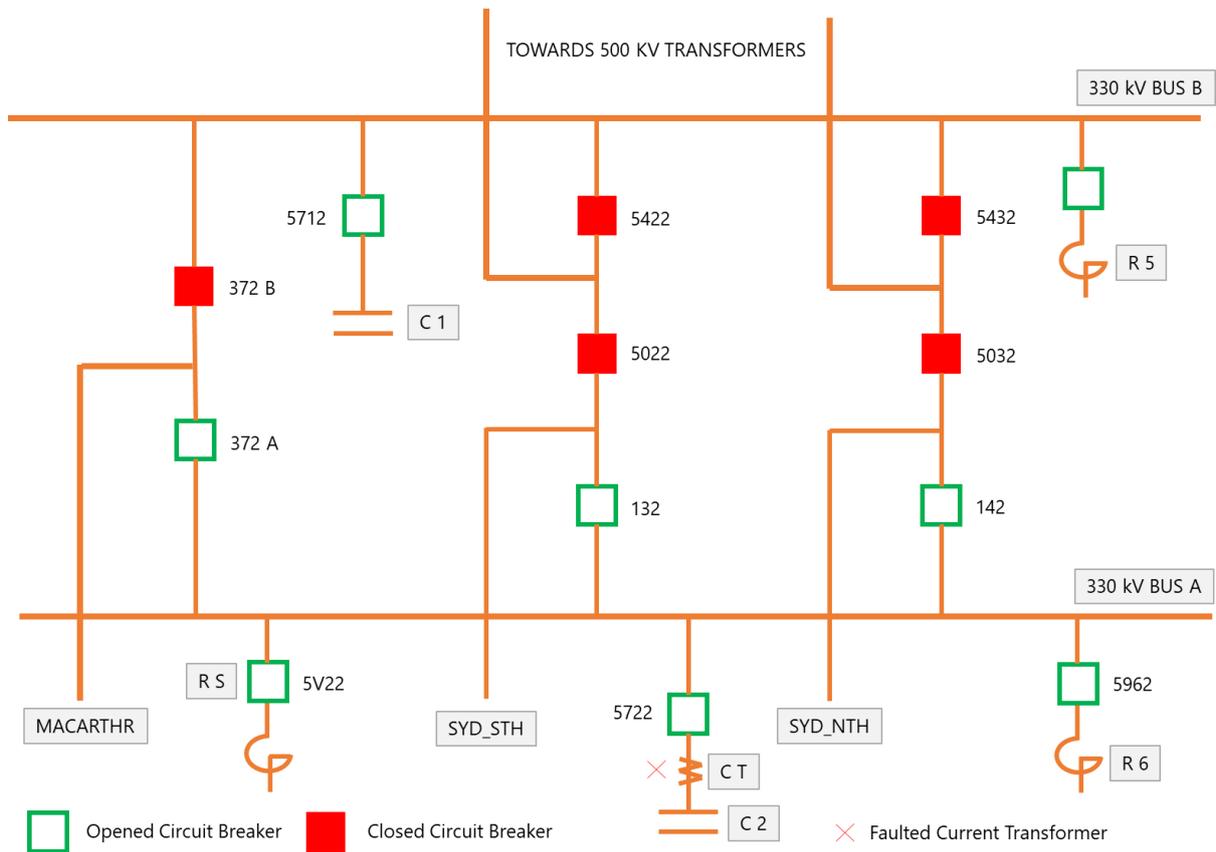
**Figure 1 Simplified single line diagram of 500/330 kV Kemps Creek Substation**

The diagram below provides an overview of part of the power system immediately after the incident.
