Trip of Newport D Power Station No. 2 220 kV busbar on 27 October 2020

February 2021

Reviewable Operating Incident Report under the
National Electricity Rules

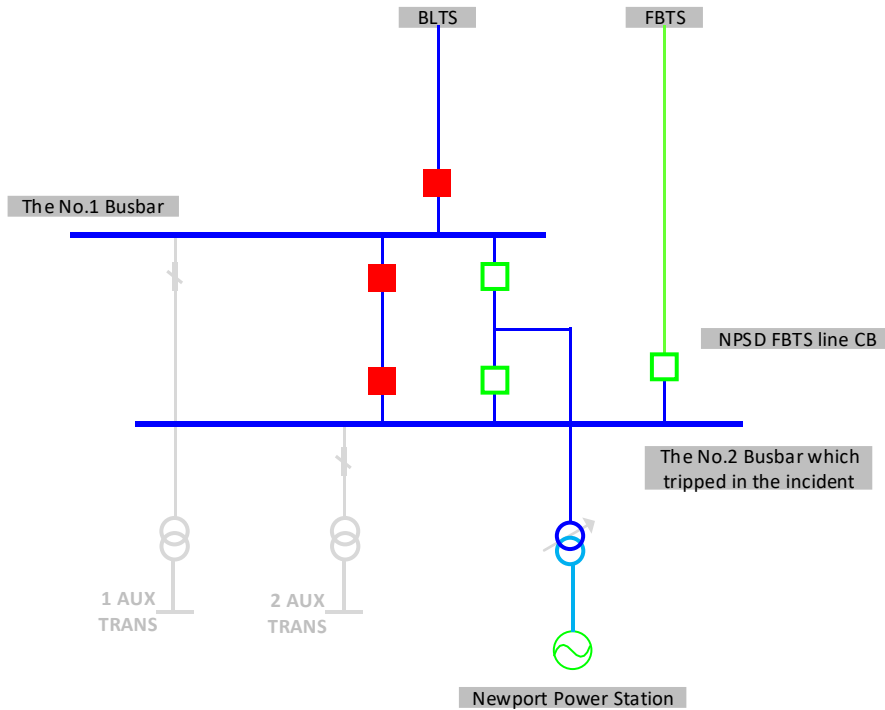
Figure 1 The configuration at Newport D Power Station immediately before the incident

Prior to the incident, the Newport D Power Station to Fishermans Bend Terminal Station 220 kV line (the NPSD-FBTS line) and the NPSD-FBTS line circuit breaker (CB) were out of service for a planned work to repair a gas leak.

The generating unit at Newport Power Station was out of service with both CBs at NPSD open.

Figure 1 shows the configuration at NPSD immediately prior to the incident.
