# Trip of the Wodonga Terminal Station No. 1 and No. 2 330 kV transformers on 23 November 2020

**April 2021**

Reviewable Operating Incident Report under the  
National Electricity Rules

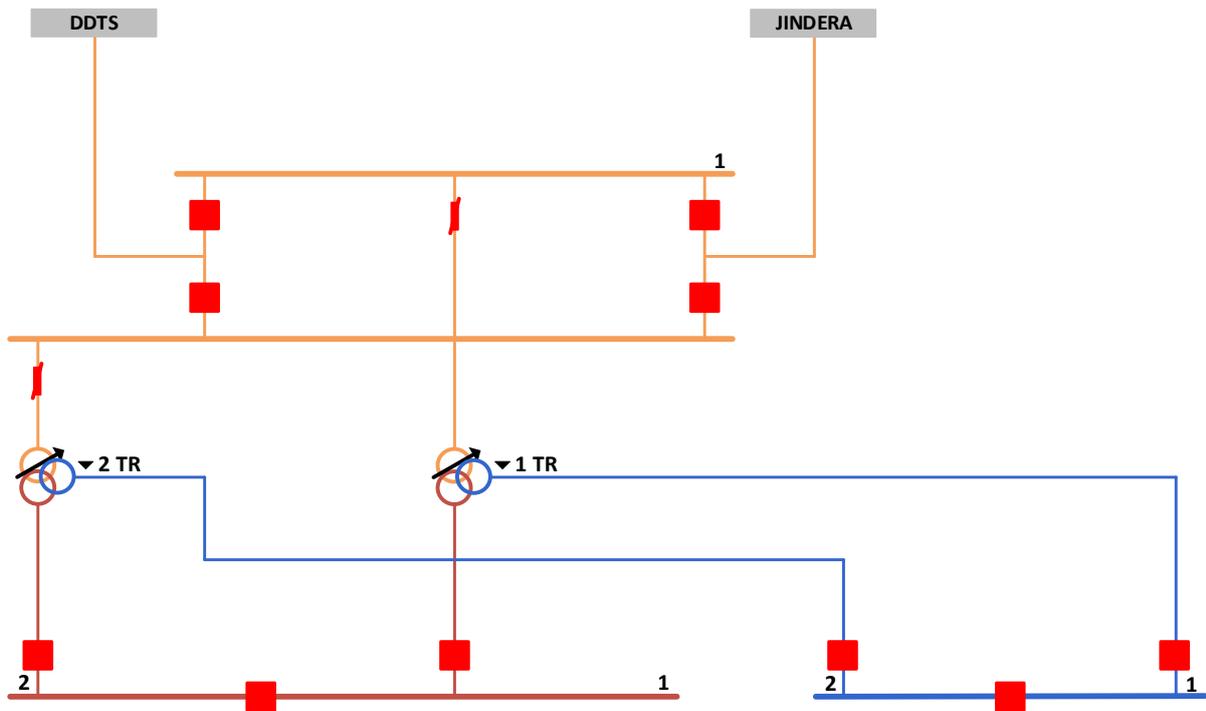
Figure 1 Substation topology at WOTS

The diagram below provides an overview of the Wodonga terminal station immediately prior to the incident.
