Trip of the Wodonga Terminal Station No. 1 and No. 2 330 kV transformers on 8 September 2020

February 2021

Reviewable Operating Incident Report under the
National Electricity Rules

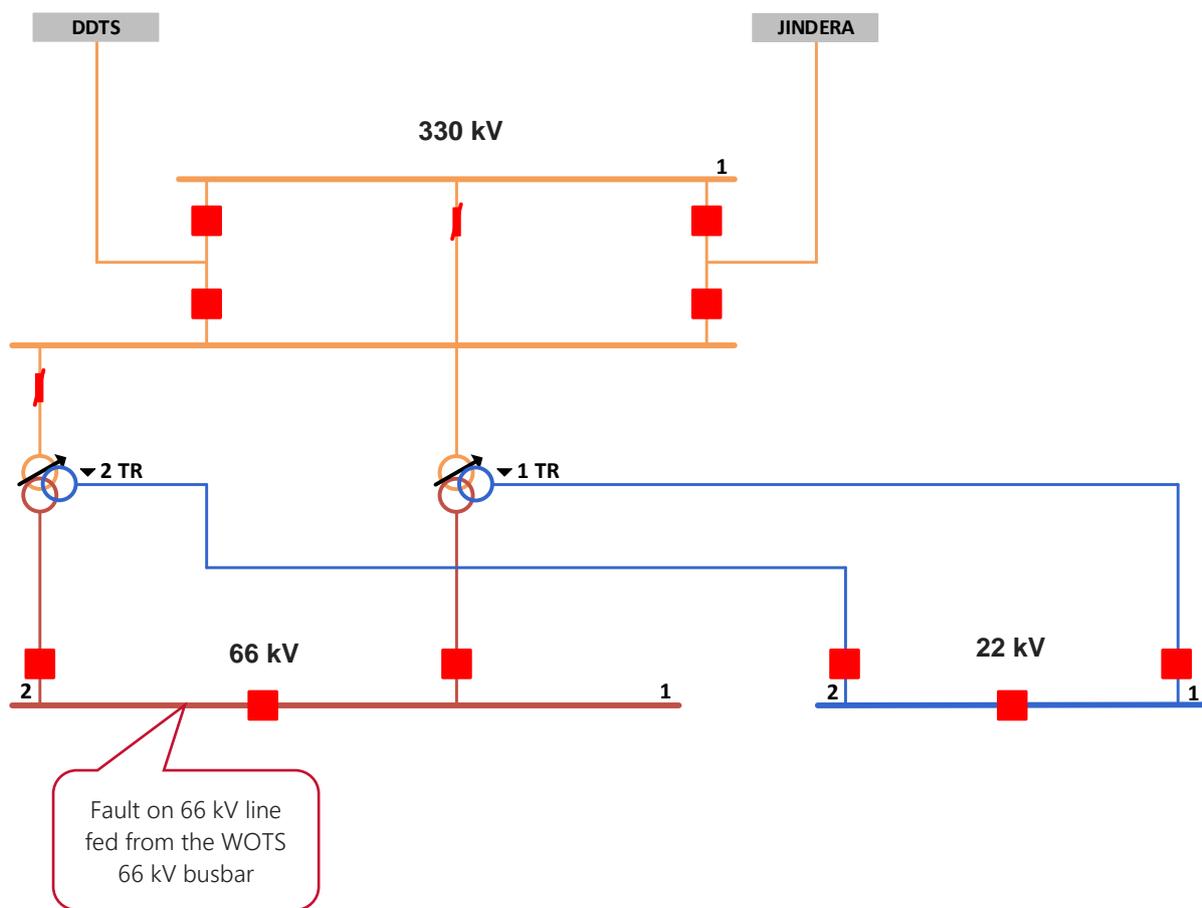
Figure 1 Substation topology at WOTS

WOTS (see Figure 1 for the WOTS layout), this transformer trip caused the disconnection of the WOTS No. 1 and No. 2 330kV busbars, and the DDTS-WOTS and WOTS-Jindera 330kV lines.

earth fault. The substation topology at WOTS meant the tripping of the transformers disconnected the No. 1 and No. 2 busbars and the DDTs-WOTS and WOTS-Jindera lines (see Figure 1).
