# Trip of New Osborne 66 kV Busbar on 11 November 2020

**May 2021**

Reviewable Operating Incident Report under the  
National Electricity Rules

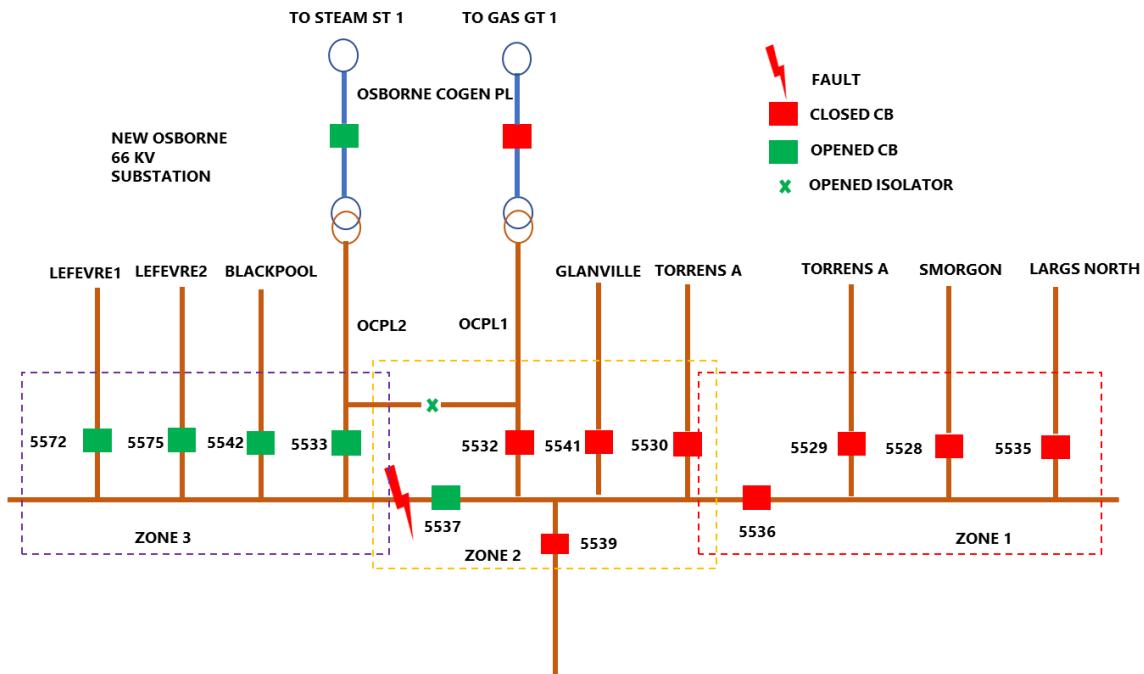
At 0819 hrs on 11 November 2020, a flashover occurred on the outside of the CT adjacent to CB 5537 resulting in an 'A' phase to earth fault at the New Osborne 66 kV bus. All protection operated correctly to clear the fault within 60 milliseconds (ms). Figure 1 shows the network configuration immediately after the fault.

**Figure 1 Simplified post-fault single line diagram of 66 kV Osborne substation**

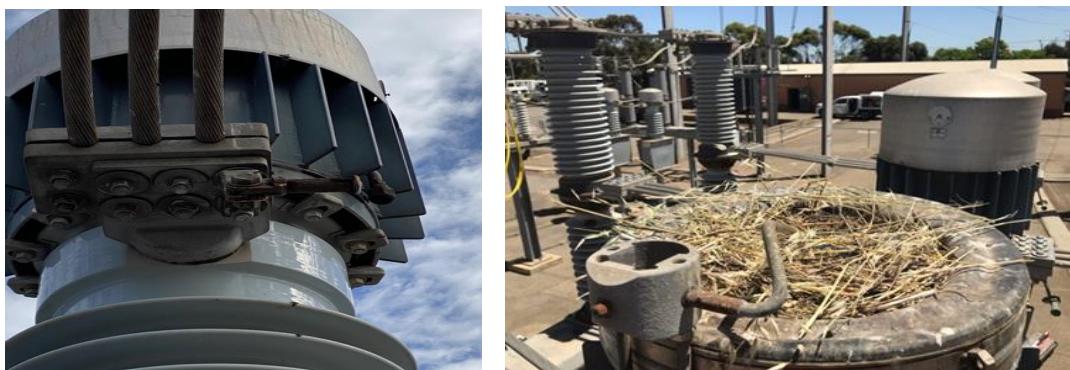
ElectraNet carried out a site inspection and identified flash burns on the CB 5537 CT. Subsequent detailed inspection of the CT revealed a bird's nest within the top section of this CT as the likely cause of the fault.

This type of CT has a large open cover over the rubber bellows at the top of the CT (see Figure 2.) which provides a convenient nesting site for birds. ElectraNet is investigating methods to prevent birds from entering this location on these CTs.

**Figure 2 CT 5337 (left) and the bird's nest (right) on the top of this CT**

1. New Osborne 66 kV Zone 3 busbar tripped due to a single phase to earth fault caused by a flashover on phase 'A' of CT associated with CB 5537.
2. The incident resulted in disconnection of Osborne Cogen Steam Turbine (ST-1).
3. The root cause of the flashover was the debris from a bird's nest which existed on the top of CT 5537.
4. The power system remained in a secure operating state through this incident.

AEMO notes challenges relating to condition monitoring, and the potential for external factors such as bushfire ash, weeds, debris, birds and vermin to result in equipment failures and supply interruptions. This has been demonstrated through numerous reviewable and non-reviewable events. In relation to the specific observations from this event, AEMO recommends that asset owners review their site inspection procedures to identify potential CT failures of this type. AEMO plans to discuss this topic with other NSPs through Power System Security Working Group (PSSWG) in mid-2021.
