# Trip of the Vales Point Generator 330 kV bus and No. 1 Transformer, 6 January 2020

**July 2020**

Reviewable Operating Incident Report under the  
National Electricity Rules

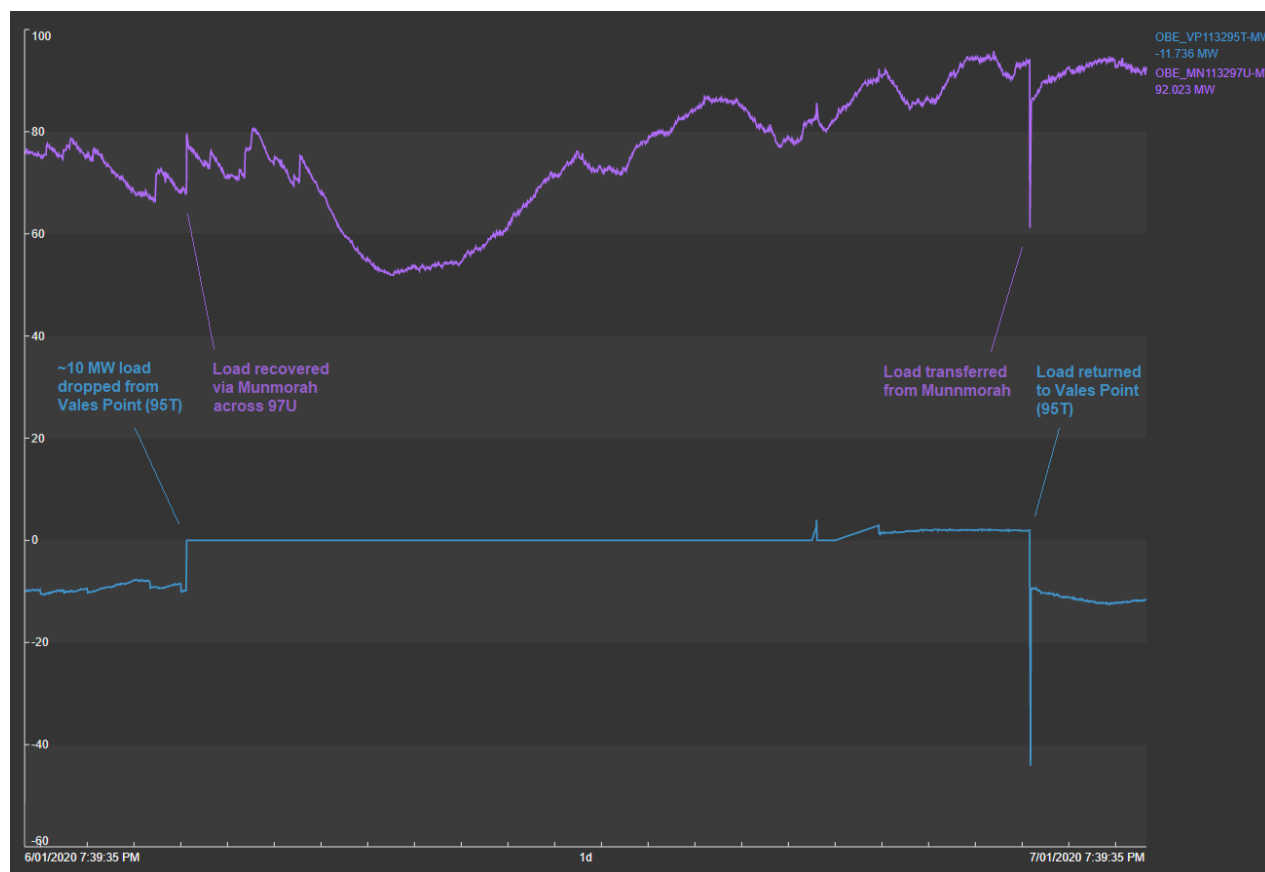
**Figure 5 Real power trend for Vales Point 95T and Munmorah 97U feeder throughout incident and recovery**

The chart below shows the trip of the Vales Point supply to Lake Munmorah (95T) and the corresponding load (MW) increase at Munmorah substation (over line 97U) due to auto-close of AusGrid circuit breaker at Lake Munmorah (97J). Transfer of load from Munmorah back to Vales Point is shown on the following day.

Note that the Vales Point trend is inverted as positive load flow is displayed towards Vales Point.
