Trip of Yallourn generating units 1, 3, 4 and four Macarthur Wind Farm collector groups on 11 April 2020

January 2021

An operating incident report for the National Electricity Market –
information as at 13/1/2021

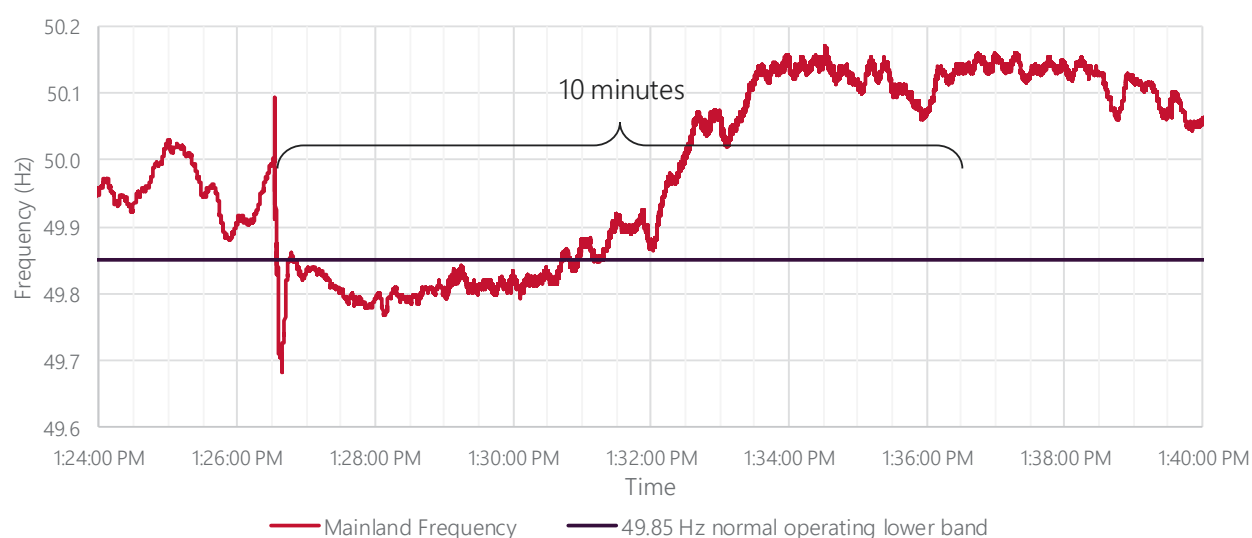
Figure 1 Mainland frequency during event

As shown in Figure 1, there was a frequency excursion upon the trip of Yallourn unit 3 and Macarthur Wind Farm collector groups. These excursions remained within acceptable limits. The Frequency Operating Standard (which states that for a multiple contingency event the frequency must be contained within 47 hertz (Hz) to 52 Hz, stabilise to within 49.5 to 50.5 Hz and recover to within 49.85 to 50.15 Hz within 10 minutes) was met for the event.

Due to the unloading of Yallourn unit 1 and unit 4 before they tripped, the frequency nadir was not as low as would be expected had all 1,091 MW of generation tripped at the same time.

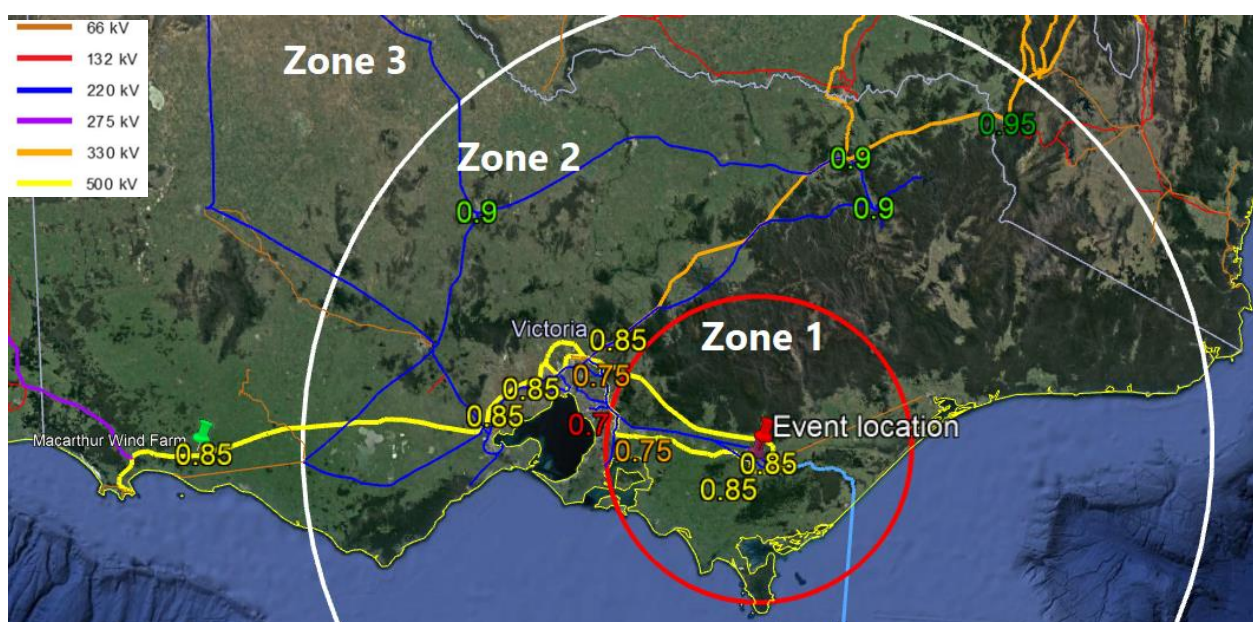
Figure 2 Minimum voltages recorded (pu minimum on a single phase) at the time of fault (13:26 hrs)

Figure 2 shows the minimum voltages measured across the Victorian transmission network at the time of the event, as context for interpreting distributed PV responses. The locations of YPS and Macarthur Wind Farm are indicated (Event location). The zones indicated in red and white concentric circles were used to analyse distributed PV responses by proximity to the fault that occurred at YPS.

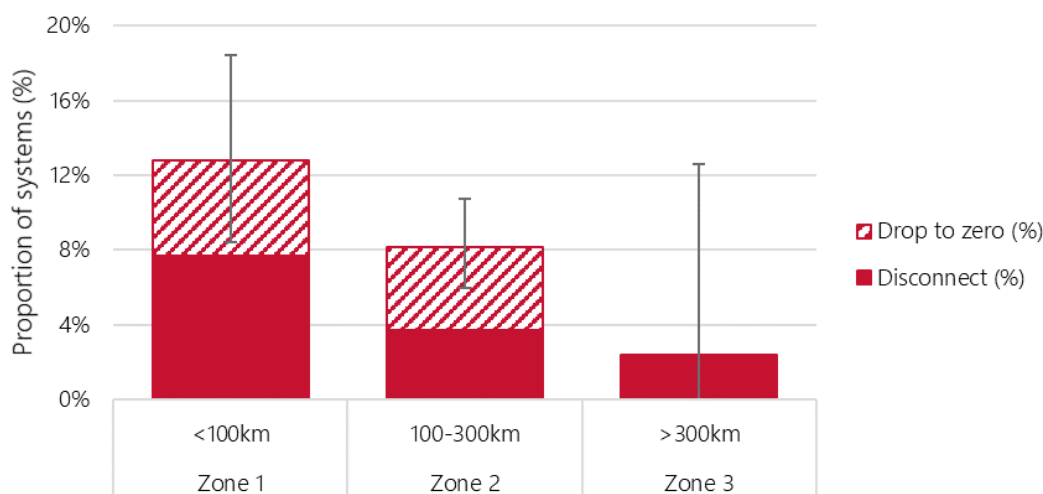
Figure 3 Distributed PV disconnections in Victoria by distance from Yallourn Power Station

Figure 3 shows the disconnection of distributed PV observed in each of the zones illustrated in Figure 2.

A higher disconnection rate is observed closer to the event location, consistent with the depth and geographic extent of voltage measurements recorded. Minimal distributed PV disconnections were observed in locations further than 300 km from the separation location (where there was minimal voltage disturbance), suggesting that the primary cause of distributed PV disconnections in this area was the voltage disturbance.

Uncertainty estimates are based on sample sizes and observed number of disconnections, calculated at a 95% confidence level.
