# Bayswater – Mt Piper 5A3 500 kV line Trip and Bayswater No. 4 Generator Trip on 10 August 2021

**December 2021**

Reviewable Operating Incident Report under the  
National Electricity Rules

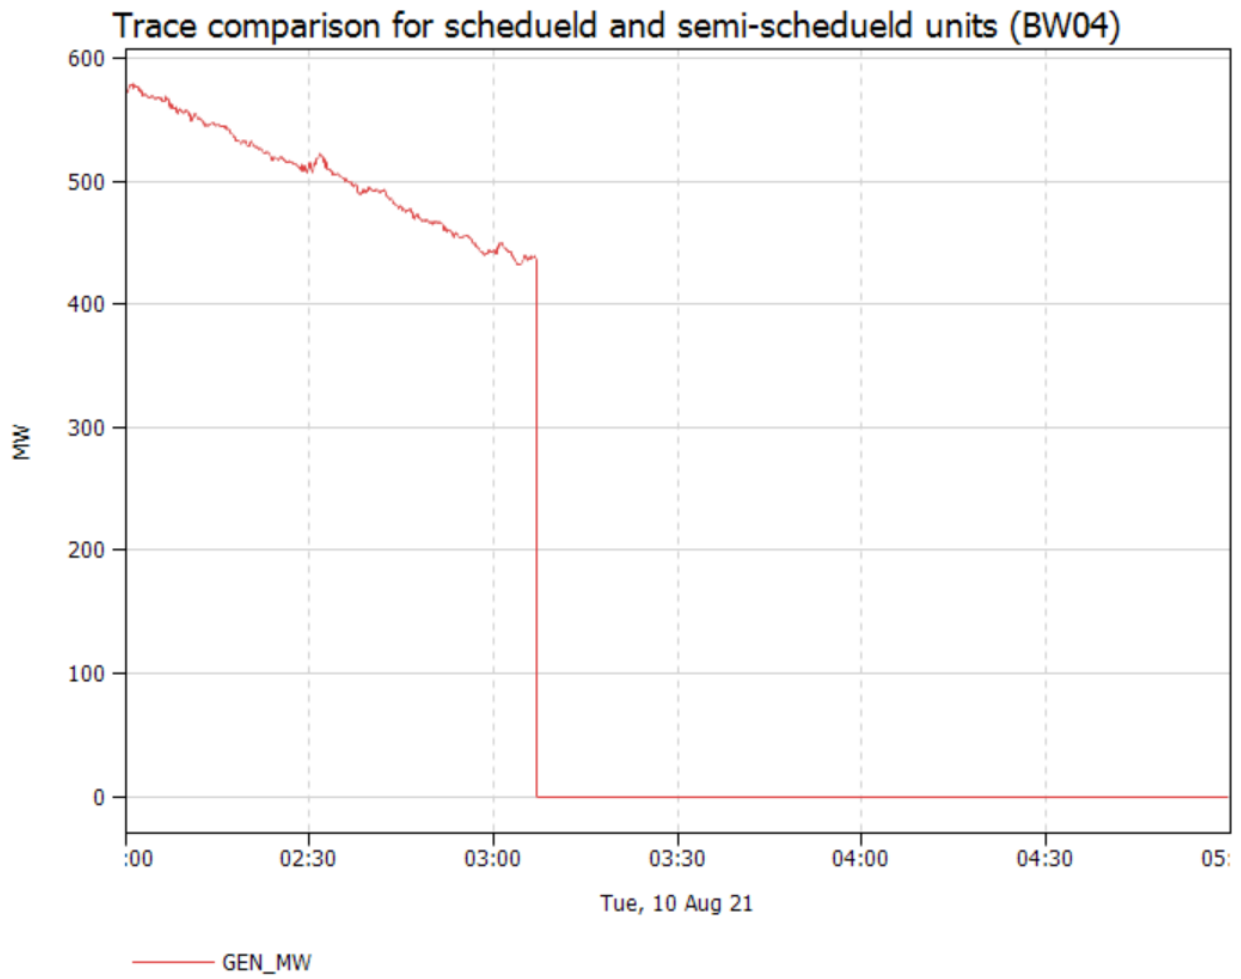
Figure 1 BW04 active power trace

Details
<b>Reviewable operating incident type</b>	Non-credible contingency event impacting critical transmission elements.
<b>Incident details</b>	This report relates to a reviewable operating incident <sup>4</sup> that occurred on 10 August 2021 in New South Wales. The incident was a non-credible contingency event involving the trip and auto reclose of the Bayswater – Mt Piper 5A3 500 kilovolt (kV) and simultaneous trip of Bayswater Unit No. 4 (BW04).
<b>Incident classification</b>	Other causes – human error.
<b>Generation impact</b>	440 megawatts (MW) of generation was lost at 0306 hrs.
<b>Customer load impact</b>	No load was lost as a result of this incident.
<b>Pre-incident conditions</b>	Prior to this event, the Bayswater – Mt Piper 500 kV circuit was in service. At Bayswater Power Station, a 23/11 kV auxiliary transformer associated with BW04 was out of service for maintenance. BW04 was in service and following dispatch targets (see Figure 1).

<b>Incident key events</b>	<ol style="list-style-type: none"> <li>On 10 August 2021 at 0306 hrs: <ul style="list-style-type: none"> <li>Bayswater – Mt Piper 5A3 500 kV line tripped and auto-reclosed 17 seconds later.</li> <li>BW04 generator tripped from 440 MW.</li> </ul> </li> <li>At 2030 hrs Transgrid confirmed 5A3 Line tripped due to a fault on the line.</li> </ol>
<b>Incident cause</b>	Post-event, Transgrid confirmed that a fault had occurred on 5A3 line, approximately 89 km from Bayswater on the red phase. Terrain in the area of the fault is generally steep undulating terrain where no damage was found and no vegetation encroachment hazard was identified. The fault caused the trip and auto-reclose of the line. Simultaneously BW04 tripped unexpectedly due to operation of the unit's restricted earth fault protection.
<b>Power system response (facilities and services)</b>	<p>A fault on the red phase of line 5A3 caused protection no. 1 and protection no. 2 on line 5A3 to operate, tripping the line. Line 5A3 successfully auto-reclosed 17 seconds later. Transgrid has completed an aerial inspection of this circuit but has been unable to identify the cause of the fault. In addition, Transgrid's inspection did not identify any damage on the circuit.</p> <p>Simultaneously BW04 unexpectedly tripped due to operation of its Restricted Earth Fault (REF) protection. Prior to this incident at BW04, one of its 23/11 kV auxiliary transformers was in the process of being reinstalled. During these works, a Current Transformer (CT) from the de-energised transformer was incorrectly connected to an active protection system.</p>

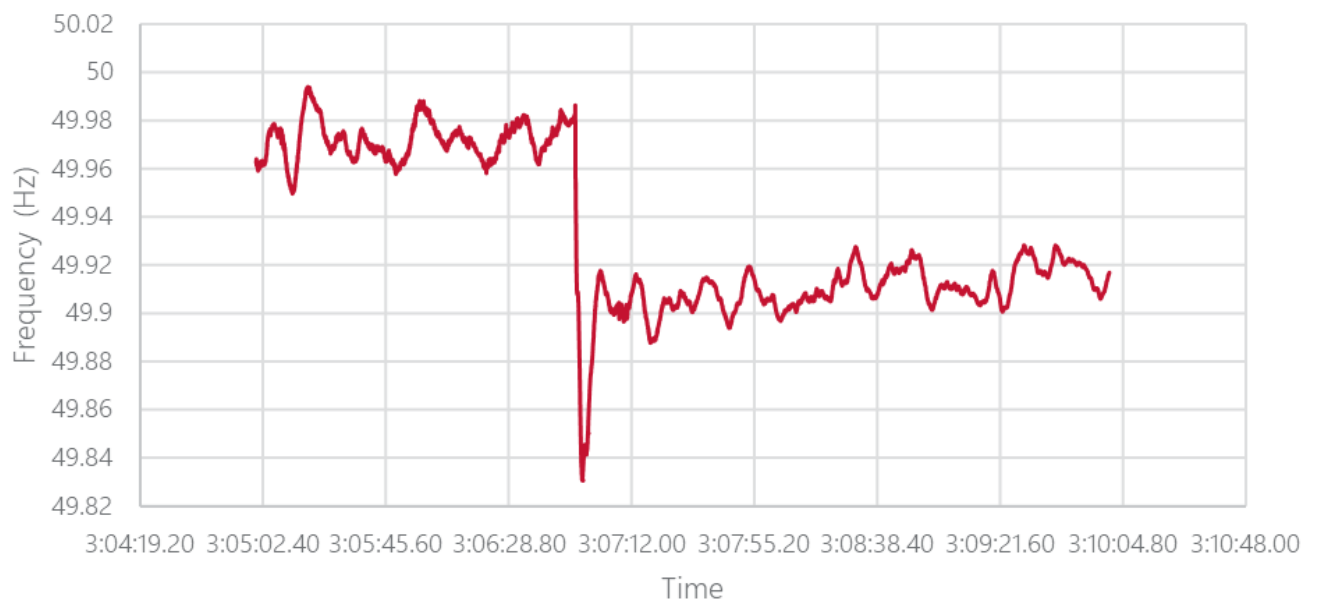
Figure 2 Mainland frequency performance

Details
	The incorrect connection resulted in a short between the B phase CT and the neutral phase CT at Bayswater. The 5A3 line fault caused a circulating current in the shorted CTs at BW04, causing the unit's REF protection to operate. This protection should not have operated for the external 5A3 line fault.
<b>Rectification</b>	Transgrid was unable to identify the cause of the 5A3 line fault, however this circuit's protection operated as per design to clear the fault.  Bayswater Power Station personnel identified and resolved the cause of the BW04 trip on 10 August 2021. The bridge between the two shorted CTs was removed prior to BW04's return to service. AGL also confirmed that the generator will not trip for similar events in the future.
<b>Power system security</b>	The power system remained in a secure operating state throughout this incident and the Frequency Operating Standard (FOS <sup>5</sup> ) was met for this incident. The minimum system frequency during this incident was approximately 49.83 hertz (Hz) at 3:06:55 and returned to above 49.85 Hz by 3:06:57 (see Figure 2).
