Trip of Alcoa Portland No. 1 220 kV Busbar on 30 November 2021

May 2022

Reviewable Operating Incident
Report under the National
Electricity Rules

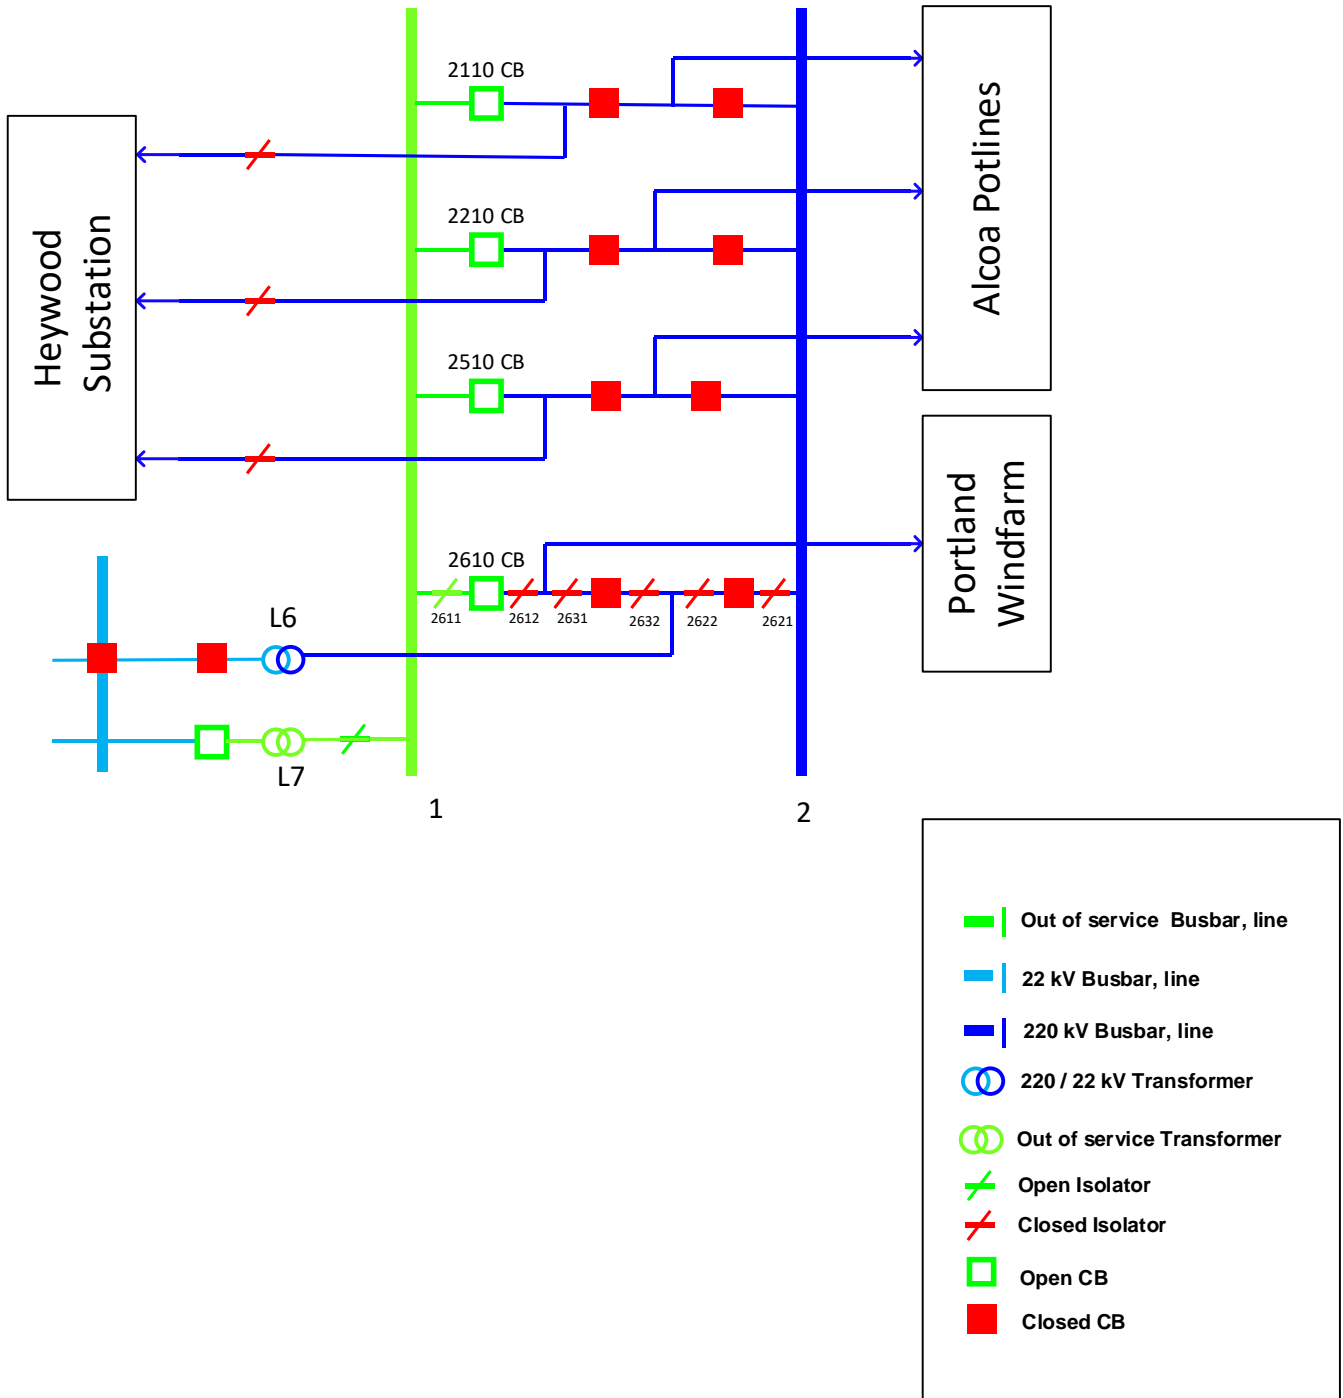
Figure 1 Post-incident diagram (all elements were in service prior to the incident)

Details	
Reviewable operating incident type	Non-credible contingency event impacting critical transmission elements.
Incident details	This report relates to a reviewable operating incident ³ that occurred on 30 November 2021 in Victoria. The incident involved the trip of the Alcoa Portland (APD) No. 1 220 kV busbar.
Incident classification	Procedural error/lack of procedures.
Generation impact	Nil
Customer load impact	Nil
Pre-incident conditions	Contractor staff were present at APD 220 kV substation setting up a water transfer pump on site. A contractor was carrying out general insulator washing of Blue, White, and Red phases of isolator 2611 adjacent to the APD No. 1 220 kV busbar immediately prior to the event.
Incident key events	<ol style="list-style-type: none"> At 1133 hrs on 30 November 2021, No. 1 220 kV busbar tripped. This also removed Transformer L7 from service (see Figure 1). From 1154 hrs to 1156 hrs at APD 220 kV substation, isolators 2612 and 2611 were opened to prepare for the return to service of the No. 1 220 kV busbar. At 1206 hrs, the No. 1 220 kV busbar and Transformer L7 were restored following CB2210, CB2110 and CB2510 closure.

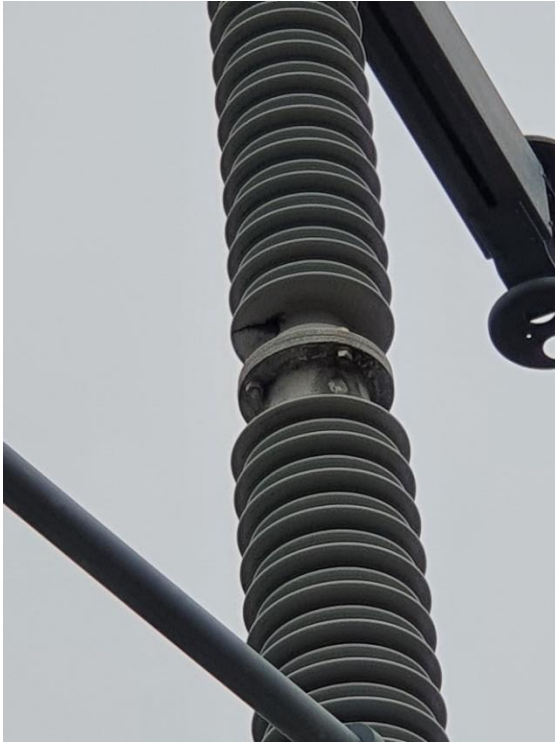
Figure 2 Visual Inspection of Isolator 2611 insulators

Incident cause	Post-incident investigation confirmed that a flashover occurred on the red phase of isolator 2611, causing No. 1 220 kV busbar to trip. The flashover was caused by existing salt contamination on isolator 2611’s insulators and overspray/misting that landed on the insulators during the washing of adjacent equipment.
Power system response (facilities and services)	<p>On 30 November 2021, Alcoa Portland contractors were carrying out planned insulator washing at the APD 220 kV substation. The contractors had just finished washing isolator 2611 Blue and White phases and were moving their equipment to access the isolator 2611 Red phase. At 1133 hrs, a flashover occurred on isolator 2611’s Red phase. As a result, busbar protection at APD 220 kV operated to clear the fault, resulting in disconnection of APD No. 1 220 kV busbar and Transformer L7.</p> <p>To prepare for return of the No. 1 220 kV busbar to service, at 1154 hrs, Portland Aluminium staff opened isolator 2612. At 1156 hrs, isolator 2611 was opened and busbar protection trip relays were reset. Following these actions, at 1206 hrs, No. 1 220 kV busbar and Transformer L7 were returned to service.</p> <p>Post-incident investigation by Portland Aluminium has confirmed that:</p> <ul style="list-style-type: none"> Prior to the incident there was no indication that a flashover on isolator 2611 was likely. The flashover occurred in the middle of the insulator stack on isolator 2611’s Red phase. This was confirmed through visual inspection (see Figure 2). A number of factors contributed to this incident including: <ul style="list-style-type: none"> Salt contamination of isolator 2611 insulators. A rapid change in prevailing wind direction, from North around to South-East, around the time of the incident.

Red Phase – East side insulators (South aspect)

Details	
	<ul style="list-style-type: none"> – Positioning of the insulator washing truck which allowed overspray/misting across isolator 2611 before this isolator had been fully washed.
Rectification	<p>Immediately after the incident and prior to the return to service of the No. 1 220 kV busbar and Transformer L7, Portland Aluminium identified the cause of the incident and isolated the affected equipment.</p> <p>Portland Aluminium’s post-incident review identified the following actions to reduce the risk of future occurrence:</p> <ul style="list-style-type: none"> • Completion of Insulation testing of isolator 2611 insulators. • Insulator washing procedures have been updated to ensure that atmospheric conditions are monitored and taken into account throughout the activity. • Insulator washing procedures have been reviewed to reset good practice standards and outline instructions for when atmospheric conditions change. • In addition, Portland Aluminium has confirmed it will advise AEMO of similar risks in future, in accordance with NER Clause 4.2.3A.

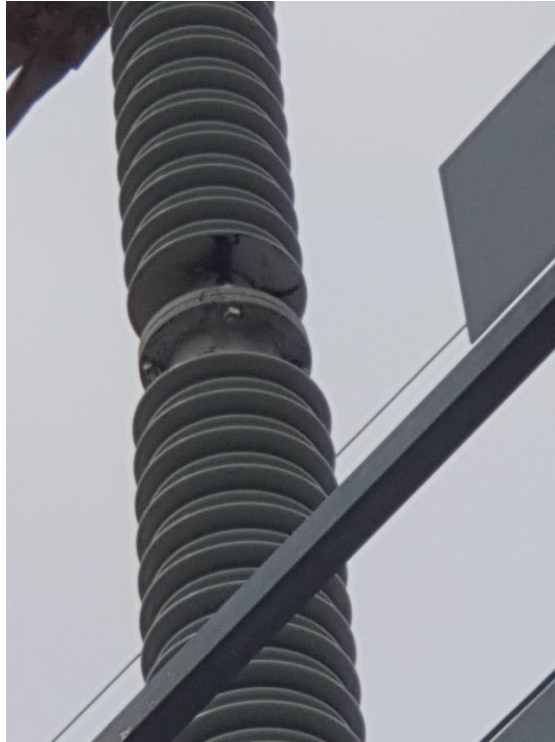
Red Phase – East side insulators (West aspect)
