# Trip of multiple Cherry Gardens 275 kV and 132 kV lines on 16 July 2021

**November 2021**

Reviewable Operating Incident Report under the  
National Electricity Rules

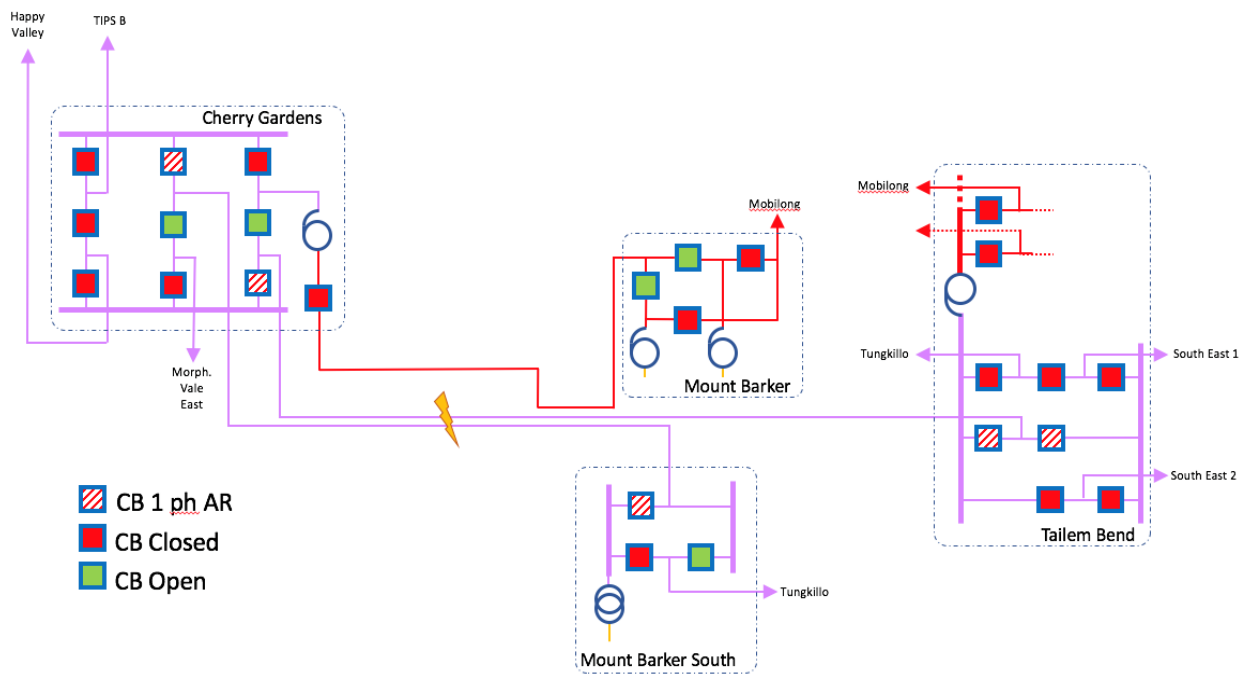
Figure 1 State of the system following fault clearance

Figure 1 in Appendix Error! Reference source not found. shows which circuit breakers (CBs) tripped during the incident.

High voltage phase to ground faults occurred on the 'W' phase conductors of the CHG – TBE and the CHG – MTBS 275 kV lines simultaneously as a result of a lightning strike. The protection systems on the lines operated as expected to clear the fault by tripping only the 'W' phase of CB6714 at Cherry Gardens, CB6682 at Mount Barker South. As per design, CB6715 at Cherry Gardens and CB6680 at Mount Barker South tripped all three phases and did not reclose. CB6714 and CB6682 successfully auto-reclosed on 'W' phase approximately 1 s after fault clearance, re-energising all three phases of both circuits. At 2155 hrs, CB6715 and CB6680 were closed remotely by operators. Two phases of both CHG – TBE and the CHG – MTBS 275 kV lines remained in service throughout the event.

The tripping of MTB – CHG 132 kV line CBs (CB6083 and CB6084) at Mount Barker was initiated by the DEF protection at Mount Barker. The line protection at Cherry Gardens did not operate, and the line remained energised from this end. At 2205 hrs, CB6083 and CB6084 at Mount Barker were closed remotely by operators.
