Trip of South East Substation No. 1 and No. 2 Static Var Compensators

March 2022

Reviewable Operating Incident Report under the National Electricity Rules

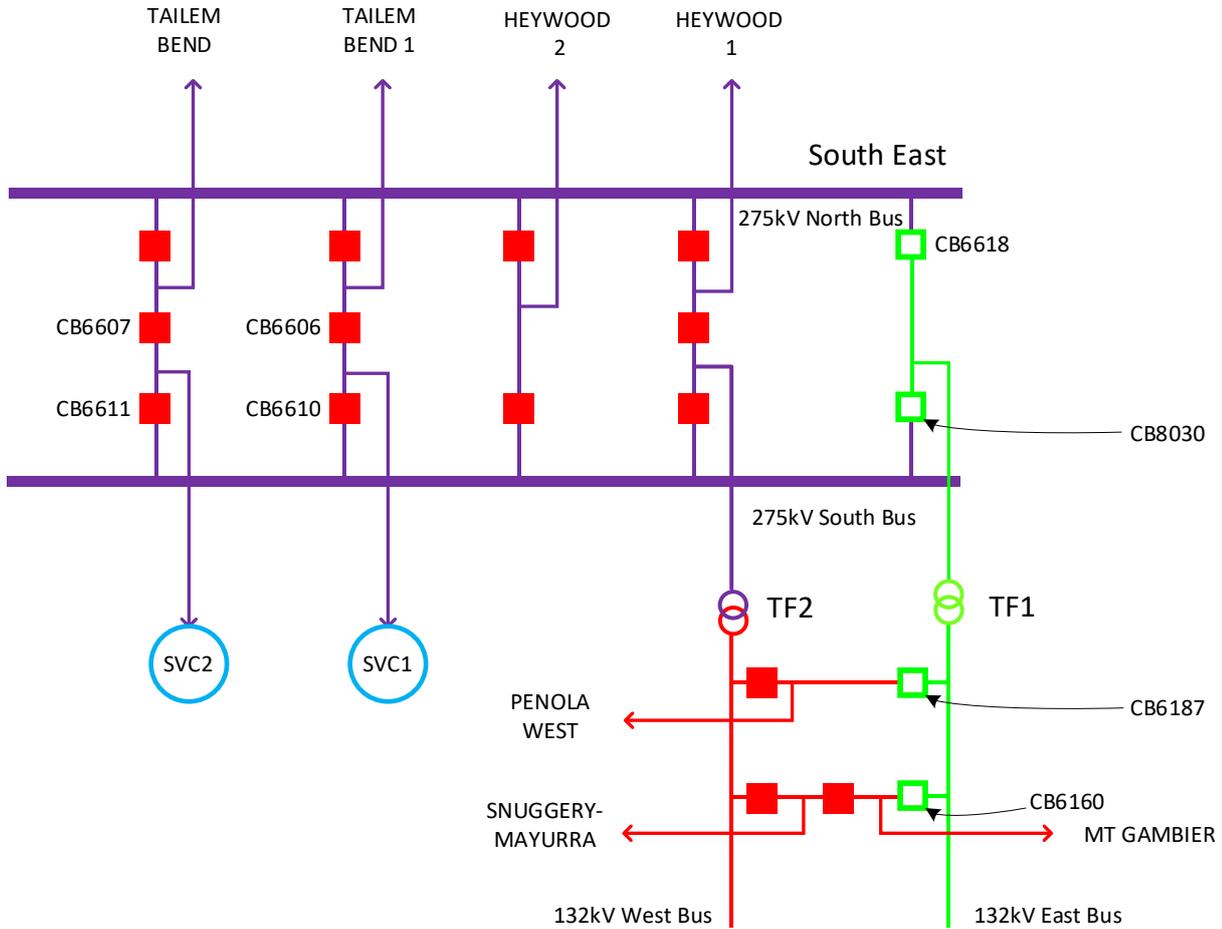
Figure 1 Incident diagram – Network representation immediately prior to the incident

Incident key events	<ol style="list-style-type: none"> At 1133 hrs on 22 September 2021 the ElectraNet control room opened CB6618 remotely, disconnecting South East TF1 from the power system. Approximately 5 seconds later, at 1134 hrs, the South East No.1 and No.2 SVCs tripped. South East No.1 and No.2 SVCs were returned to service at 1218 hrs and 1230 hrs respectively.
Incident cause	<p>ElectraNet was carrying out switching to isolate the South East 132 kV East busbar, to allow insulator cleaning of the South East 132 kV East busbar Voltage Transformer (VT). As part of this isolation process, ElectraNet de-energised the South East TF1 by opening CB6618. As 415 V supplies to both SVCs were being provided by TF1 at the time, the auto changeover system was expected to have automatically switched the 415 V supplies to South East Transformer 2's (TF2's) auxiliary supply. However, after approximately 5 seconds, the 415 V supplies had not switched supplies to the South East TF2. Subsequently, the No.1 and No. 2 SVCs' cooling system trip protection operated. This cooling system trip protection operated in line with its settings and tripped the 275 kV CBs associated with the South East No.1 and No.2 SVCs.</p> <p>Post incident investigation by ElectraNet has confirmed that prior to this incident, several auto changeovers relays had experienced failure which caused both South East SVCs to be supplied from TF1. These relay failures also meant that the 415 V auto changeover system was unable to switch supplies to TF2 when required to do so. ElectraNet was unaware of these relay failures prior to this incident.</p>

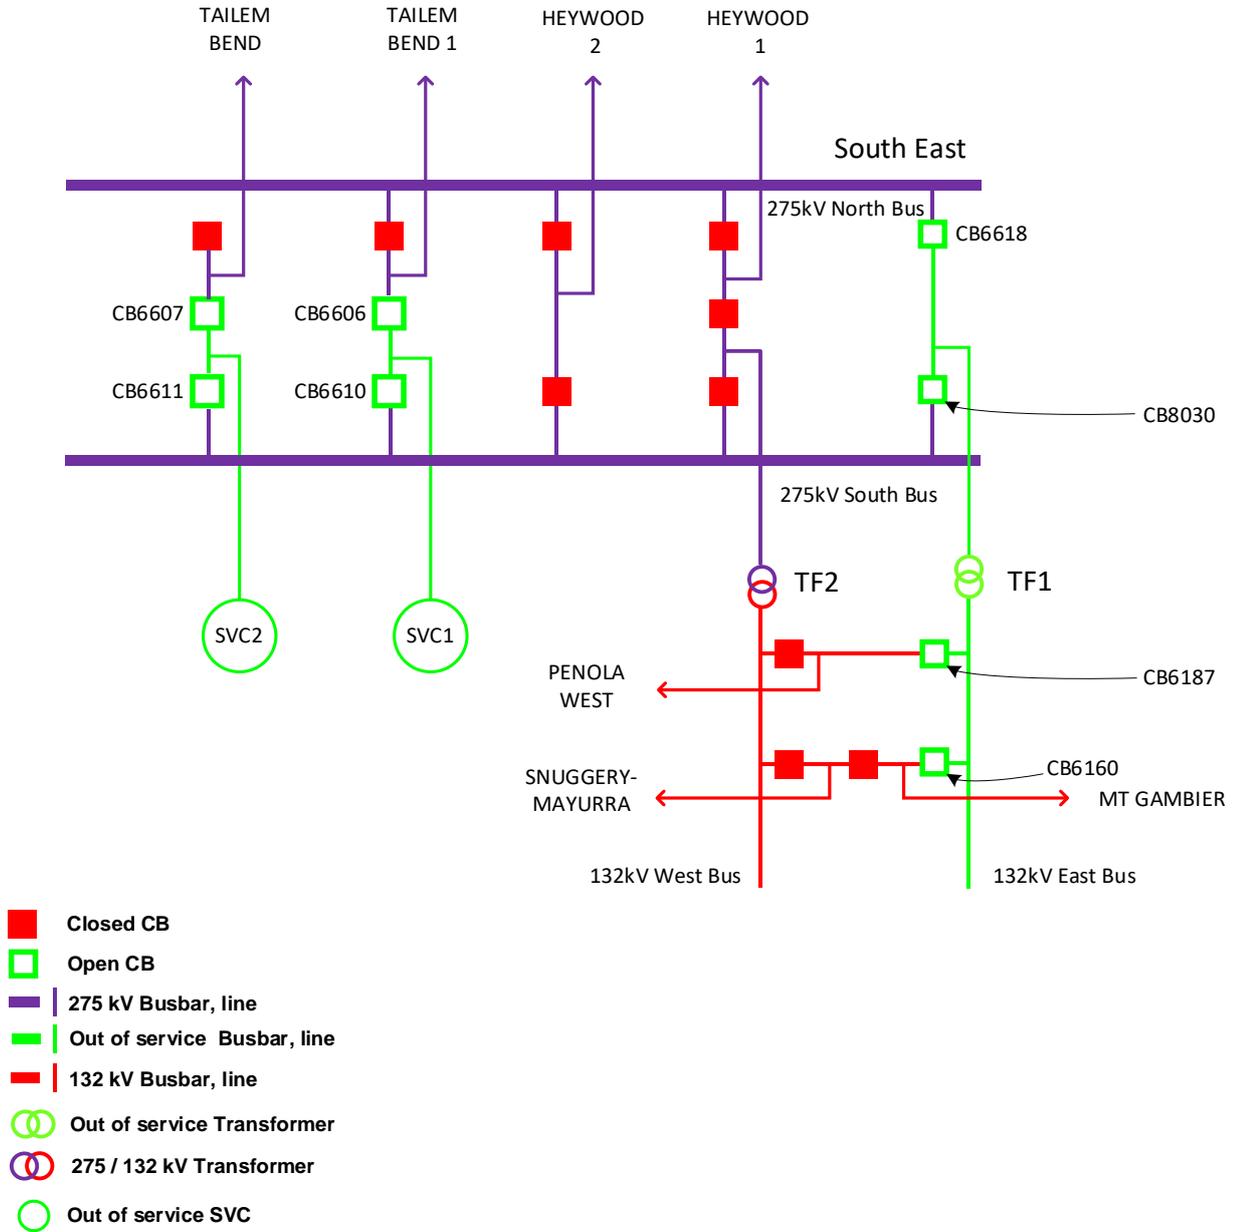
Figure 2 Incident diagram - Network representation immediately following the incident

Conclusions	<p>AEMO has concluded that:</p> <ol style="list-style-type: none"> 1. The No. 1 and No. 2 275 kV South East SVCs were simultaneously tripped due to defects in the South East automatic changeover system which resulted in an unexpected loss of 415 V AC supply. 2. The rectification of the incident involved the separation of the AC supply for the SVCs through re-configuration of the changeover boards and the affected AC changeover CBs being left in the manual mode. ElectraNet has confirmed that the LV CBs in changeover boards have been re-configured such that this incident will not re-occur and has advised its control room of this arrangement. In addition, ElectraNet has confirmed that the affected circuit breakers are not present on transmission equipment/equipment LV supplies elsewhere in its network. 3. AEMO correctly identified the need to reclassify this incident as a credible contingency, as at the time of the incident the cause was unknown. Subsequently ElectraNet identified the incident cause and determined the incident was unlikely to re-occur. AEMO subsequently cancelled the reclassification. 4. The power system remained in a secure operating state and the Frequency Operating Standard was met during the incident.

Details	
Rectification	<p>To avoid a reoccurrence of this incident, ElectraNet has connected the AC supply for each South East SVC to separate transformer auxiliary supplies through re-configuration of the changeover boards. The changeover circuit breakers impacted have been left in manual mode (preventing any automatic changeovers). ElectraNet has confirmed that its control room has been advised of the affected AC changeover circuit breakers, ElectraNet has also reconfigured SVC power supply so the SVCs will remain in service following transformer trip.</p> <p>During its investigation, ElectraNet was made aware of a manufacturer equipment recall on several low voltage (LV) circuit breakers installed in the AC changeover boards at South East substation involved in this incident. This recall highlighted that one failure mode causes the affected circuit breakers not to operate when required. ElectraNet is planning to replace the affected LV circuit breakers at South East 275 kV substation but has not determined a timeframe for completion of this work at this stage. ElectraNet have confirmed that the affected circuit breakers are not present on transmission equipment/equipment LV supplies elsewhere in their network.</p>

Recommendations	<ol style="list-style-type: none"> 1. ElectraNet to replace LV circuit breakers affected by manufacturers recall at South East substation. 2. ElectraNet to share details of the manufacturers LV circuit breaker recall with the Power System Security Working Group.
