Trip of the Farrell – John Butters and Farrell – Roseberry – Newton – Queenstown lines on 10 April 2021

September 2021

Reviewable Operating Incident Report under the
National Electricity Rules

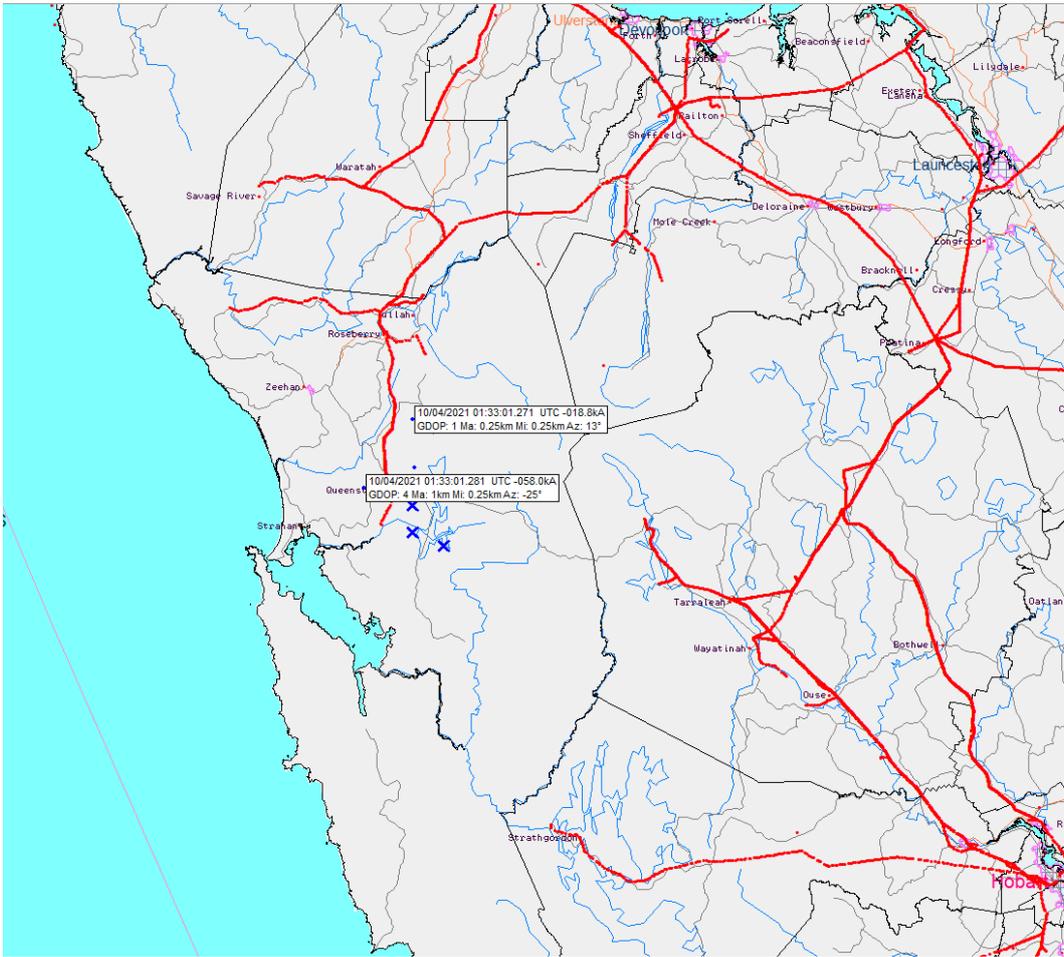
Figure 2 GPATS lightning data near to Queenstown substation and Tower 108 (time is in Coordinated Universal Time (UTC))

Power system response (facilities and services)	<p>Prior to the incident, there was lightning activity in the area of these transmission lines, however, no lightning strikes had been recorded in LWZ or LAZ in 30 minutes prior to the faults occurring.</p> <p>Post incident investigation has confirmed:</p> <ul style="list-style-type: none"> • The protection systems on the FA-JB 220 kV line and the FA-RB-NT-QT 110 kV line operated correctly to isolate the faulted lines. • There were two lightning strikes near the lines at the time of incident. The lightning strikes had an approximate magnitude of 18.8 kiloamperes (kA) and 58.4 kA respectively. The simultaneous trip of the FA-JB 220 kV line and the FA-RB-NT-QT 110 kV line was likely caused by the high magnitude lightning strike. • Protection systems at Farrell indicated that the faults were approximately located at 38 km to 41 km south of the Farrell substation which is in the region of Towers 98 and 108 of the FA-JB 220 kV line. At the same time of incident, Global Position and Tracking Systems (GPATS) recorded the high magnitude lightning strike of 58.4 kA which was several kilometres from west of Queenstown substation and near to the faults recorded by protection systems at Farrell. Refer to Figure 2 for the lightning data recorded by GPATS. The FA-RB-NT-QT 110 kV line and the FA-JB 220 kV line share common towers⁵ located in mountainous terrain approximately 460 metres above sea level and are protected by an overhead earth wire in this area. • A ground patrol of the lines in the fault area has been completed by TasNetworks, with no obvious signs of damage which may have caused (or be the result of) the incident.
