# Trip of Torrens Island 66 kV East busbar on 22 September 2021

March 2022

Reviewable Operating Incident  
Report under the National  
Electricity Rules

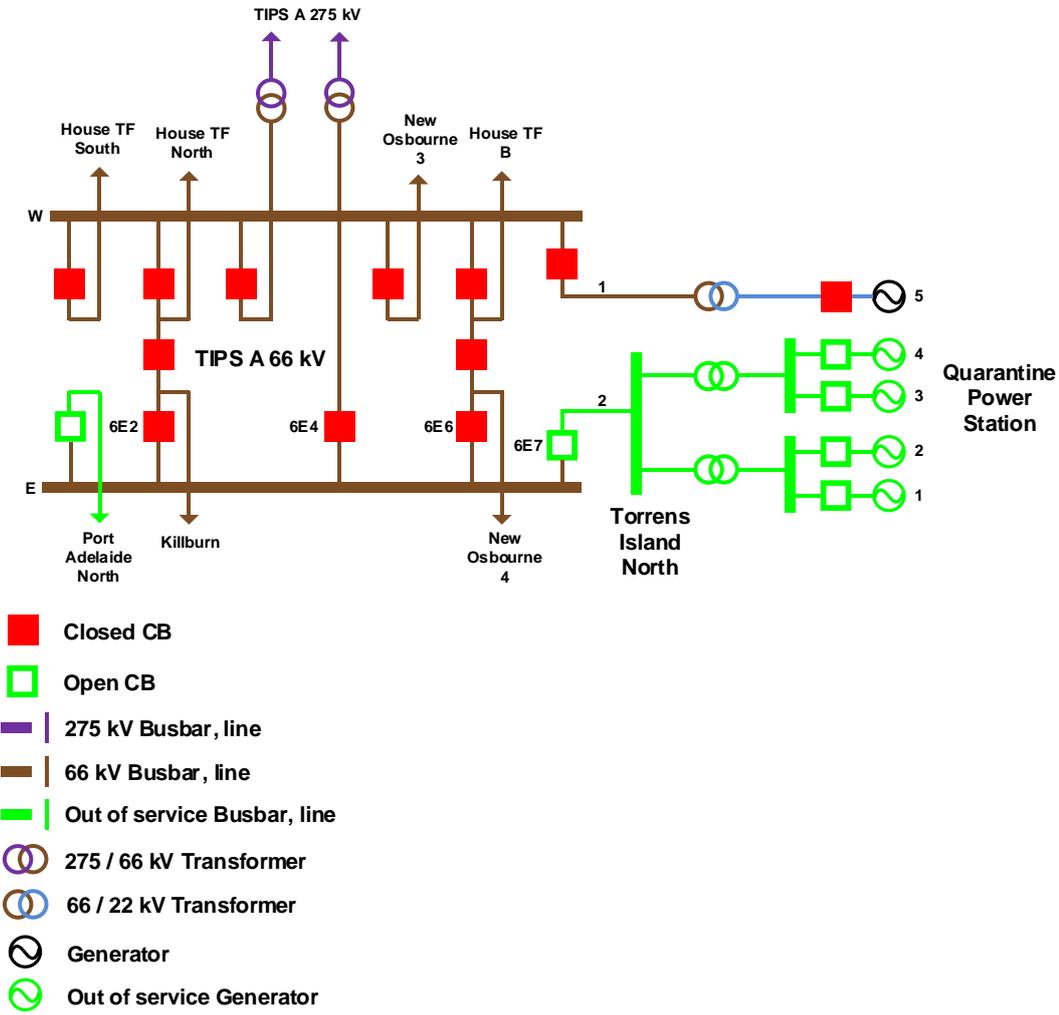
Figure 1 Incident diagram – Pre incident configuration

<b>Incident key events</b>	<ol style="list-style-type: none"> <li>At 1730 hrs on 22 September 2021, during restoration of TIPS A – TIN 2 66 kV line (upon closing Circuit Breaker (CB) 6E7) the TIPS A 66 kV East busbar tripped. Circuit Breaker Fail (CBF) protection operated tripping all CBs connected to this busbar, which offloaded the TIPS A East Tie Transformer (see Figure 2).</li> <li>Following the TIPS A 66 kV East busbar trip, QPS was informed and identified a trip signal being sent from its QPS 3 generator. This trip signal was reset by QPS staff and equipment restoration commenced.</li> <li>At around 1846 hrs on 22 September 2021, TIPS A 66 kV East busbar was returned to service.</li> </ol>
<b>Incident cause</b>	<p>ElectraNet's post incident investigation has confirmed that:</p> <ol style="list-style-type: none"> <li>A previously sent inter-trip signal on TIPS A – TIN 2 66 kV line at 1458 hrs on 21 September 2021 from QPS was not reset and remained persistently in "initiated" status.</li> <li>The Set X protection CBF scheme logic at TIPS 66 kV substation did not have any signal conditioning (in the form of a current check element) on its CBF time delay initiation. This meant that the persistent inter-trip signal had pre-triggered CB 6E7 "CB Fail" protection timer at TIPS A.</li> </ol> <p>Therefore, when the CB 6E7 closed, the Set X CBF protection immediately initiated a busbar trip.</p> <p>Origin Energy's initial investigation confirmed that:</p> <ol style="list-style-type: none"> <li>On 21 September 2021, ElectraNet was conducting trip testing on the 6E7 66 kV line. As expected, during this testing, trip signals were sent to the 6E7 66 kV line protection systems, and to TIPS A and TIN 66 kV substations.</li> </ol>

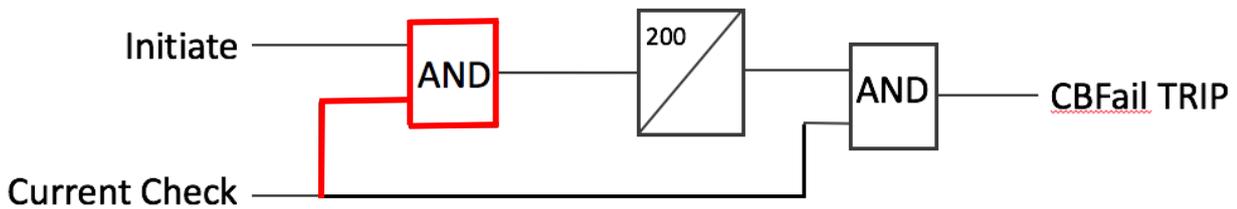
Figure 3 Incident diagram – Representation of modified Circuit Breaker Fail logic

<b>Conclusions</b>	<p>AEMO has concluded that:</p> <ol style="list-style-type: none"> <li>1. The cause of the trip of TIPS A 66 kV East bus has been identified as a pre-triggered Set X protection CBF Timer signal on TIPS A – TIN 2 line. The CBF Timer was pre-triggered as its logic did not include conditioning (in the form of a current check). This logic arrangement combined with a persistent intertrip signal being sent from QPS, due to a wiring issue, caused the incident.</li> <li>2. The power system remained in a secure operating state throughout this incident and the Frequency Operating Standard was met.</li> <li>3. AEMO correctly identified there was no requirement to reclassify this incident as a credible contingency.</li> <li>4. ElectraNet modified the Circuit Breaker Fail logic in the Set X protection to include a current check requirement before the CBF time delay (as illustrated in Figure 3). This modification avoids CBF maloperations under similar circumstances in the future.</li> </ol> <p>Origin Energy has identified the root cause of the persistent inter-trip signal from QPS as a wiring issue introduced during a protection scheme update in 2008. This wiring issue is scheduled for rectification during the next available outage of the affected equipment in Q2 2022.</p>

Note: the highlighted section of Figure 3 is the logic added to existing TIPS A 66 kV East busbar Circuit Breaker Fail protection. In the Original logic, the “Initiate” signal goes directly to the timer with no conditioning.

<b>Recommendations</b>	<p>Origin Energy plans to rectify the identified wiring issue in Q2 2022.</p>
